**DESIGN BASIS REPORT
SNAKE BROOK DAM**

MA01119

WAYLAND, MASSACHUSETTS

APRIL 2020

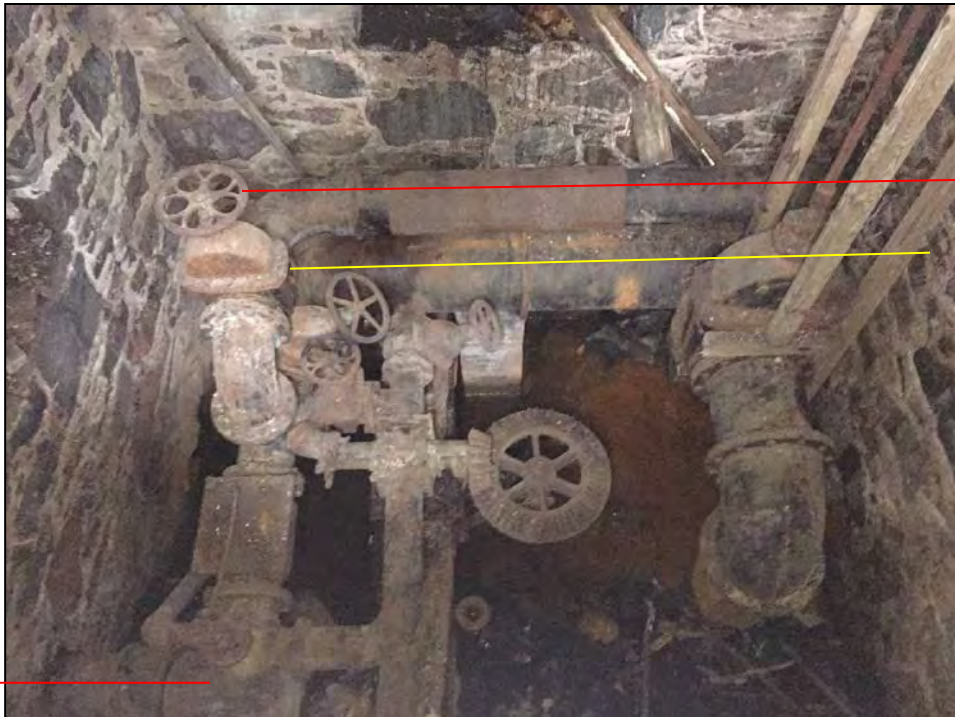
Photo No. 18: Gatehouse interior from the access door looking down and slightly right. 10-inch intake line and 10-inch distribution line both marked with a red line. 18-inch intake line marked with yellow line.

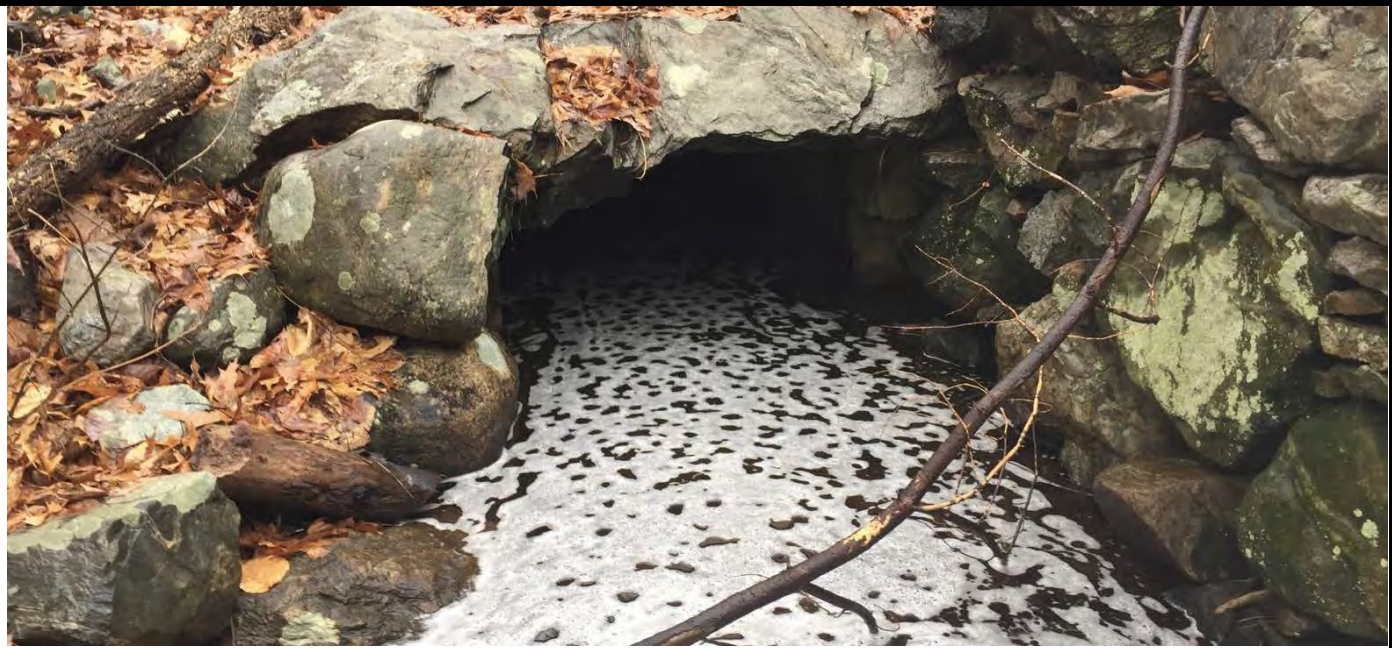
Distance	Clock	Features & Defects	VIDEO
0'-		outlet	
@10'		zoomed view appears to be collapsed

Conclusion	The culvert appears to be collapsed near the outlet.
------------	--

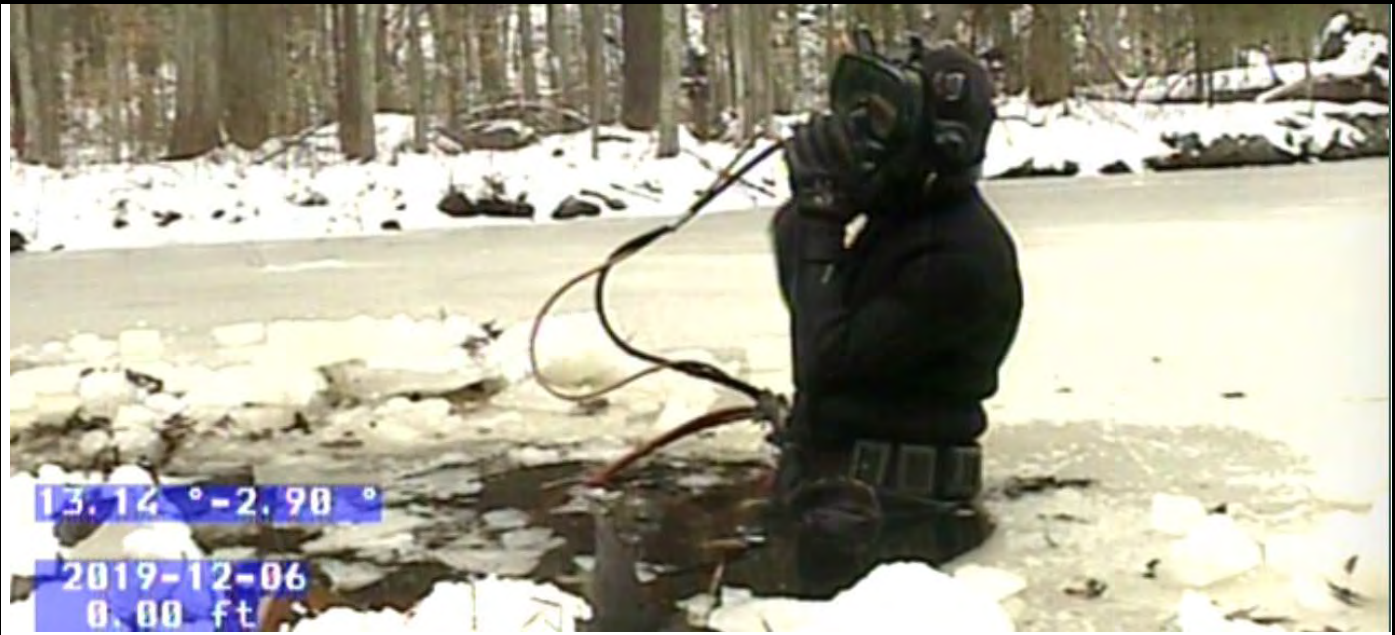
Distance	Clock	Features & Defects	VIDEO
25'		offshore-approximate location of inlet

Conclusion	The inlet pipe is buried in mud. No visibility.
-------------------	---

REMEDY PROCEDURES: The outlet pipe could not be inspected due to the presence of the soft mud inside the pipe. Possible remedies for eliminating the mud are placing an inflatable plug with a bypass in the outlet pipe and attempt to operate the outlet gate, to flush out the mud. The gate could be repaired to replaced while the plug is in place. Tapping a large hole into the outlet pipe in the gate house and installing a gate valve. Attempt to pump out the mud in the outlet pipe from the outside.
