22 October 2012

Reference: Old Stone Bridge, Wayland, MA

John M. Wathne, PE, President  
Structures North Consulting Engineers, Inc.

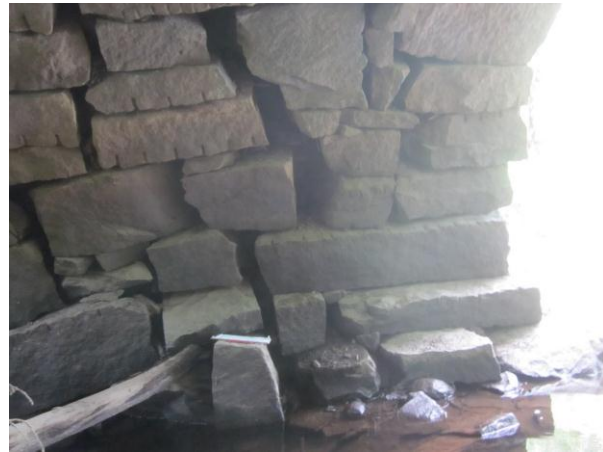
- On the intrados (underside) of each arch one can see oriented widenings of head joints that follow lineal orientations that run circumferentially to the arch. These are in essence longitudinal structural “cracks” in the unmortared structure that directly correspond to above-noted out-of-plane deviations of the side walls. Some of the widenings total more than 8”, which again correspond to the summed widths external deviations.

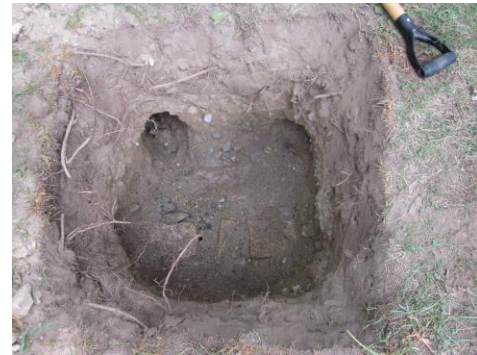
- Where the widenings occur, there is a loss of chinking and an eventual loss of soil. We experienced such soil loss first hand when we excavated one of our test pits near but not directly over one of these widenings and encountered a cavity within the soil at the side of the test pit that quickly turned into a sink hole.

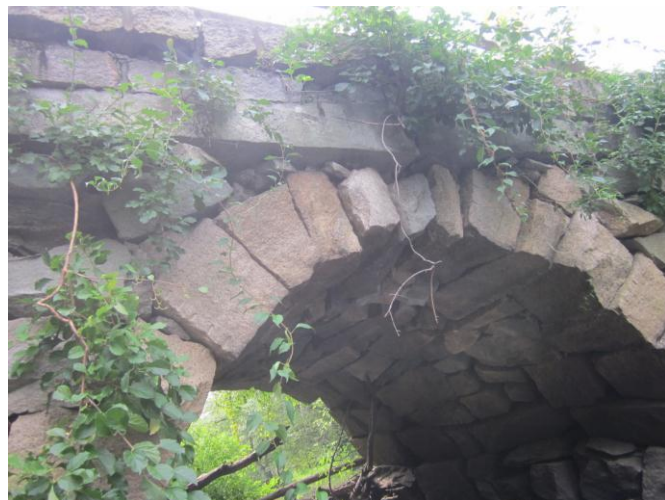
- In addition to the overall spreading movements, there are localized bulges in the sidewalls where the stonework has become unstable and has moved out. The worst of this is along the south side of the bridge where there is massive vegetation growth.

The secondary effect is fact that the parapet walls and edges of arches lean, and will continue to do so until they reach a point of instability. This has already started to occur at the south face of the bridge, where stones are buckling outward from parapet and edges of the arches. All portions of the bridge that are approaching instability must be dismantled and reconstructed.

3. Fully document and dismantle the bulged and leaning parapet walls and ends of arches.
4. Wet-chink and partially underpin the ends of the piers to restore solid bearing.
5. Re-chink the remaining piers from the outside, the remaining walls from both sides, and the arches from above, and replace stones that are missing.
6. Reconstruct the dismantled masonry elements to match their original configurations, up to the top of the lower top course of the parapet walls.
7. Cover the structure with filter fabric that turns up against the side parapet walls to create containment for fill.

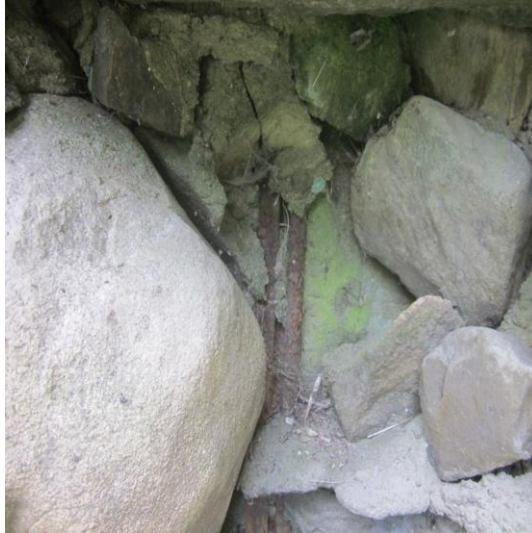
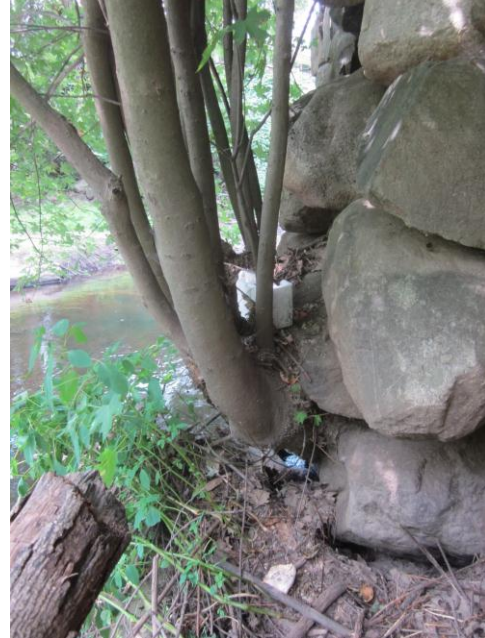
- There are also places where stones are missing or chinkers have fallen out, revealing cavities within the arch and sidewall construction.
- At the west end's concrete pier, stones are becoming detached from the north face and, to a greater extent, south face (the far west face seems

basically intact). Behind the fallen stones, one can see concrete and a few rusted rebars. At the south face, a significant patch of stones has moved out by as much 12" creating an earth filled pocket that is supporting the base of a tree.

At the far end of the bridge there is a totally different type of construction, and a totally different behavior. There the stones are becoming unbonded from the concrete mass that was placed against their back surfaces and need to be reapplied.

8. Document and remove all loose and shifted stones.
9. Inspect and repair exposed portions of the concrete core, cleaning and coating or removing rusted reinforcing and grout injecting cracks.
10. Reinstall all removed and missing stones, wet bonding and pinning them back into place.
11. Additionally pin any other potentially loose stones and grout any voided collar joints encountered.
12. Create a surface bonded mortar topping layer over the concrete to positively pitch the top of the pier into unmortared westernmost arch construction, and cover the parging with a pre-formed drainage composite.
