Reference: Old Town Bridge, Wayland, MA

On 10 August 2012 we performed an investigation of the Old Town Bridge in Wayland. This included visual observations from the top, sides, and undersides of the bridge, three test pits, and several samplings and probes.

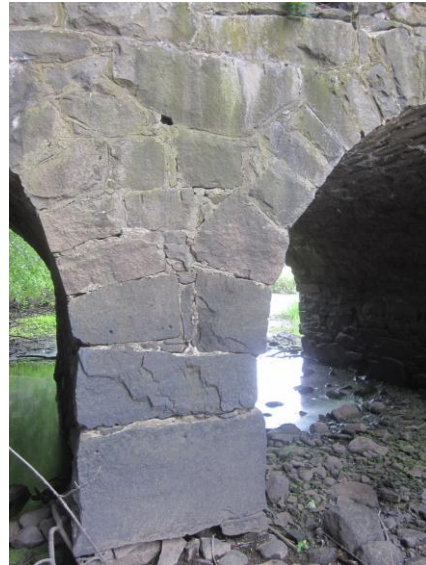
1. A combination of buried rubble and solid cap stones were dry laid as footings within the relatively shallow riverbed, and then 3-feet wide by 18-foot long vertical piers were dry-stacked atop the footings for a height of approximately 4-feet. The ends of these piers had full-width stones to provide a solid tie-in and to counter the dynamic effects of the river flow.
2. Arched wooden forms were then constructed between the piers to support the construction of fully mortar bedded single wythe stone arches rising approximately 5-feet off of the piers. The board form lines can be seen on the intrados of each arch, where the bedding mortar was squeezed out from between the arch stones onto the forms and then hardened.

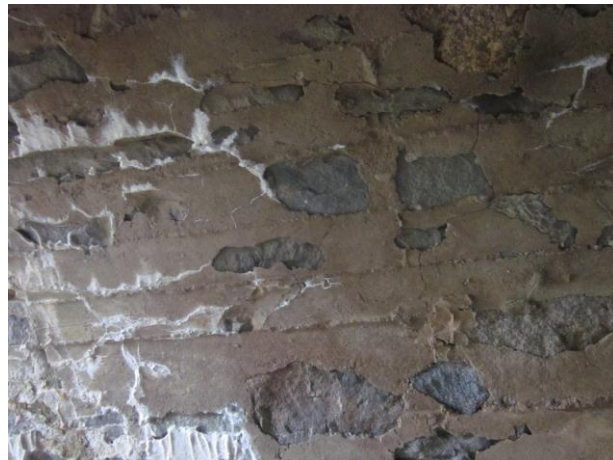
The considerable hardness of this mortar, along with the fact that it has lasted for more than 160 years strongly suggests that it contains a large proportion of hydraulic cement. Because artificial (portland) cement was not imported or manufactured domestically until the around 1870, the hydraulic component would almost certainly have been natural cement, which had first been used domestically around 1820 on the Erie Canal. The exposed mortar with the form lines, which we know is as old as the arches (since there would have been no other practical way of creating this effect), has the reddish brown hue that is common to most natural cements.

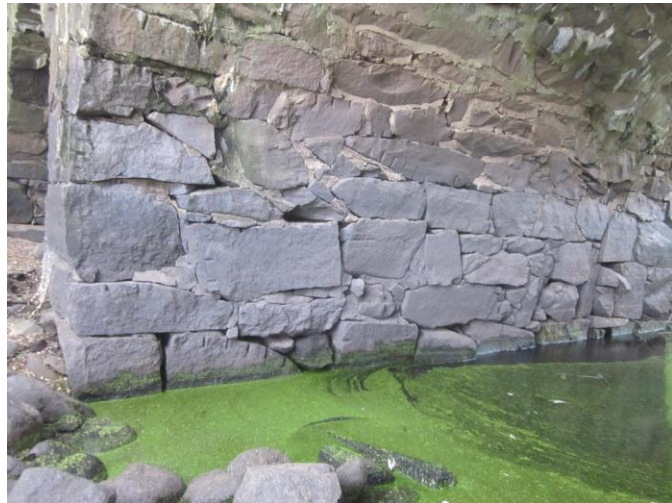
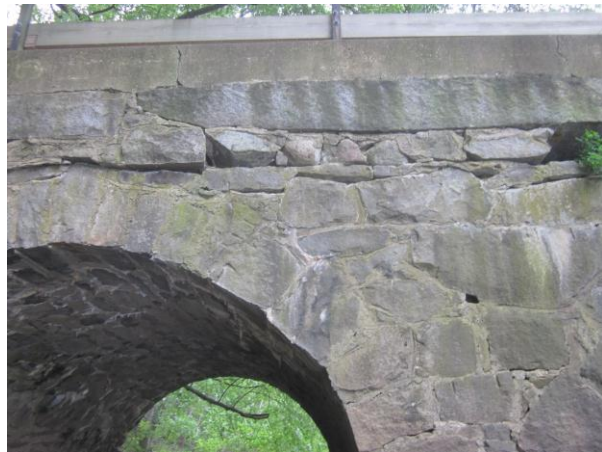
- There are oriented structural cracks that follow the some of the joint lines where the partially wet laid parapet wall construction meets the fully bedded arch and valley wedge construction, and the parapet wall construction has become loose and has shifted outward in several locations by as much as 3-inches.

- There are other scattered areas where the stonework has become loose or shifted, particularly at the end approaches, which were dry-laid and then tuck pointed with mortar.

5. Reconstruct dismantled sections of masonry to match original appearance and geometry. Removed sections of the parapet walls should be reconstructed as solidly bedded construction for greater longevity.
6. Add a bonded mortar topping over the stone arches that is pitched toward the ends and cover with a fluid applied waterproofing membrane and drainage composite. This would drain into new crushed stoned filled dry wells that would be created against the far edges of aprons within the approaches at each end.
7. Cover the bridge deck with compacted structural fill and pave to create a roadway surface.
8. Clean, hot-dip galvanize, and shop paint the original, salvaged iron stanchions and reinstall at their original positions.
9. Form and place new reinforced concrete curbs to match the original curbs.
10. Re-create the wooden side rails.

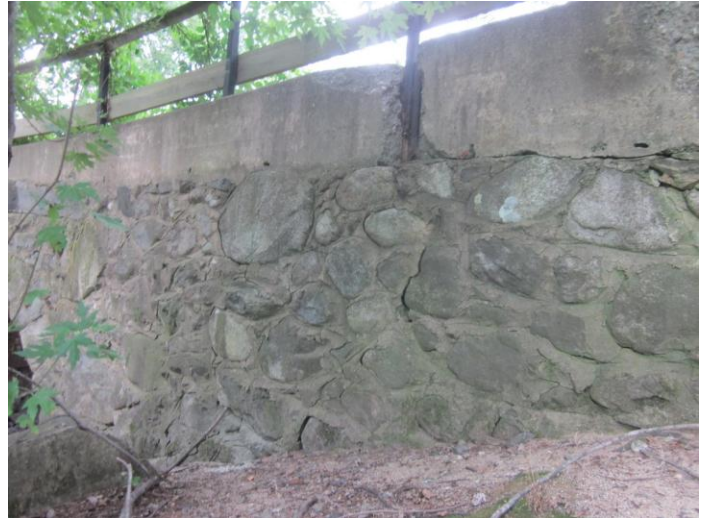
- The concrete curbs that run along the tops of the parapet walls are cracked through at most of the stanchions because the stanchion bases are rusting.
- There are efflorescent deposits and short stalactites on the undersides of the arches, caused by water seeping through the roadway and trickling through the arch masonry and leaching salts out of the mortar and soil materials within the path of flow.
