COMPREHENSIVE BUILDING/PROGRAM AUDIT
for
THE TOWN OF WAYLAND
MASSACHUSETTS

May 10, 2013

Prepared By
Drummey Rosane Anderson, Inc
Architects
Waltham, Massachusetts

BUILDING USE AUDIT

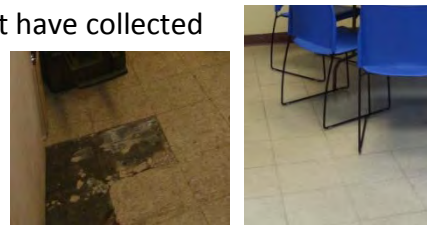
- 4 Vinyl floor tile in a number of locations have joints that have collected dirt giving a poor appearance to the floor. With re-organization of the floors it is recommended that sheet vinyl flooring be installed to replace tiles. In the storage rooms in the former kitchen adjacent to the Hearing Room floor tiles need to be replaced. 95

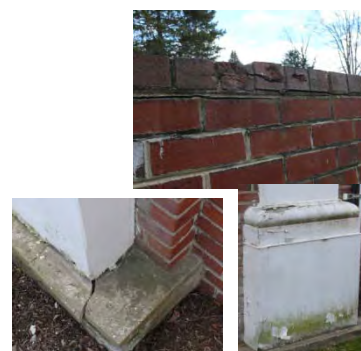
- 2 Pilaster bases are starting to rot. Replace deteriorated wood and re-paint bases.

3 Concrete at pilaster adjacent to ramp is cracked and should be replaced.

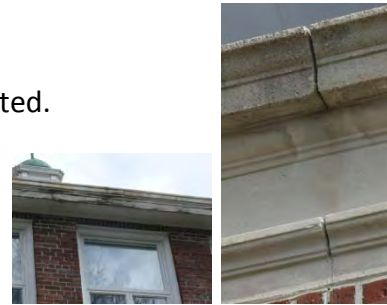
2 Major repairs are needed to wood fascia/gutters that are rotting and paint is failing at pre-school wing.

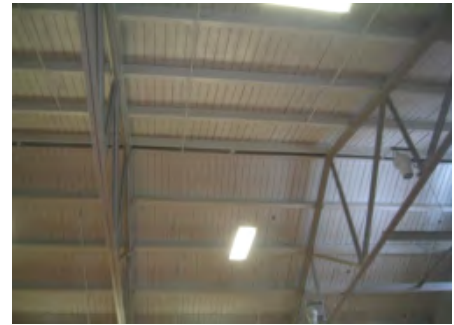
The Town Gym (original Gym/Auditorium, with a stage at the south end) is located at the northwest corner of the complex. Gable roof construction over the Gym consists of timber deck spanning up the slope to timber purlins. The purlins span across the slope (approximately 16 feet) to steel trusses (4 equally spaced), which clear span the space. Perimeter walls are brick masonry construction. See photo at right.

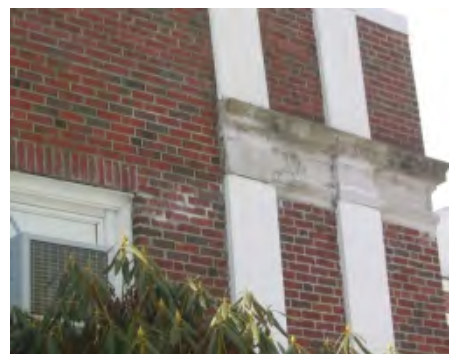
- The condition of the exterior brick is generally satisfactory; repointing is required in some areas. Brick masonry and cast stone trim at the northwest corner of the large Hearing Room section is deteriorating and shows efflorescence (See photo at right). Similar conditions are present on the back (south side of the building, adjacent to the east wing).

Loose lintels are rusted in some cases (although not significantly); cleaning and painting is required. Loose lintels at all locations conditions should be inspected and evaluated in conjunction with future renovations to the building.

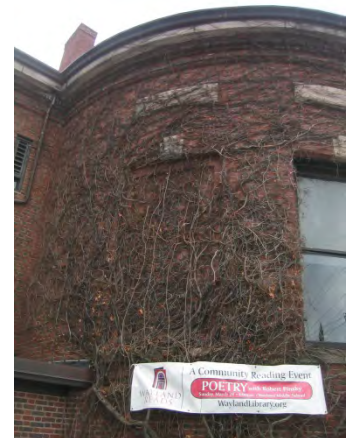
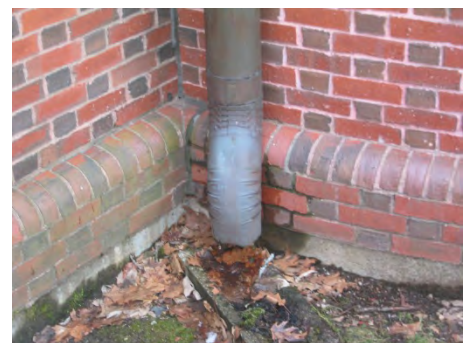
- The presence of perimeter and underslab drainage systems (in the 1987 addition) notwithstanding, there have been water issues at the Ground Floor in the past. Storm drains apparently back up during peak rainy periods. The downspouts of the 1987 addition discharge water onto splash blocks, adjacent to the foundation walls (See photo at right). FBRA recommends that water from downspouts be piped away from the building, to minimize the potential for water infiltration at the Ground Floor level and to reduce hydrostatic pressure on the foundation walls.

- Reportedly, there are air circulation problems in the Attic space of the original library, which exacerbated moisture related issues before the tile roof was replaced in 2007. Further review is recommended (Attic space was not accessed during the site visit).
