PREPARED FOR:
THE TOWN OF WAYLAND CONSERVATION COMMISSION

DESIGN BASIS REPORT
SNAKE BROOK DAM
MA01119
WAYLAND, MASSACHUSETTS

PARE PROJECT NO. 19167.00

APRIL 2020

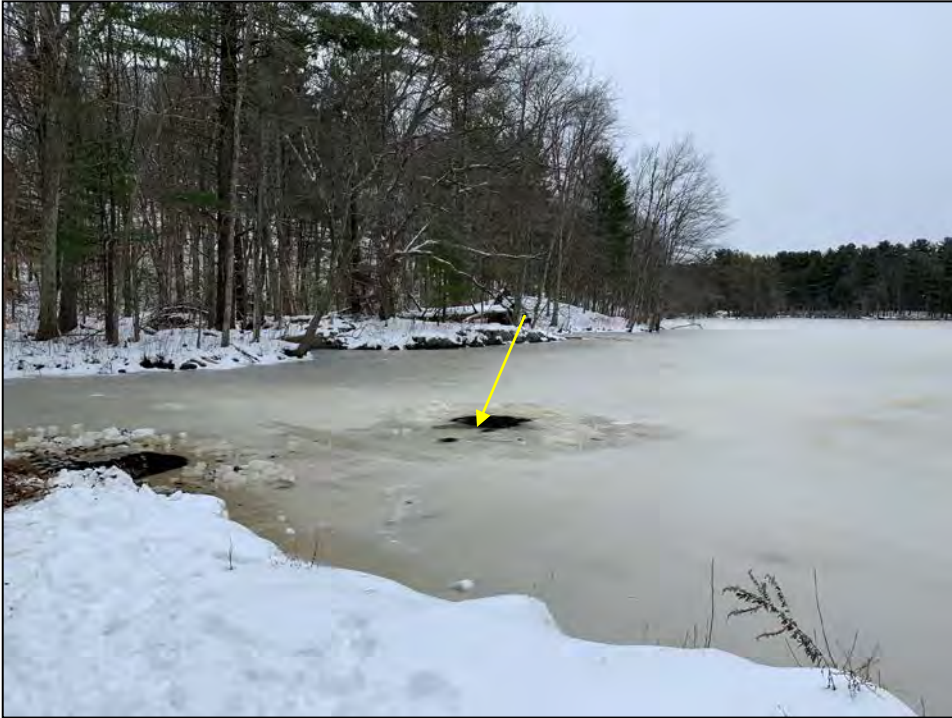
Photo No. 17: Approximate location of inlet end of the 18-inch conduit found during the dive inspection completed in December 2019.

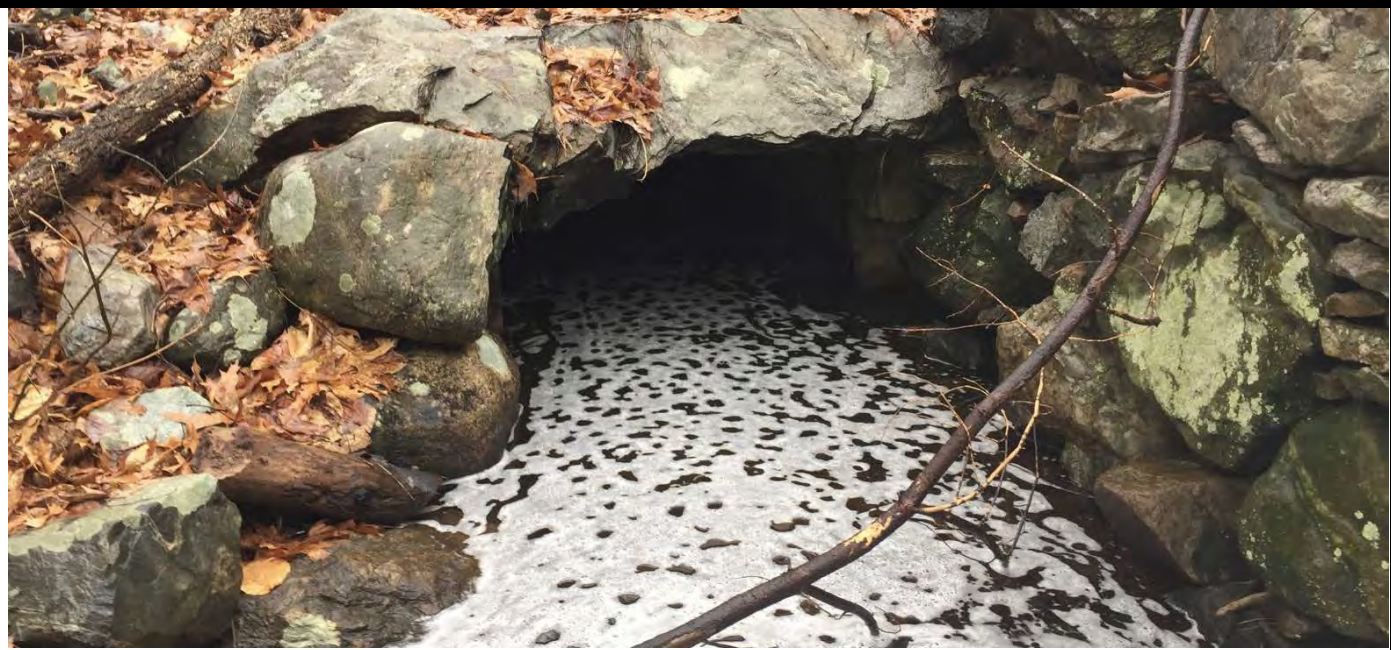
From	To	Direction	ID	System	Length
outlet	gate house	north/against flow	@2X3'	stone culvert	@90'

@10'		zoomed view appears to be collapsed	
------	--	-------------------------------------	--

Conclusion	The culvert appears to be collapsed near the outlet.
-------------------	--

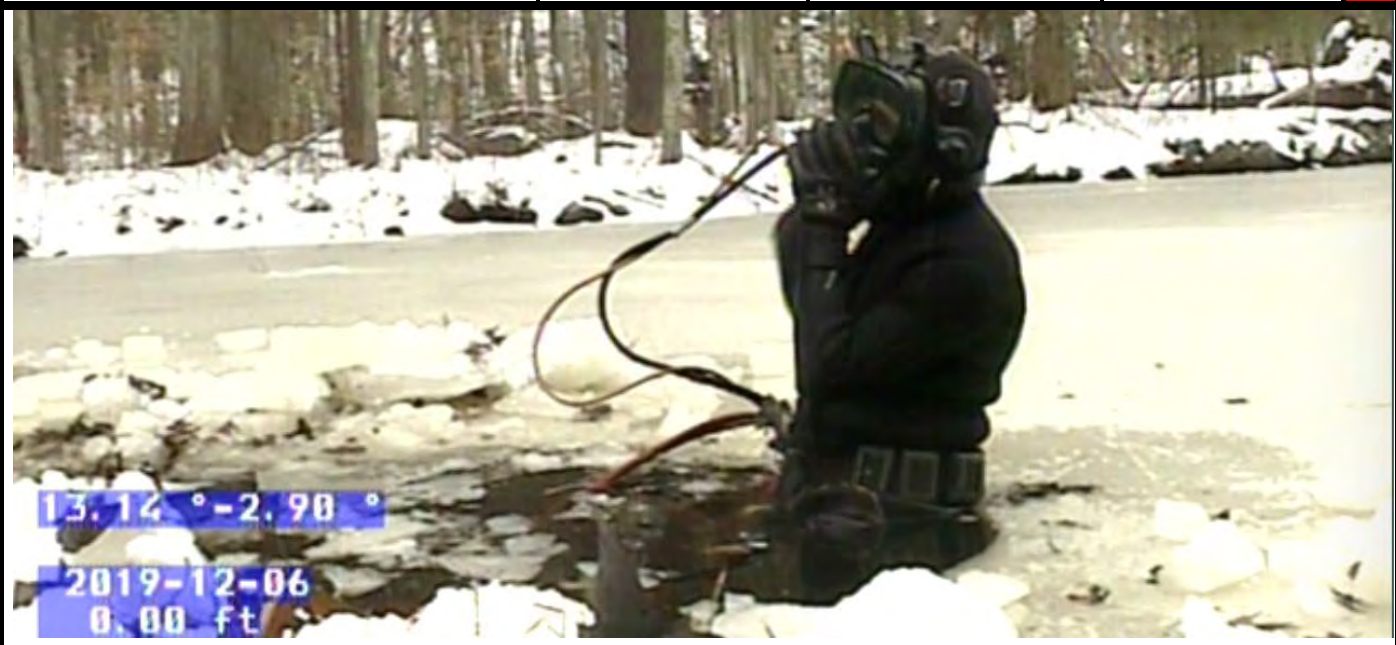
From	To	Direction	ID	System	Length
inlet	gate house	south/with flow	18"	FE/H2O	@70'

Distance	Clock	Features & Defects	VIDEO
25'		offshore-approximate location of inlet
