Re: **Follow-Up Inspection – March 2022**
Snake Brook Dam (MA01119)
Wayland, Massachusetts
(PARE Project No.: 19167.02/800)

**Commonwealth of Massachusetts
Department of Conservation and Recreation
Office of Dam Safety Poor Condition Dam Follow-up Inspection Form**

Dam Name: Snake Brook Dam
Dam Owner: Town of Wayland
Nat. ID Number: MA01119
Hazard Potential: Significant (Class II)
Location of Dam (town): Wayland
Coordinate location (lat,long): 42.33425°N/71.34166°W
Date of Inspection: March 9, 2022
Weather: 42°F, Cloudy

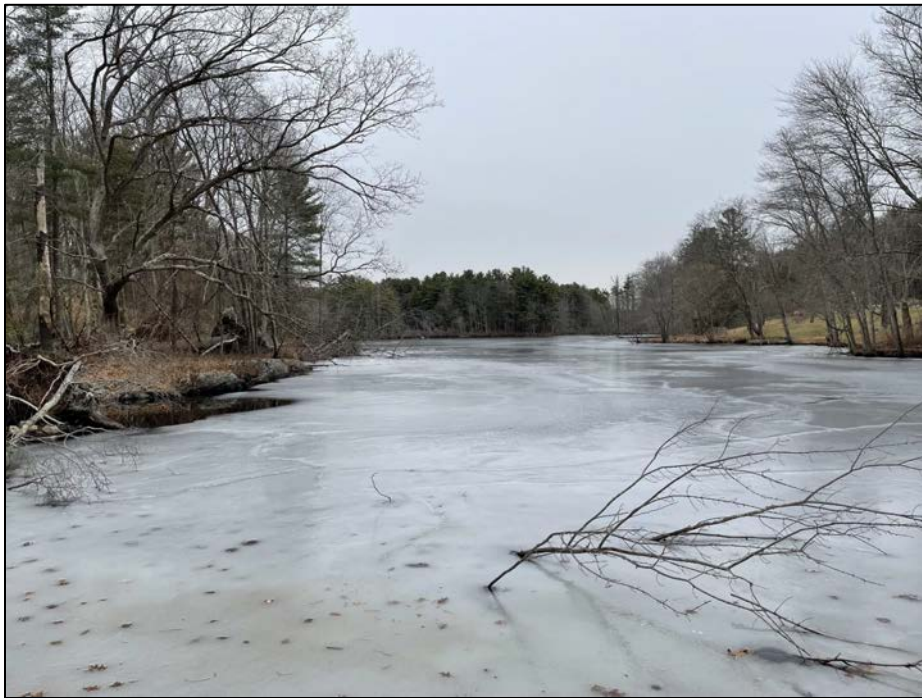
Photo No. 1.: Overview of the impoundment from the dam crest.

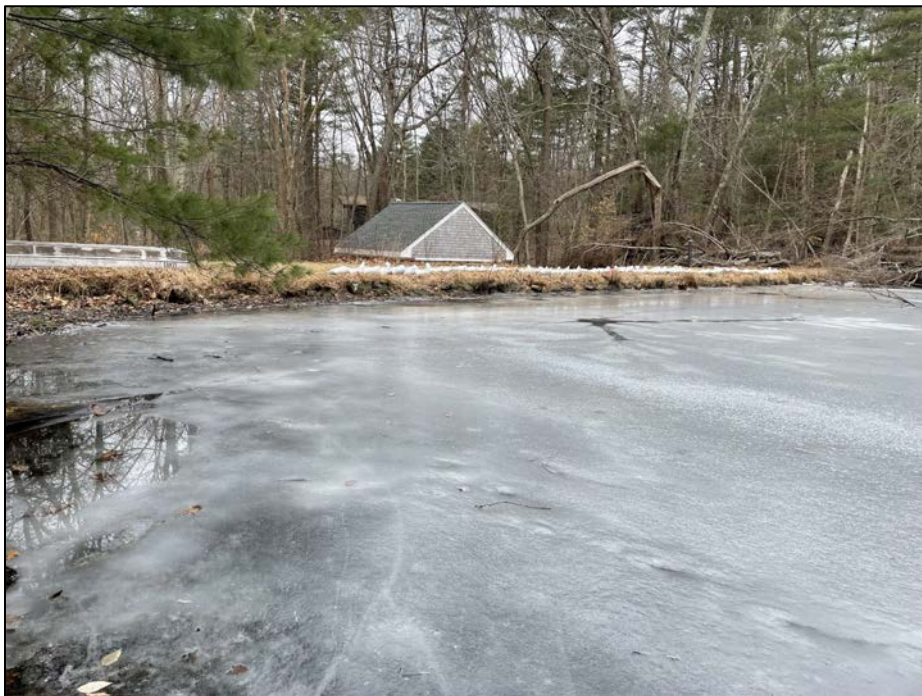
Photo No. 2.: Overview of the upstream face of the dam from the upstream left abutment looking downstream and right.

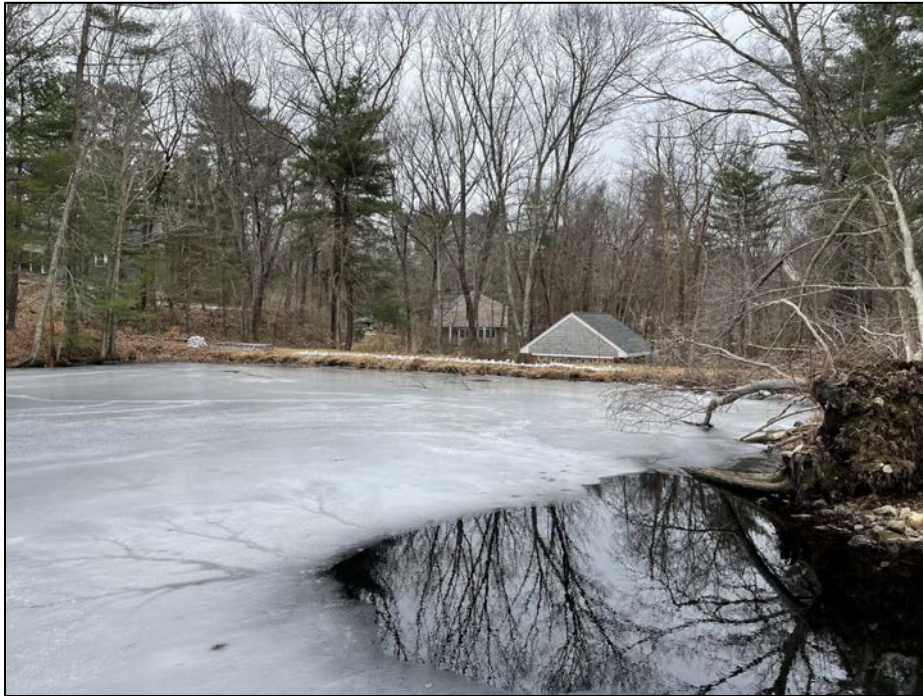
Photo No. 3.: Overview of the upstream face of the dam from the spillway approach looking downstream and left.

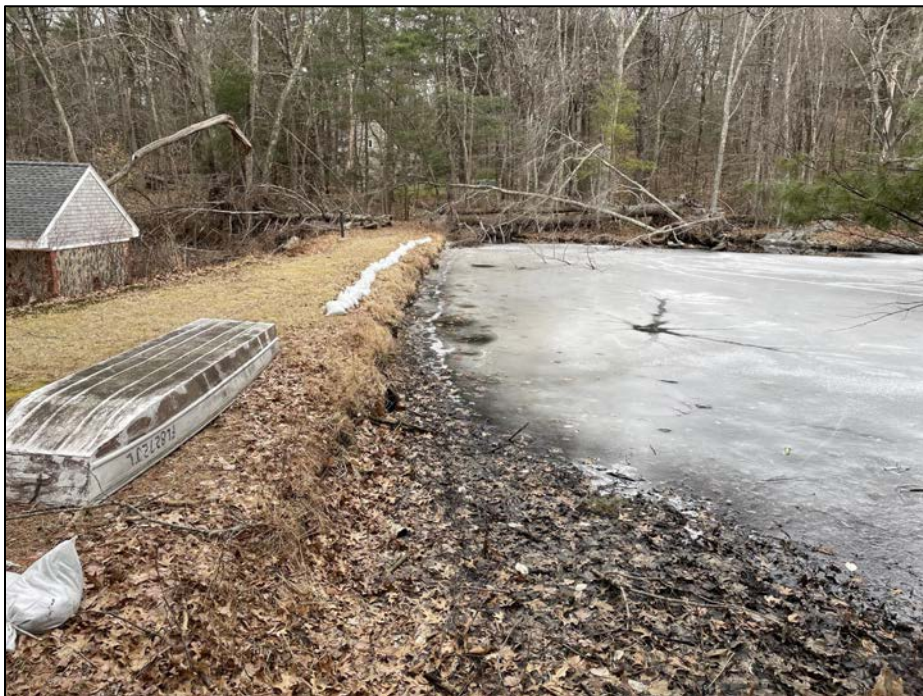
Photo No. 4.: Upstream slope from the left abutment looking right.

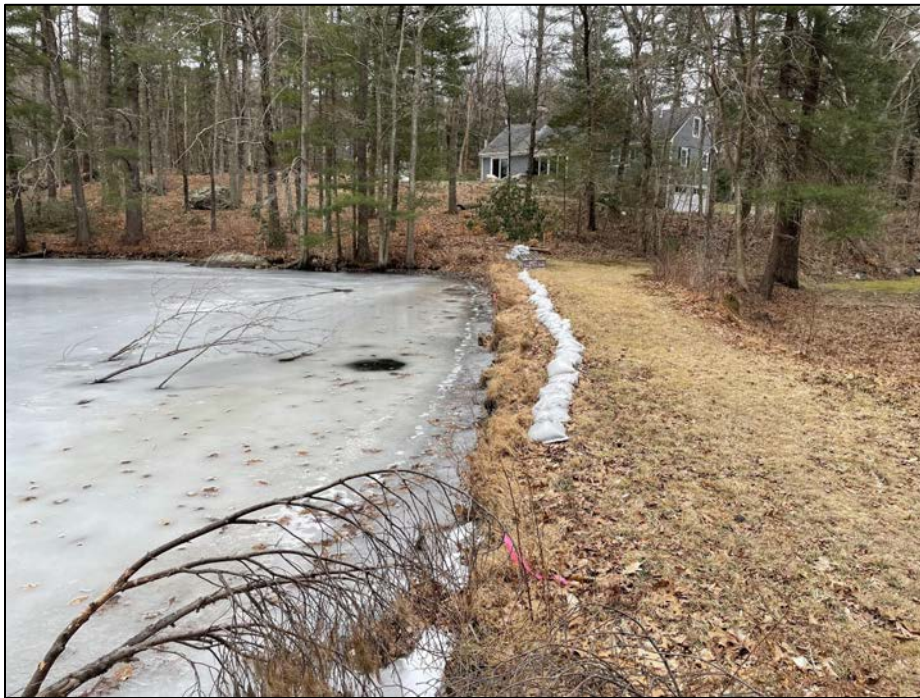
Photo No. 5.: Upstream slope from near 1+30 looking left.

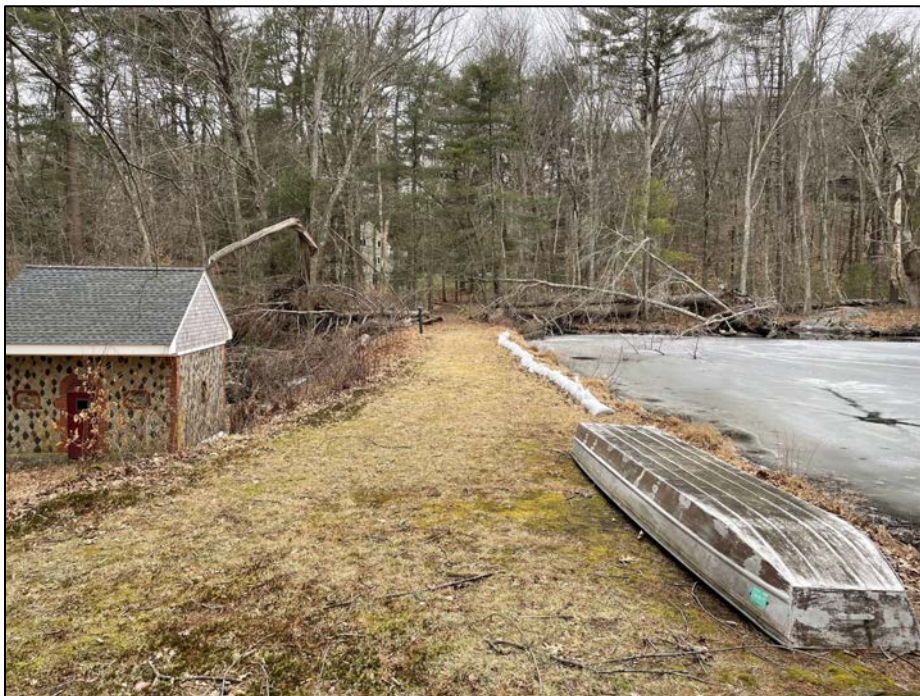
Photo No. 6.: Crest of the dam from the left abutment looking right.

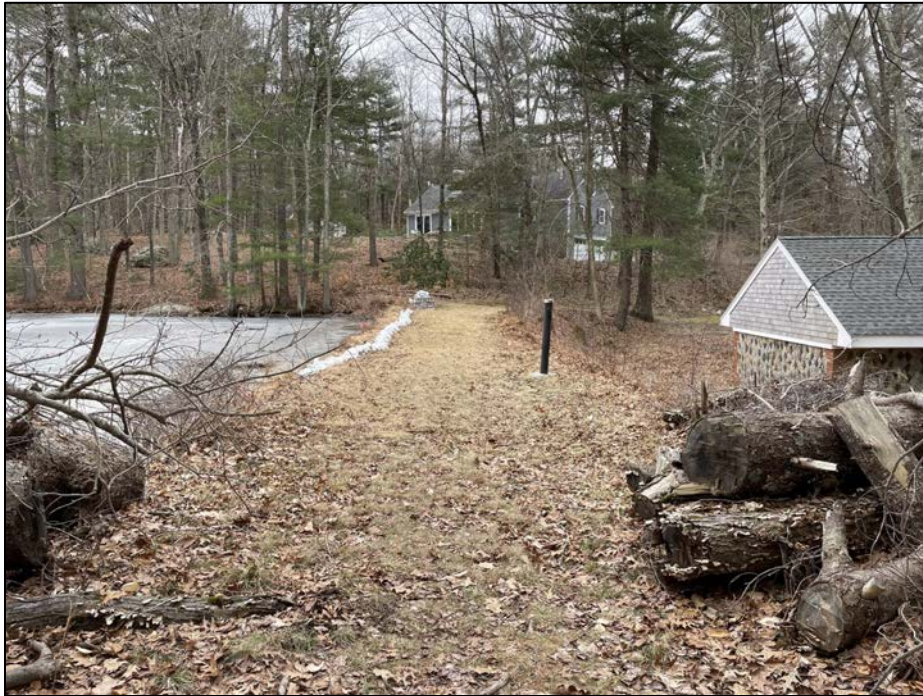
Photo No. 7.: Crest of the dam from near 1+40 looking left.

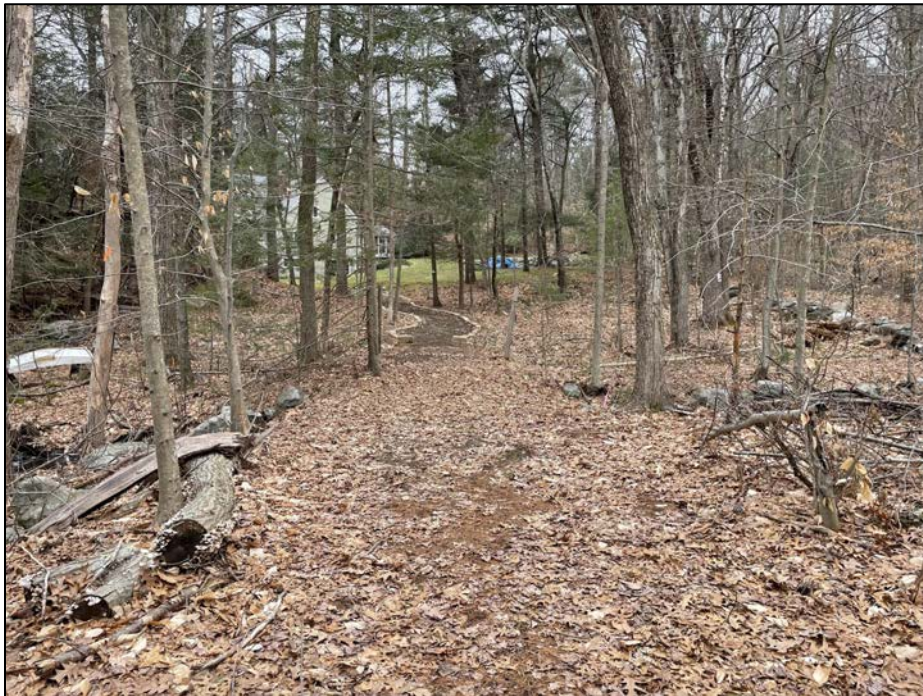
Photo No. 8.: Crest of the dam from near 1+40 looking right.

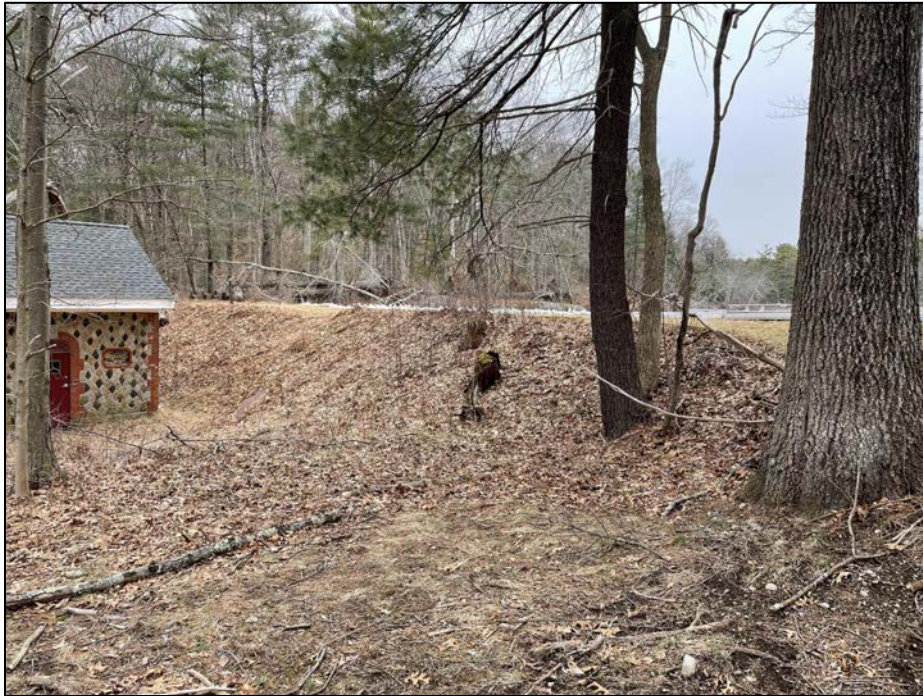
Photo No. 9.: Downstream side of the dam from the downstream left abutment looking upstream and right.

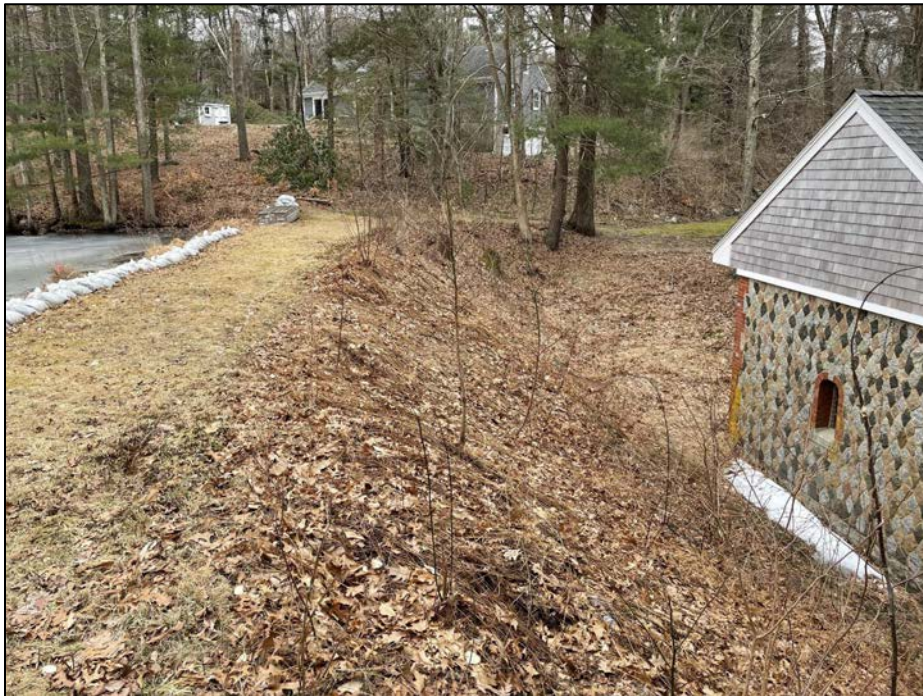
Photo No. 10.: Downstream side of the dam from near 1+00 looking left.

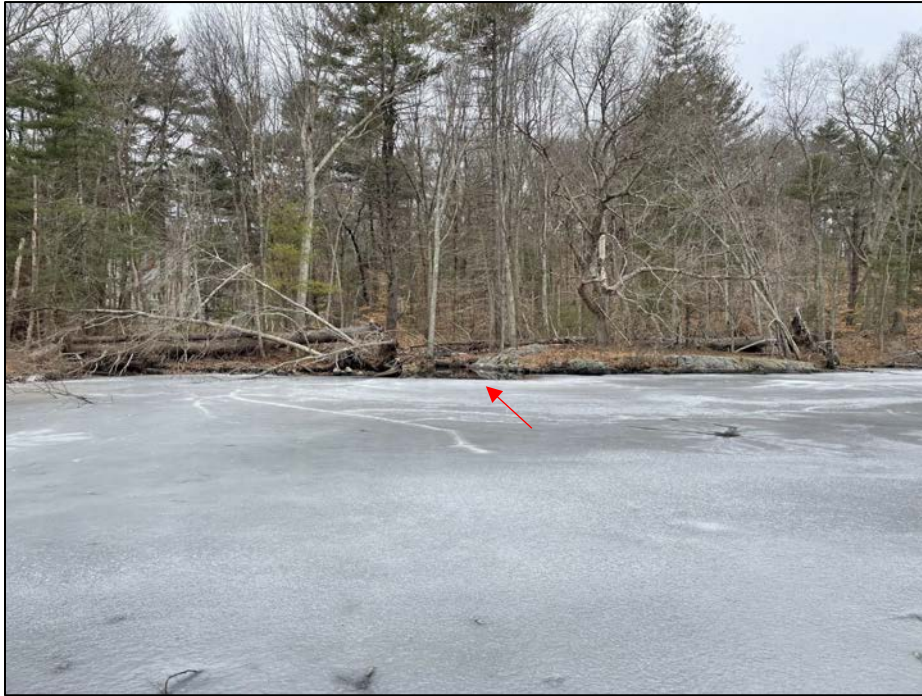
Photo No. 11.: Spillway approach (red arrow) from the upstream left abutment looking right

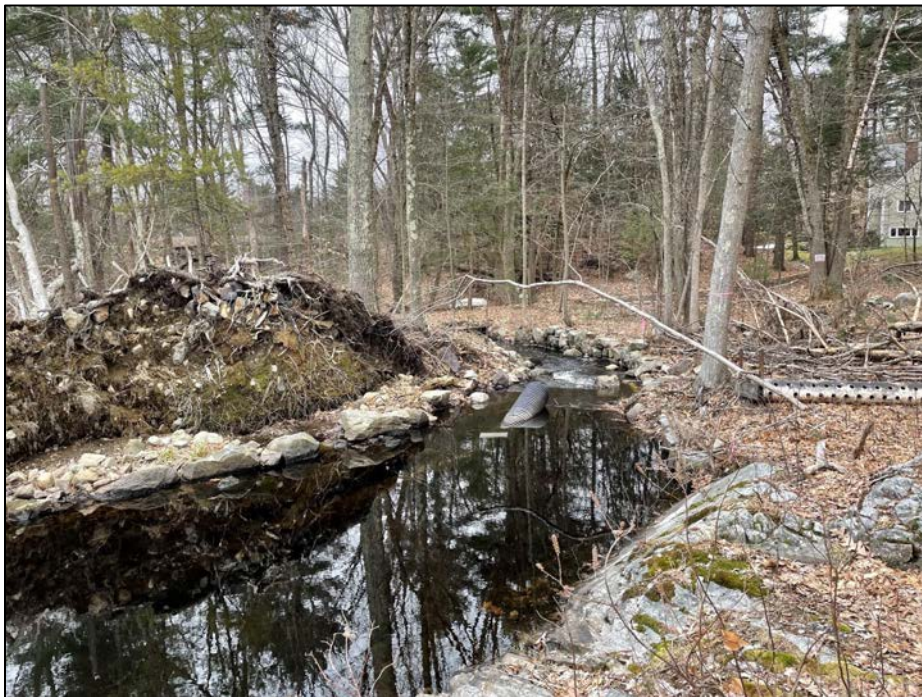
Photo No. 12.: Spillway control section from the approach looking downstream.

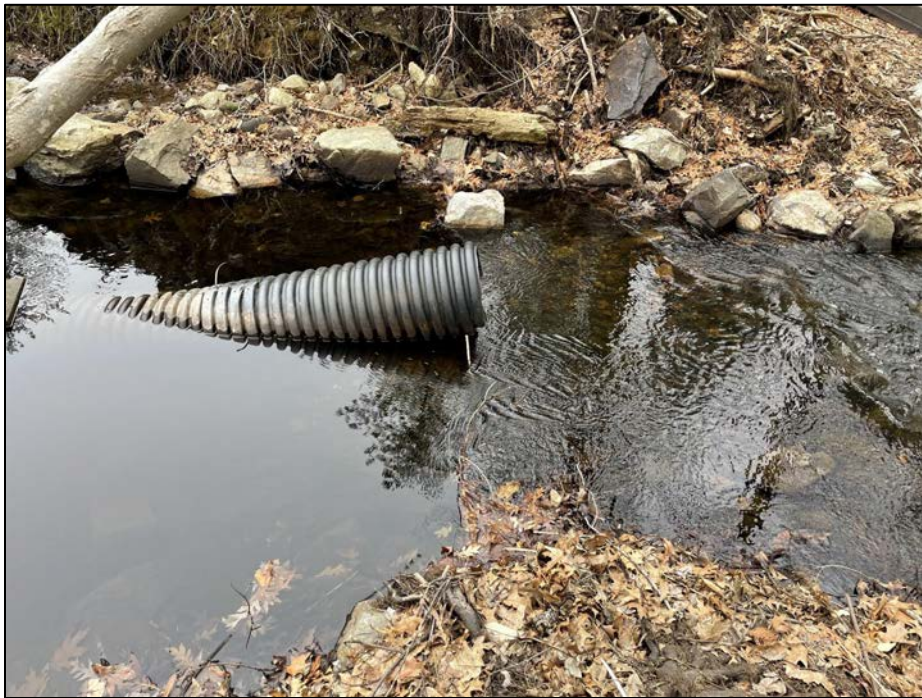
Photo No. 13.: Spillway control section. Note beaver deceiver pipe.

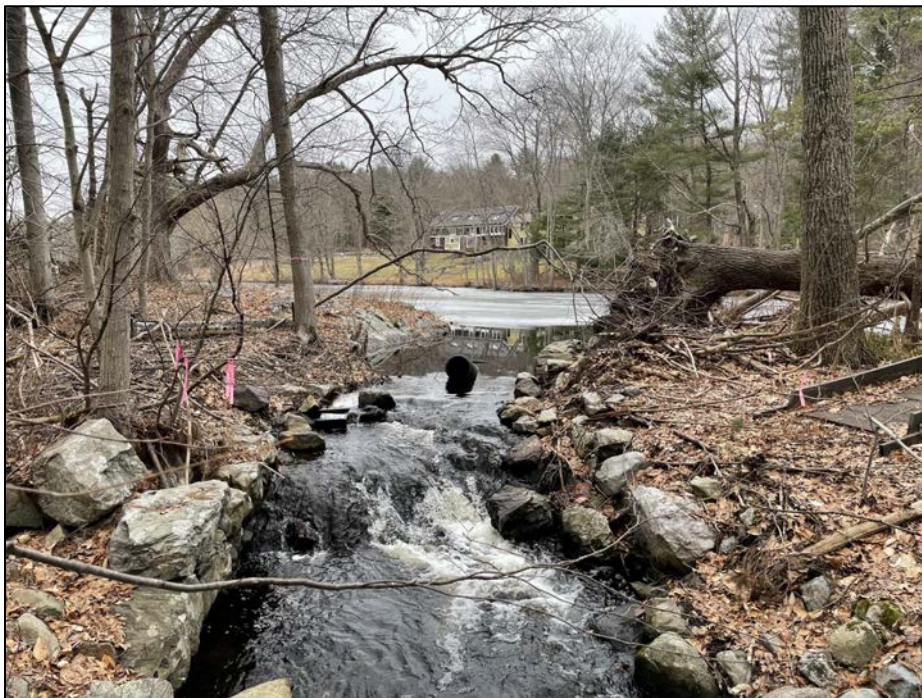
Photo No. 14.: Spillway control section from the discharge channel looking upstream.

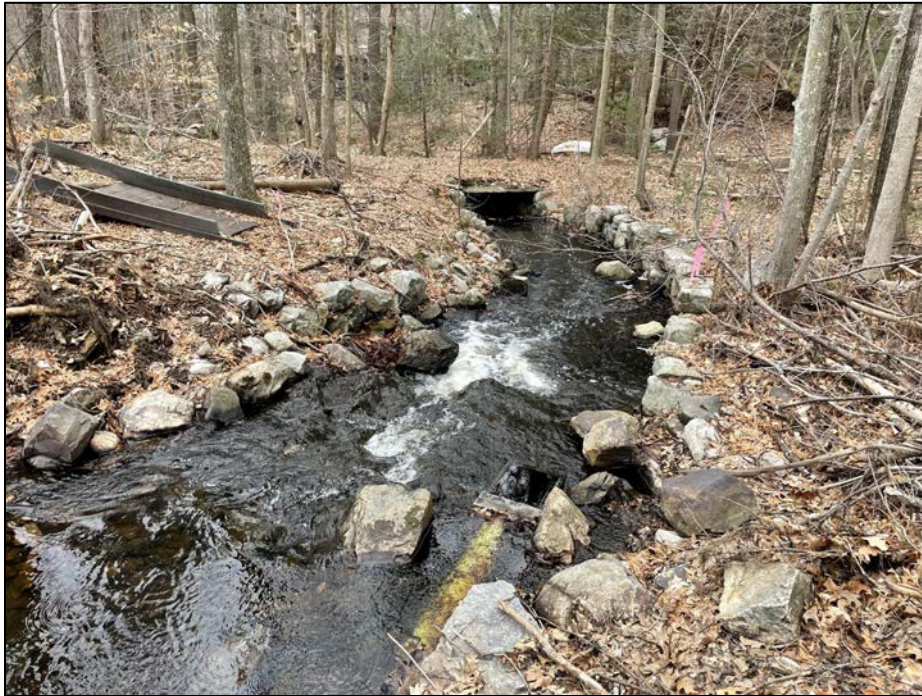
Photo No. 15.: Discharge channel of the spillway and the stone culvert from near the control section looking downstream.

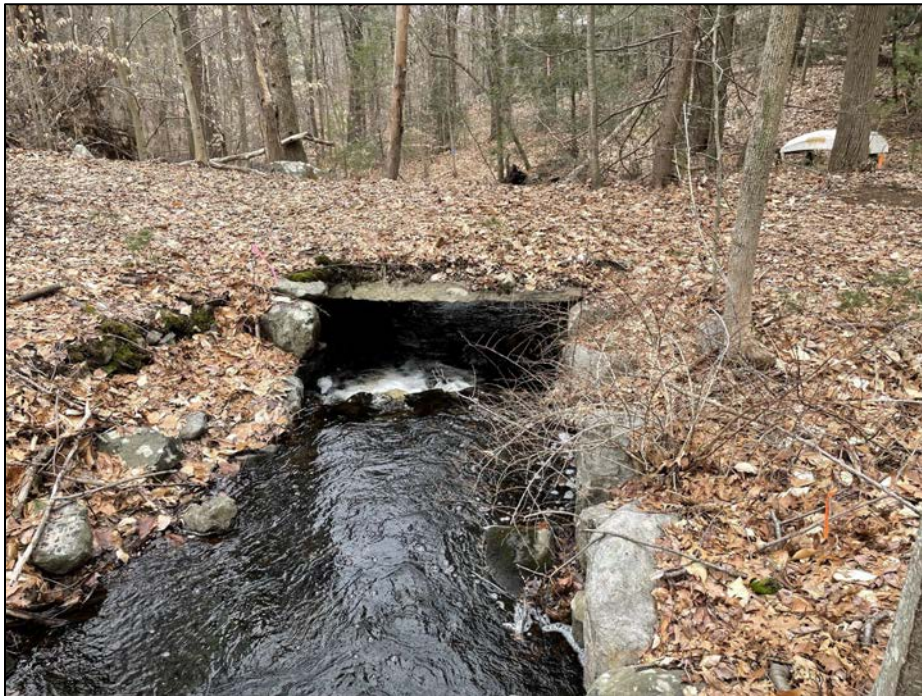
Photo No. 16.: The stone culvert that carries the spillway channel beneath the crest looking downstream.

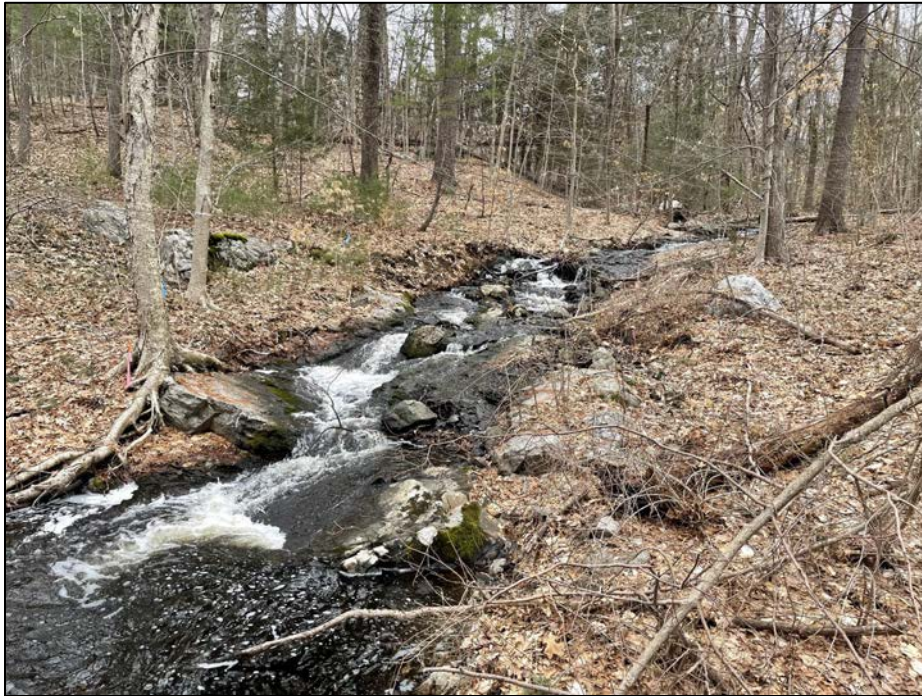
Photo No. 17.: Discharge channel of the spillway from the downstream channel looking upstream. Note the apparent bedrock outcrops throughout.

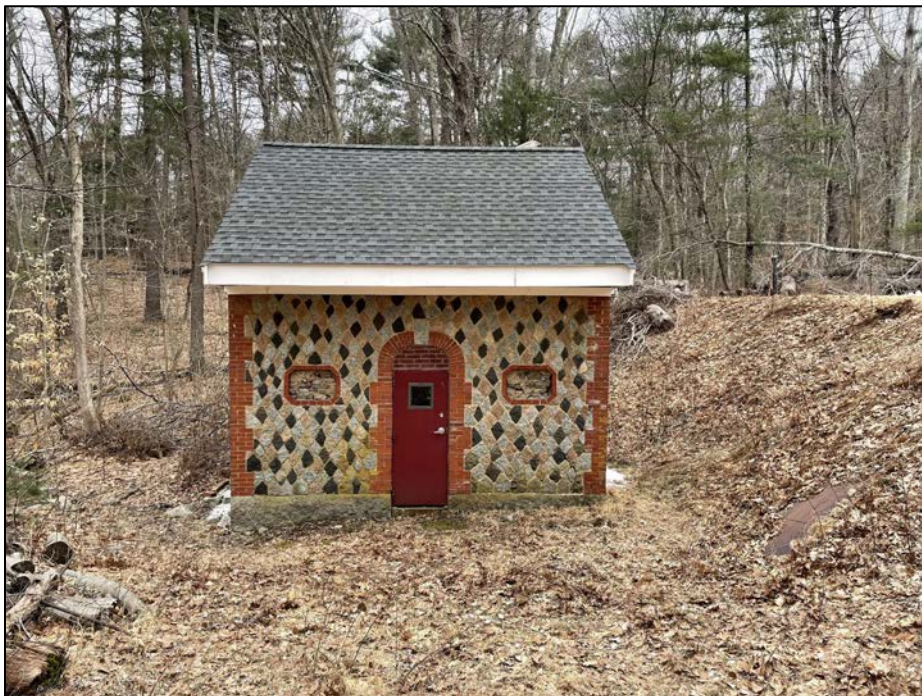
7. Gatehouse deficiencies including collapsed roof, inoperable door, and no safe access to mechanical equipment
8. Sediment/leaf accumulation up to 1-foot above the level of the 18-inch conduit within the impoundment as well several downed trees and limbs

Photo No. 18.: Left side of the gatehouse.

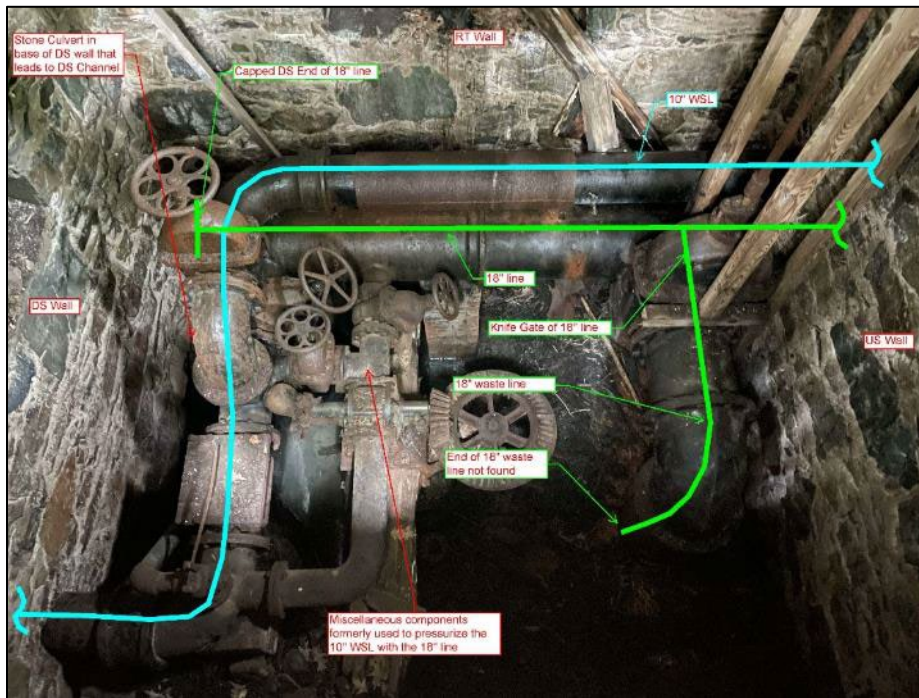
Photo No. 19.: View of the base of the chamber of the gatehouse with the various piping and controls of the 18-inch LLO and the 10-inch WSL.

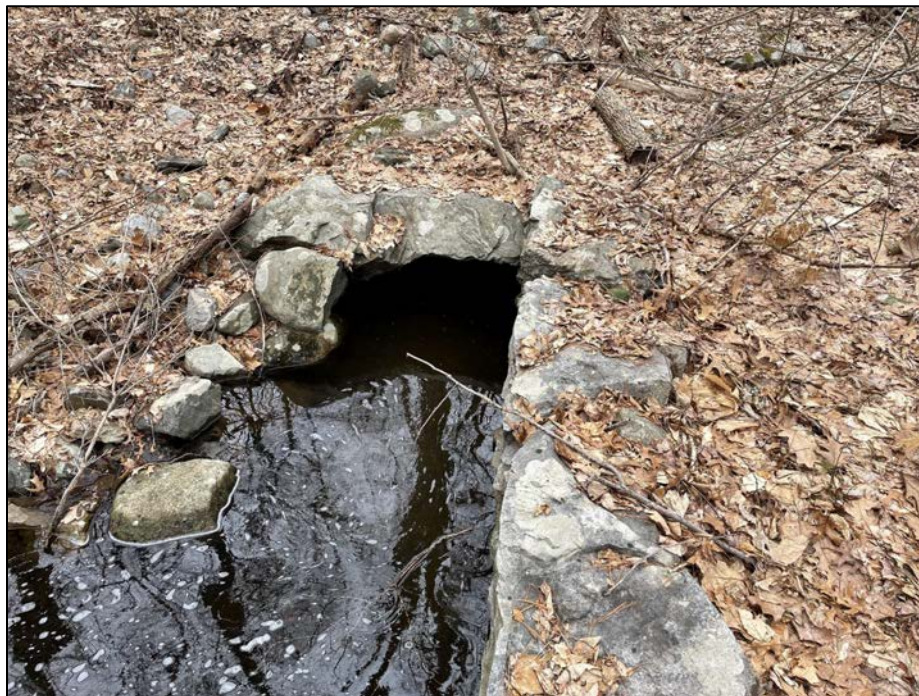
Photo No. 20.: Downstream end of the stone culvert looking upstream.

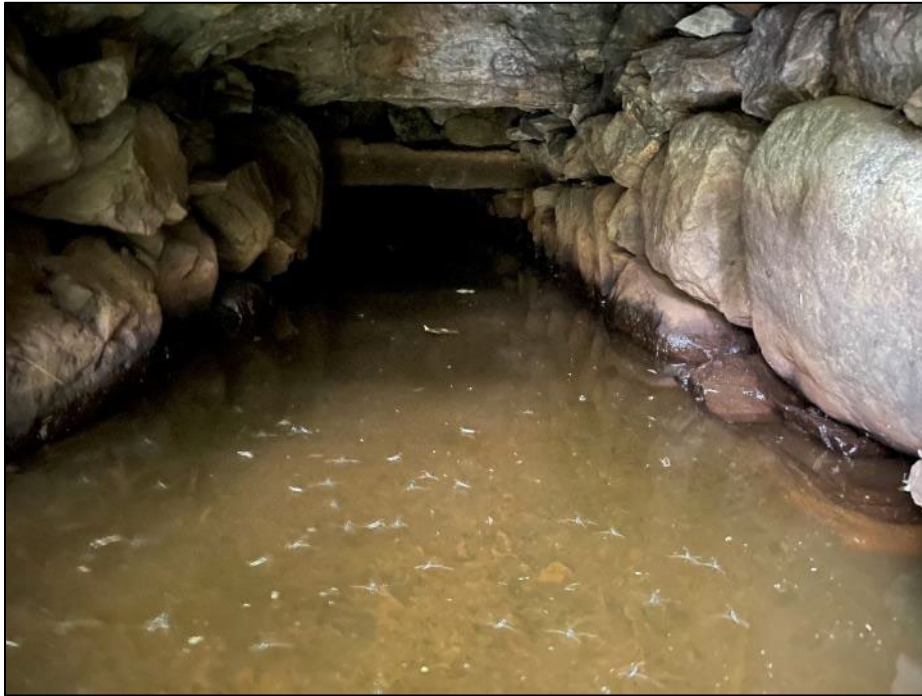
Photo No. 21.: View within the culvert from the downstream end looking upstream.

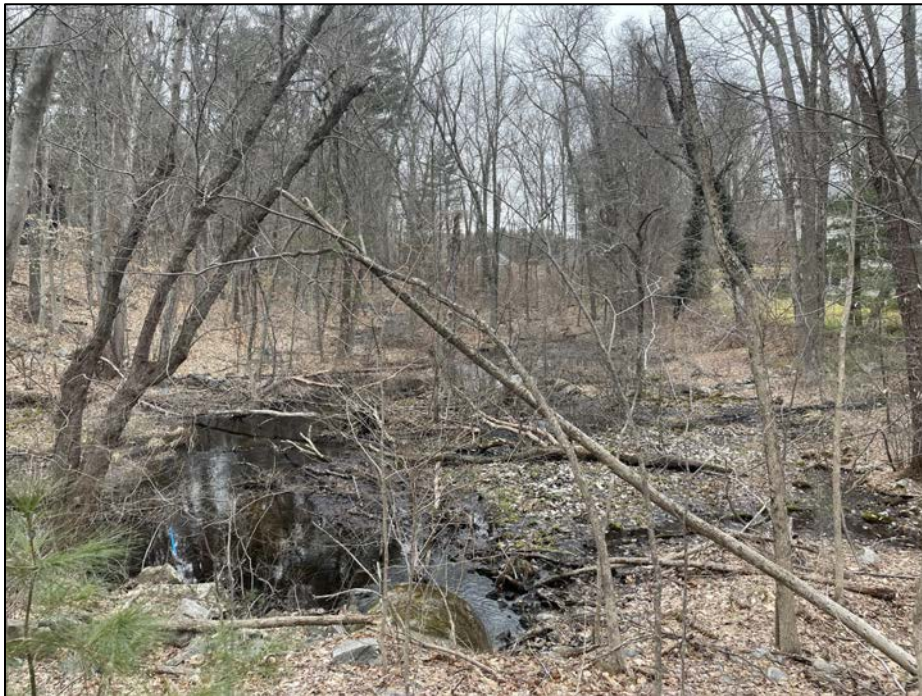
Photo No. 22.: Downstream channel from Woodbridge Road looking upstream.

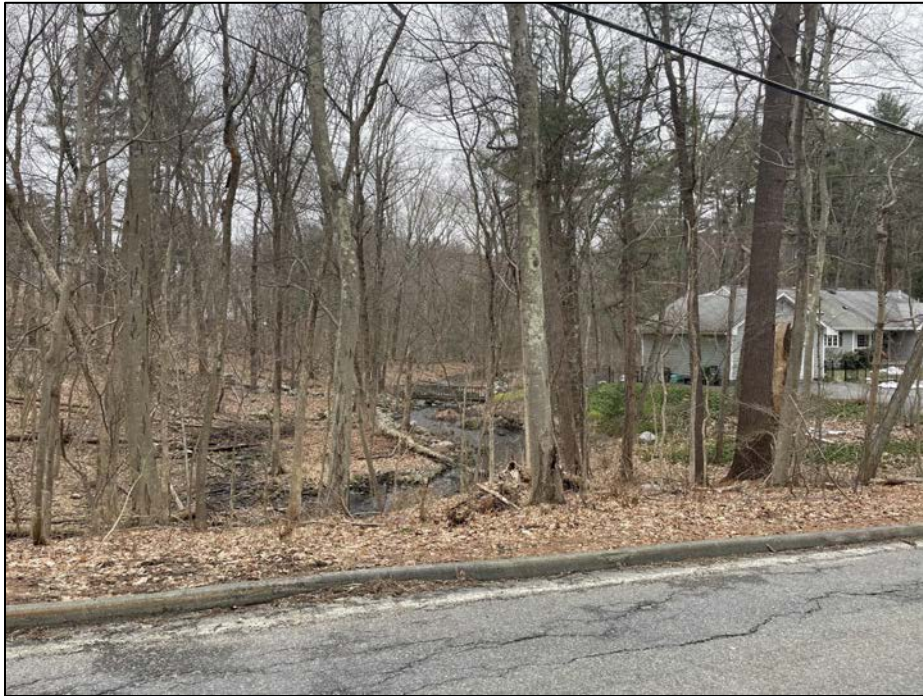
Photo No. 23.: Downstream channel from Woodbridge Road looking downstream.
