Re: **Follow-Up Inspection – August 2022**
Snake Brook Dam (MA01119)
Wayland, Massachusetts
(PARE Project No.: 19167.02/800)

**Commonwealth of Massachusetts
Department of Conservation and Recreation
Office of Dam Safety Poor Condition Dam Follow-up Inspection Form**

Dam Name: Snake Brook Dam
Dam Owner: Town of Wayland
Nat. ID Number: MA01119
Hazard Potential: Significant (Class II)
Location of Dam (town): Wayland
Coordinate location (lat,long): 42.33425°N/71.34166°W
Date of Inspection: August 18, 2022
Weather: 70°F, Clear

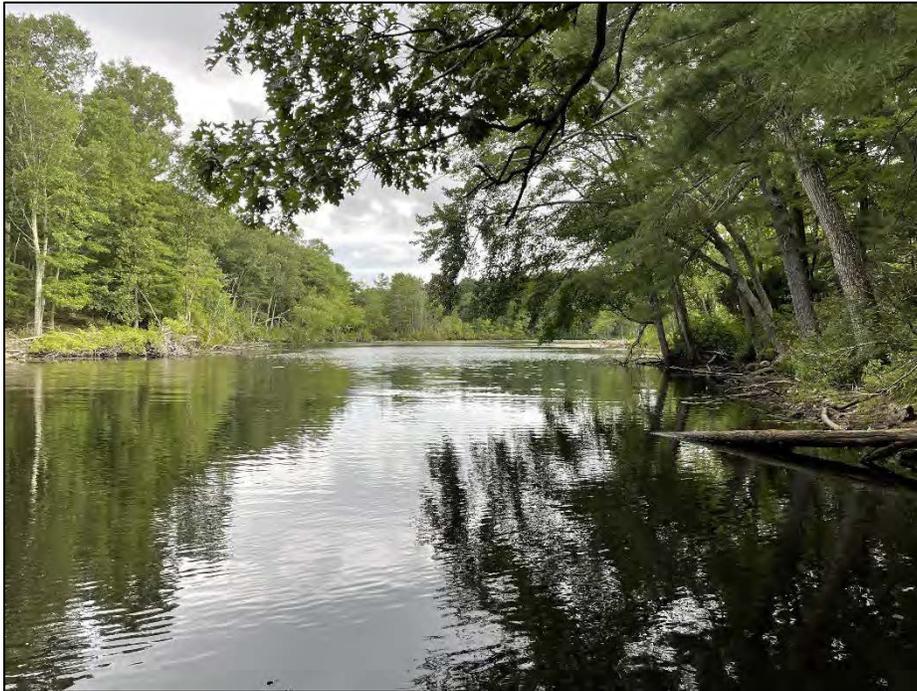
Photo No. 1.: Overview of the impoundment from the dam crest.

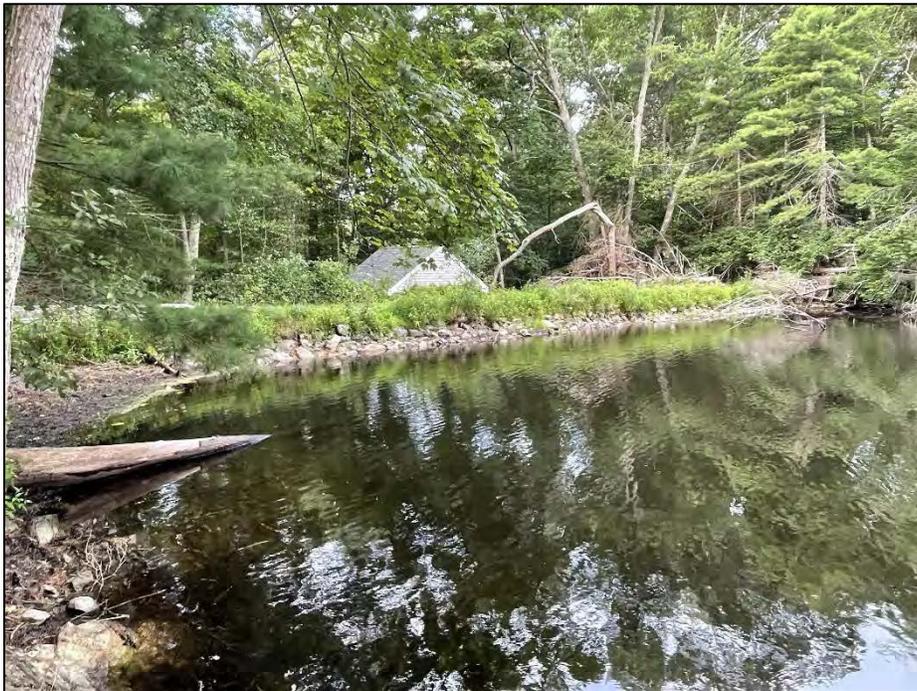
Photo No. 2.: Overview of the upstream face of the dam from the upstream left abutment looking downstream and right.

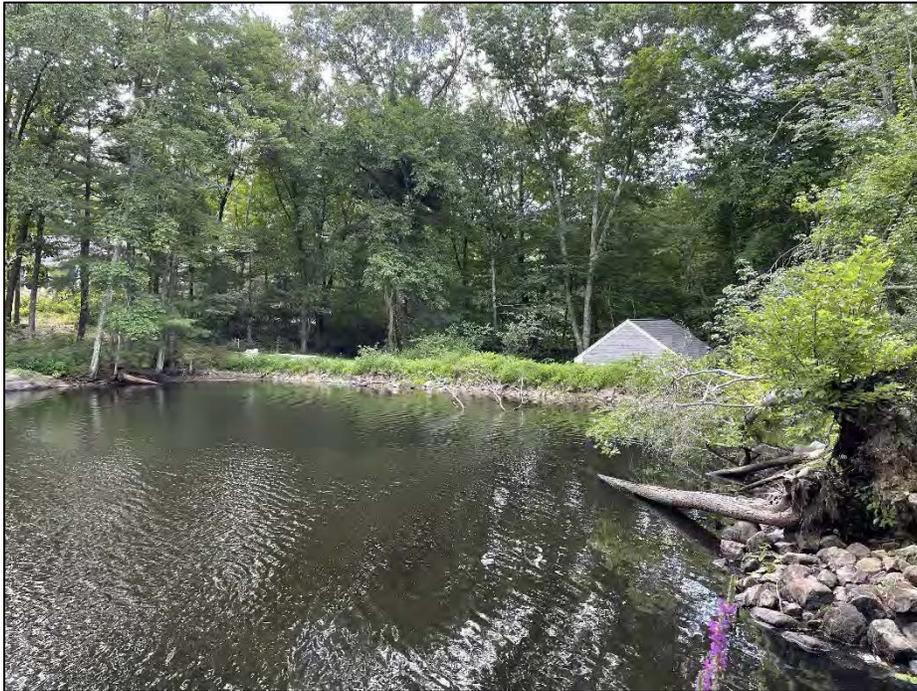
Photo No. 3.: Overview of the upstream face of the dam from the spillway approach looking downstream and left.

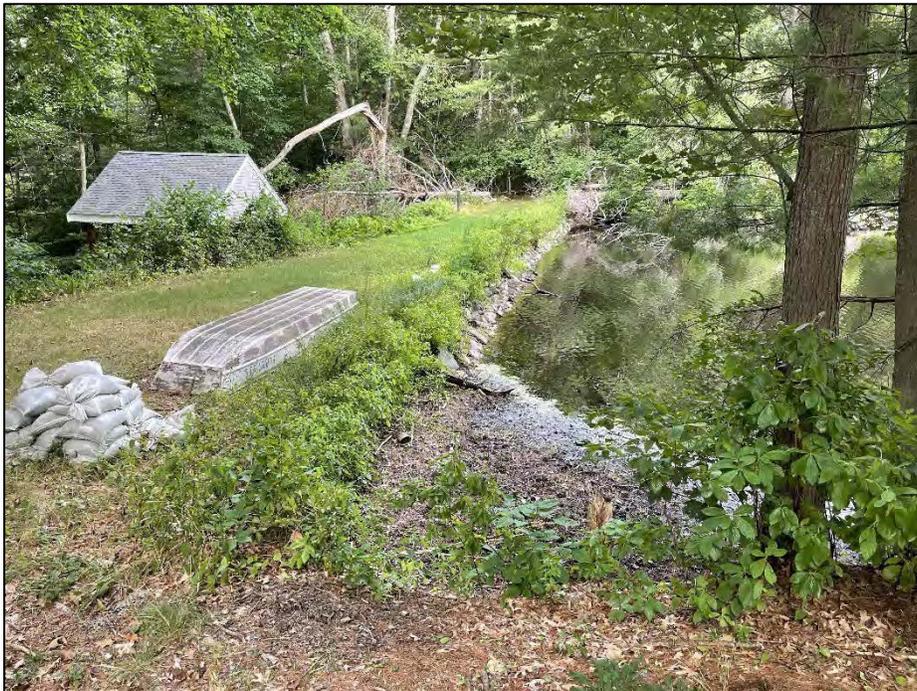
Photo No. 4.: Upstream slope from the left abutment looking right.

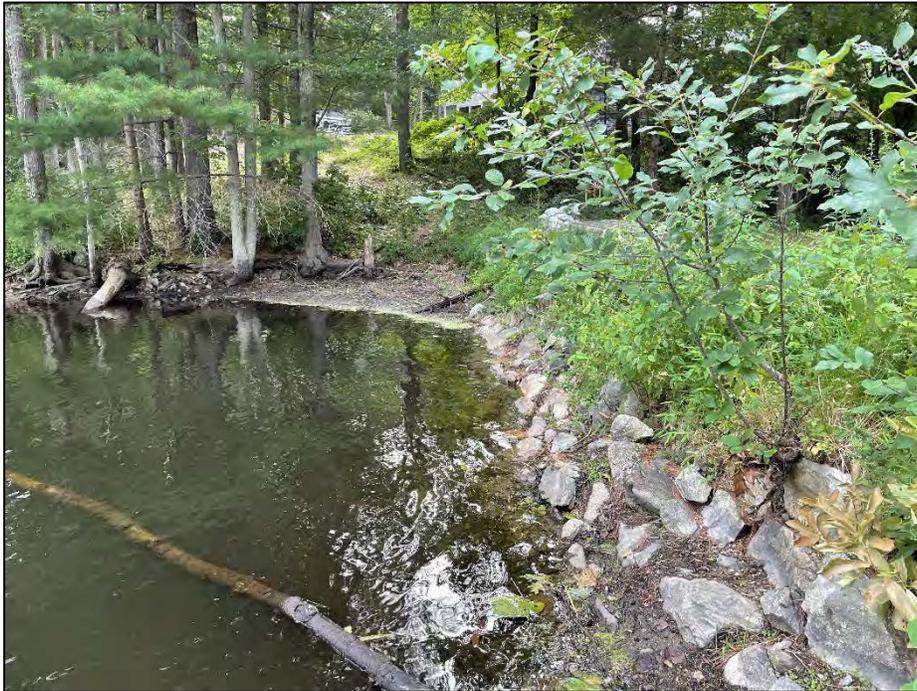
Photo No. 5.: Upstream slope from near 1+30 looking left.

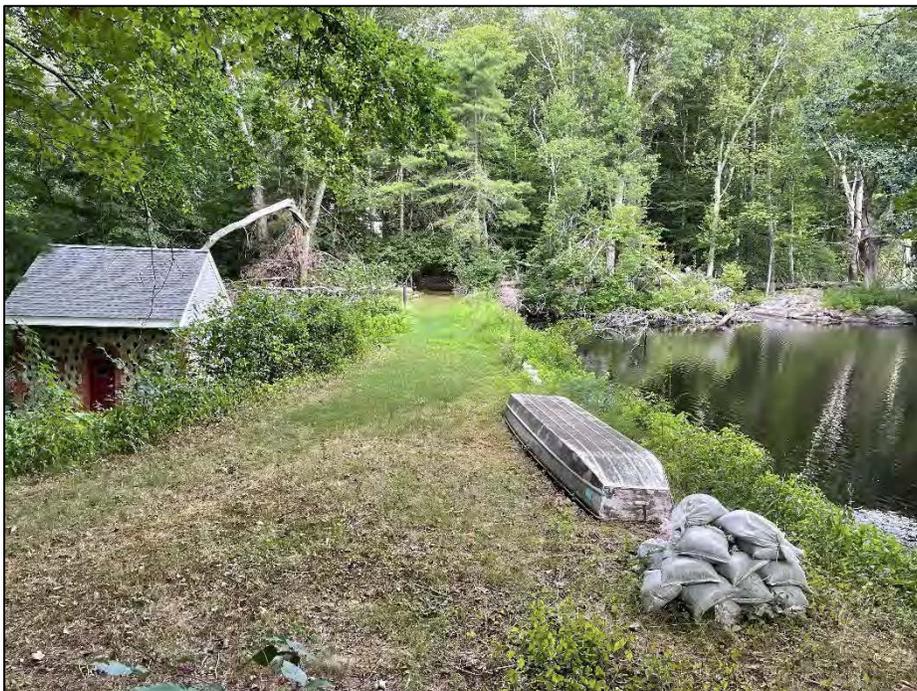
Photo No. 6.: Crest of the dam from the left abutment looking right.

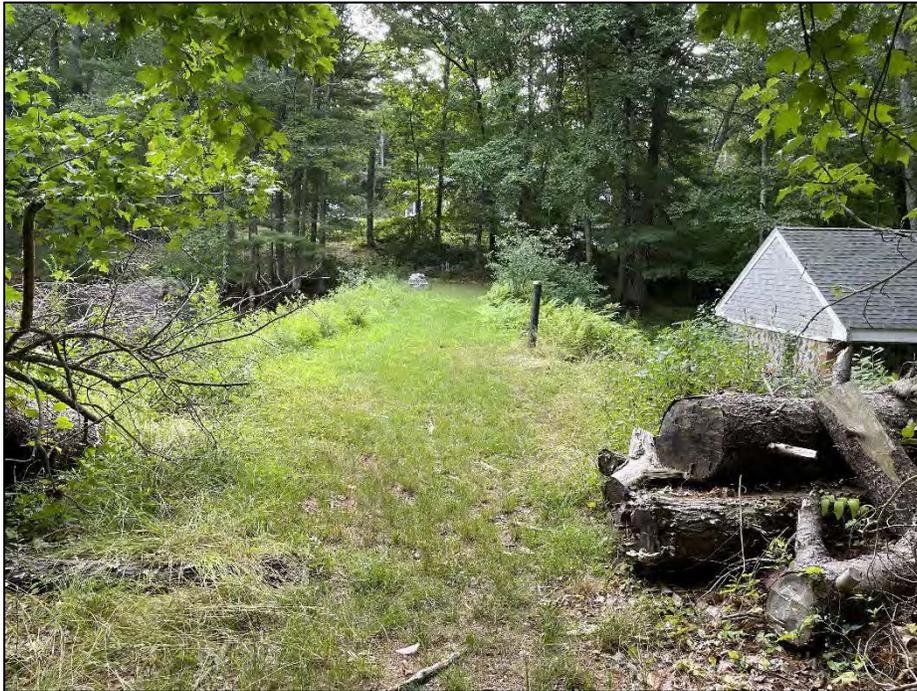
Photo No. 7.: Crest of the dam from near 1+40 looking left.

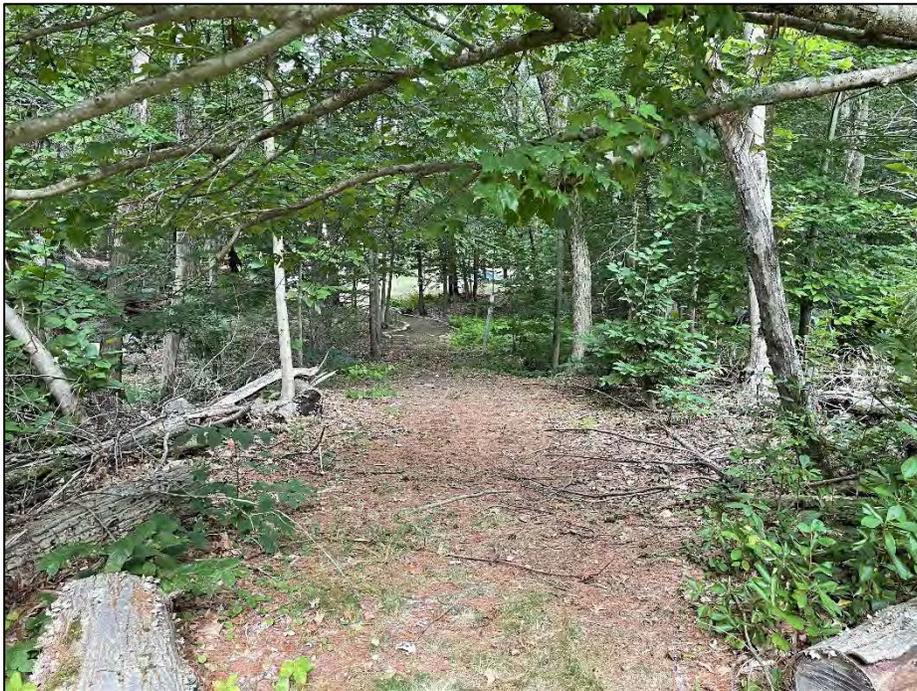
Photo No. 8.: Crest of the dam from near 1+40 looking right.

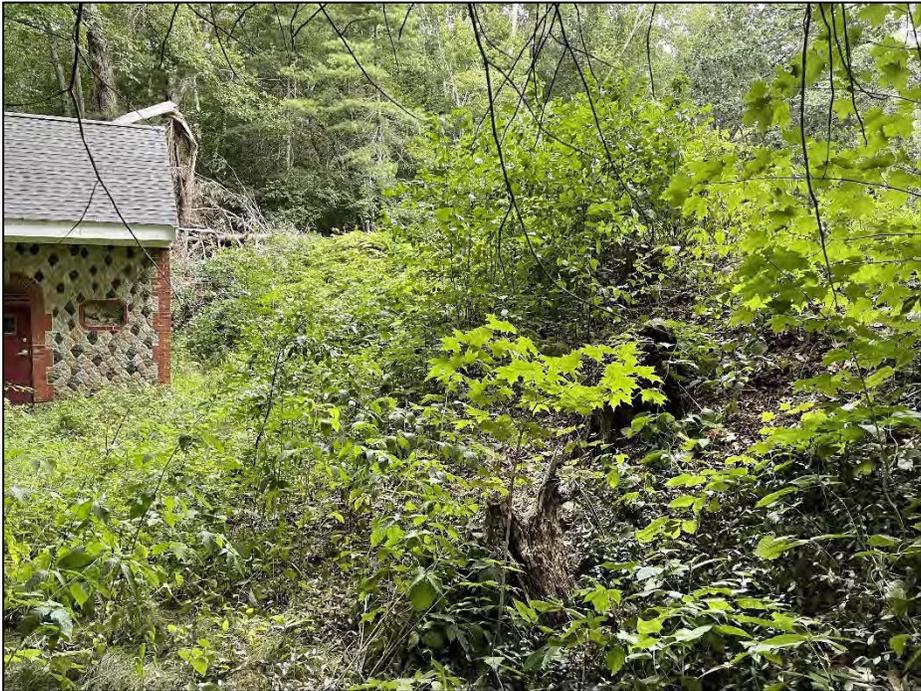
Photo No. 9.: Downstream side of the dam from the downstream left abutment looking upstream and right.

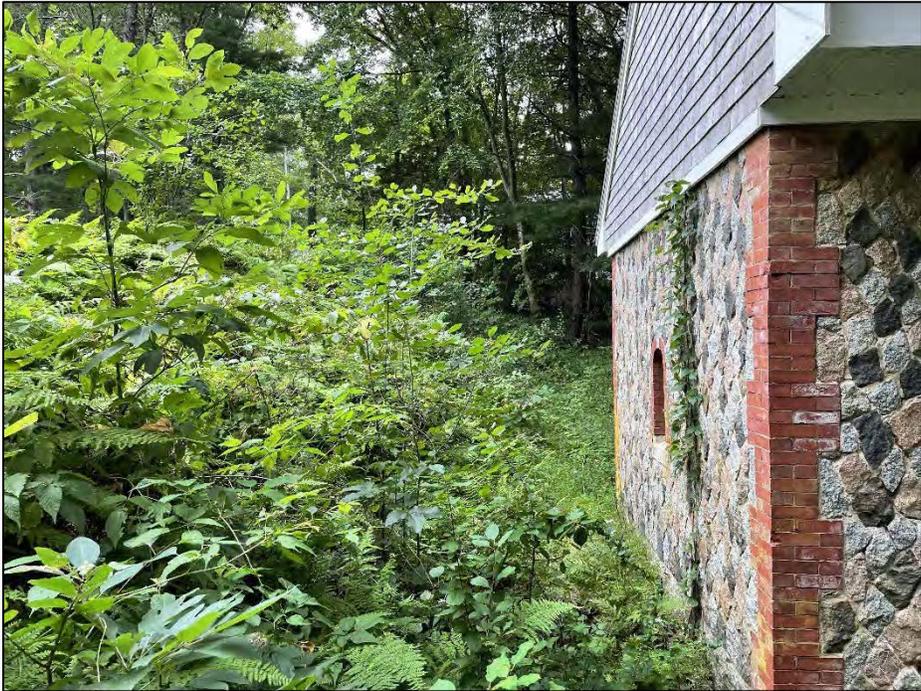
Photo No. 10.: Downstream side of the dam from near 1+00 looking left.

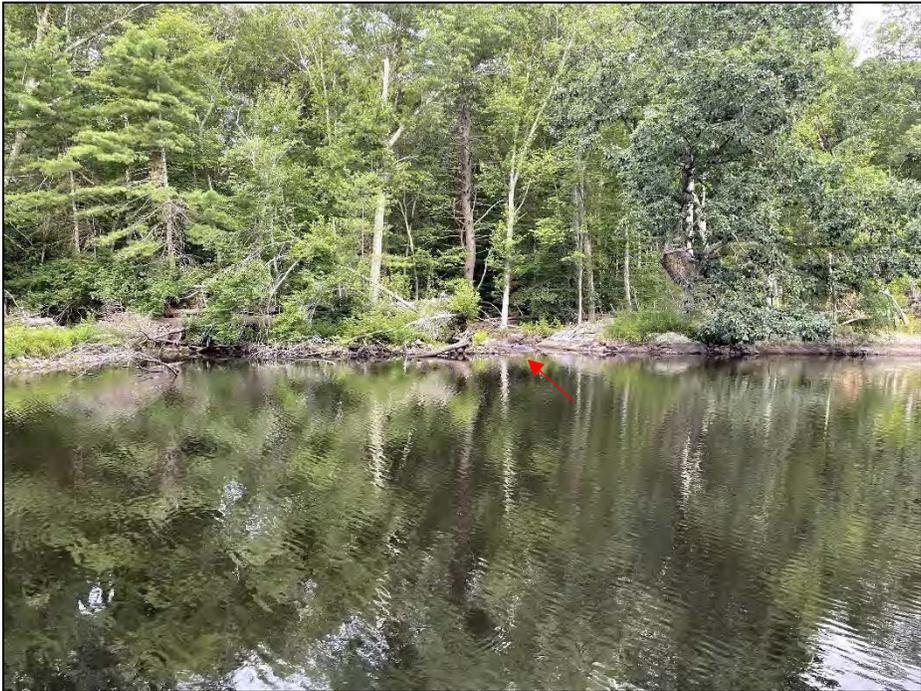
Photo No. 11.: Spillway approach (red arrow) from the upstream left abutment looking right

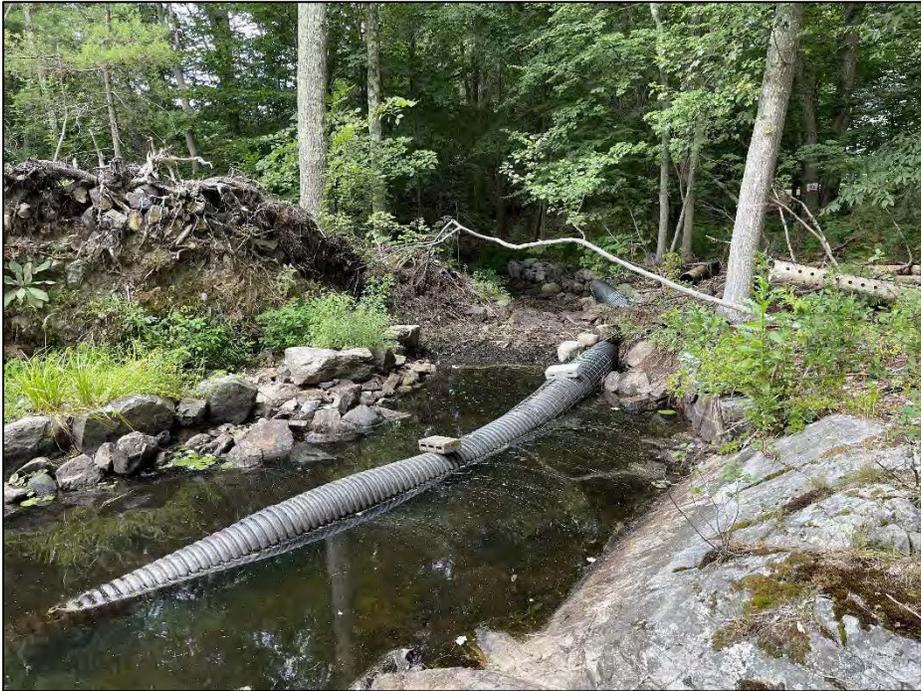
Photo No. 12.: Spillway control section from the approach looking downstream.

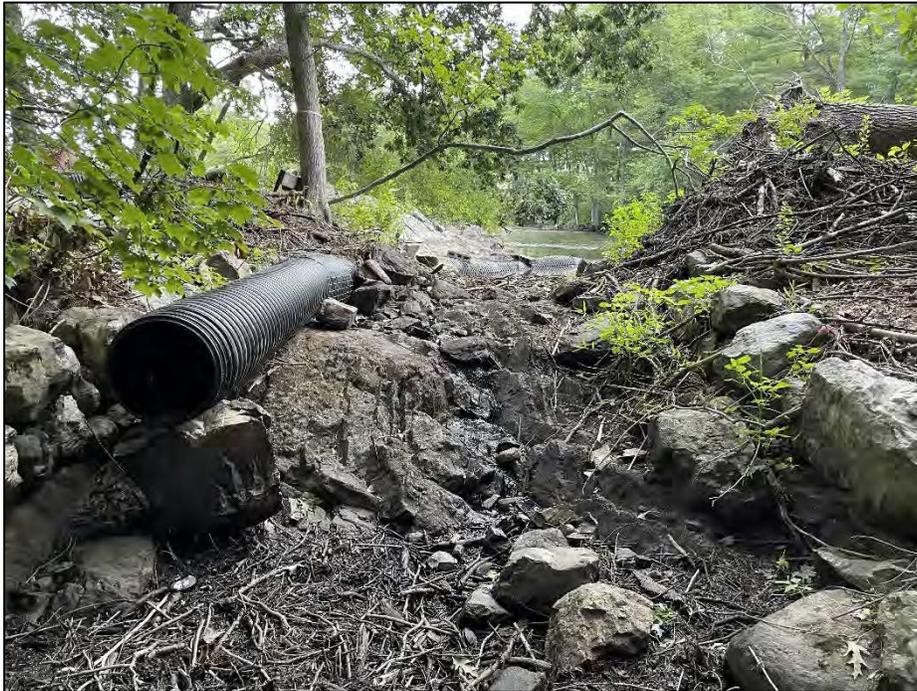
Photo No. 13.: Spillway control section. Note beaver deceiver pipe.

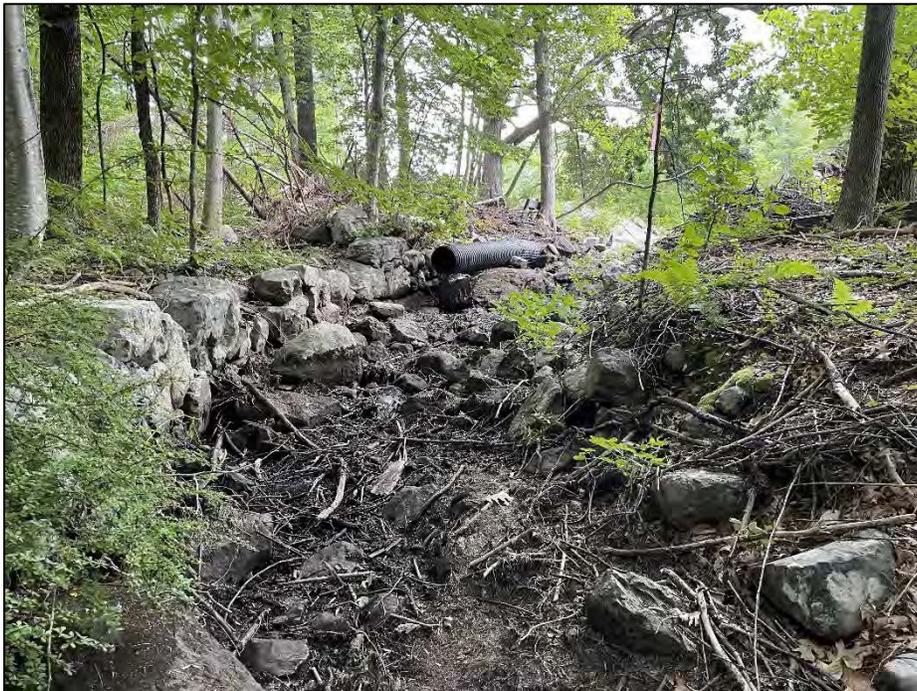
Photo No. 14.: Spillway control section from the discharge channel looking upstream.

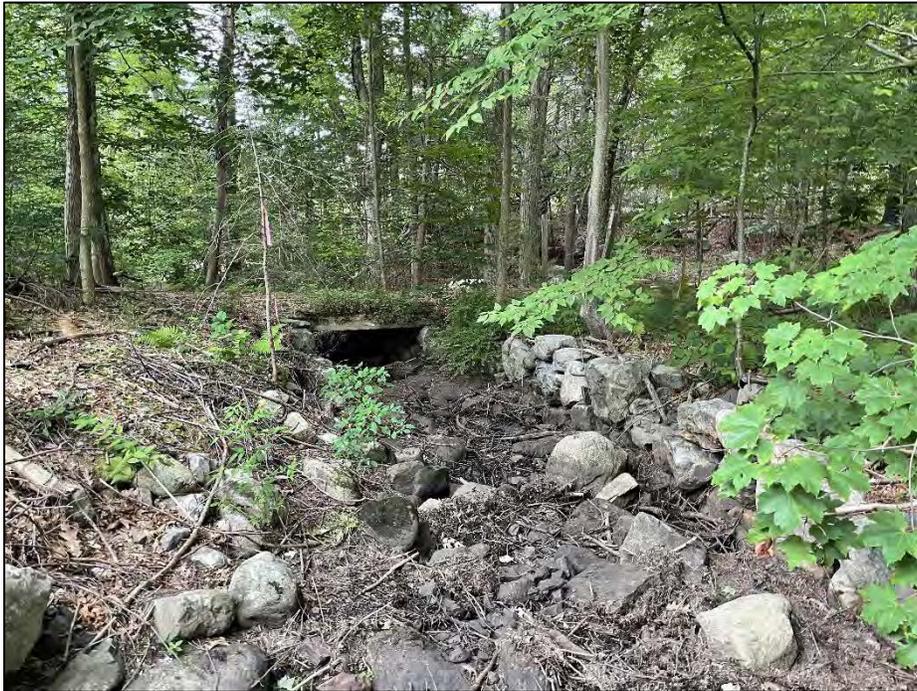
Photo No. 15.: Discharge channel of the spillway and the stone culvert from near the control section looking downstream.

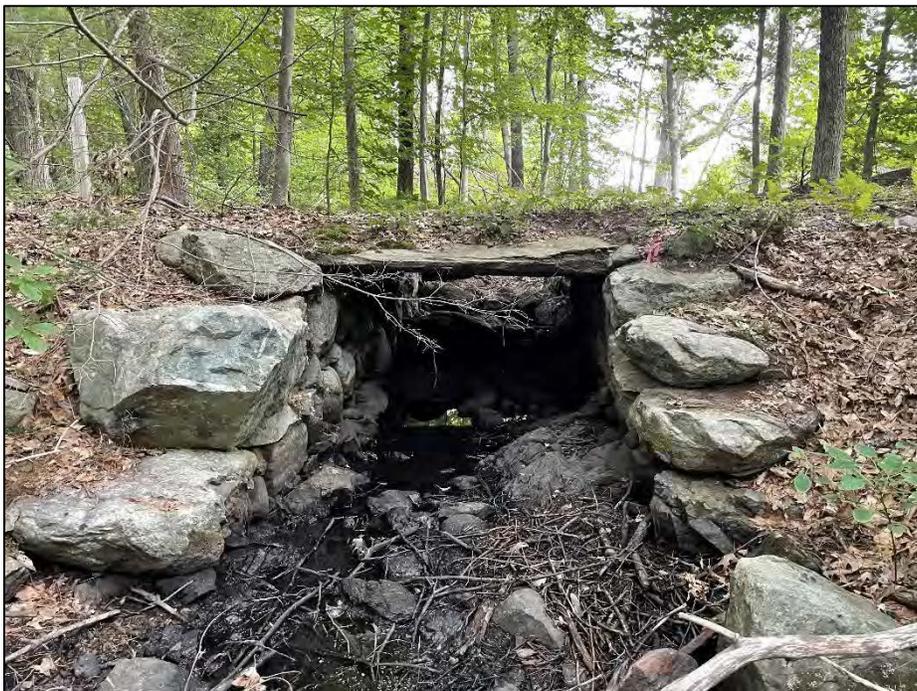
Photo No. 16.: The stone culvert that carries the spillway channel beneath the crest looking upstream.

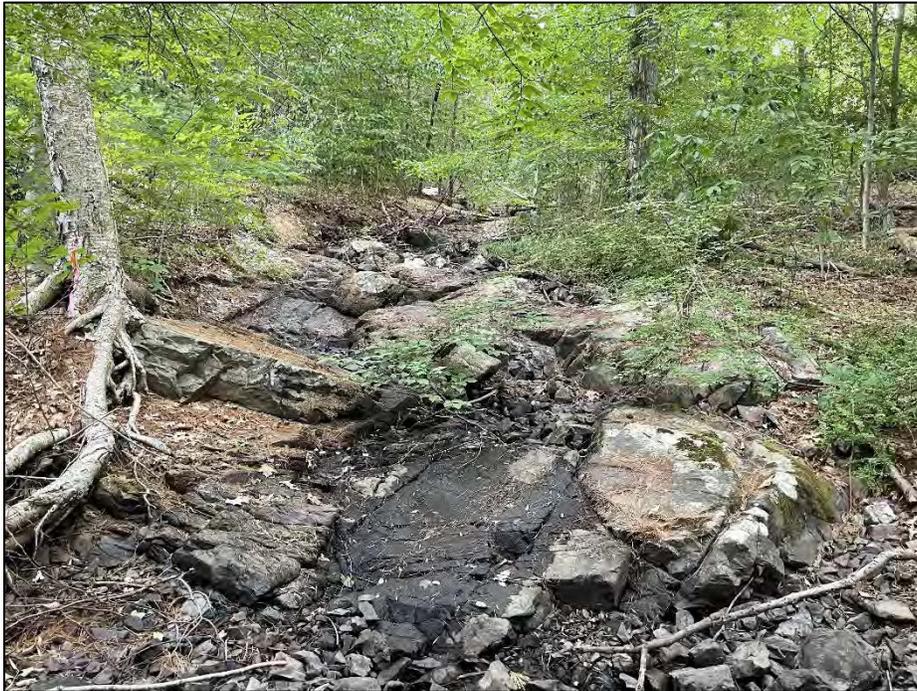
Photo No. 17.: Discharge channel of the spillway from the downstream channel looking upstream. Note the apparent bedrock outcrops throughout.

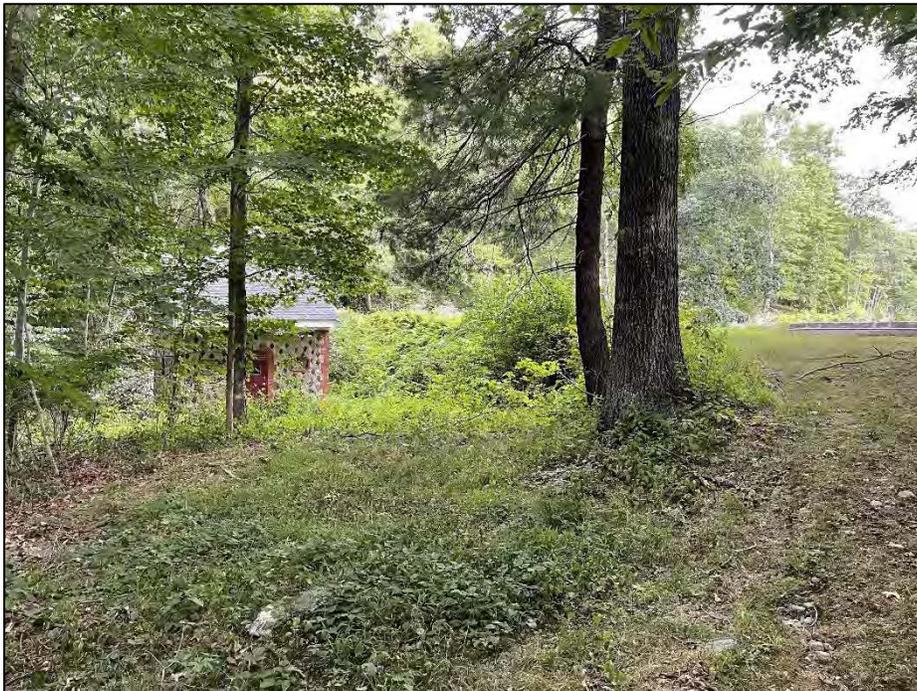
Photo No. 18.: Left side of the gatehouse.

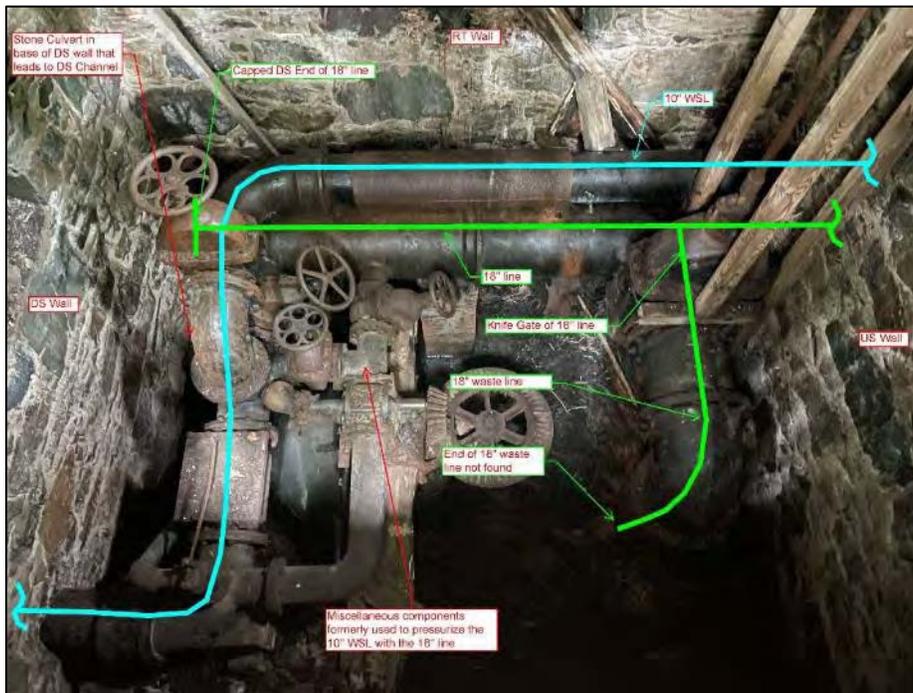
Photo No. 19.: View of the base of the chamber of the gatehouse with the various piping and controls of the 18-inch LLO and the 10-inch WSL.

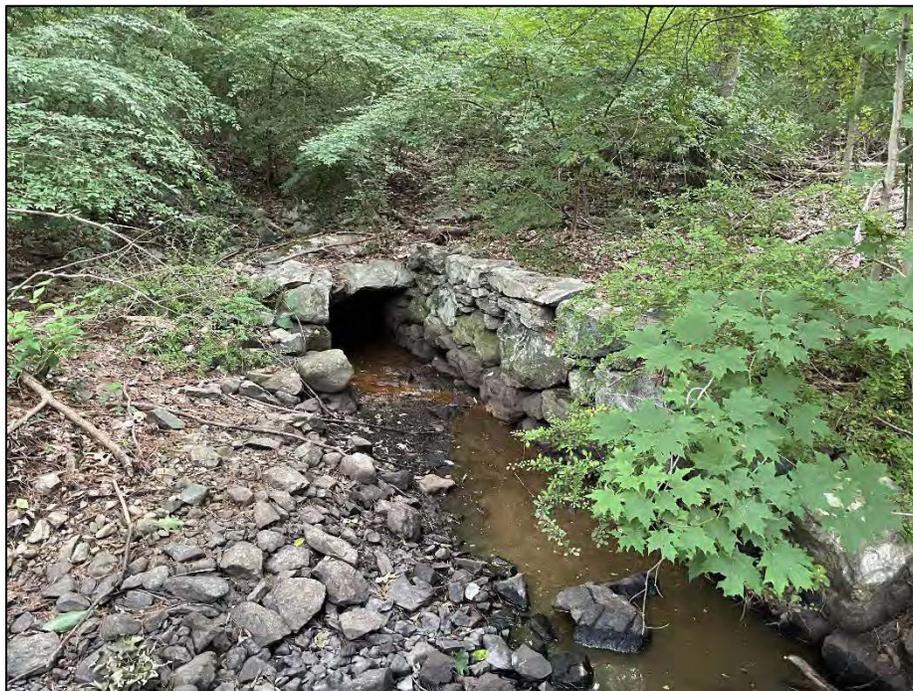
Photo No. 20.: Downstream end of the LLO stone culvert looking upstream.

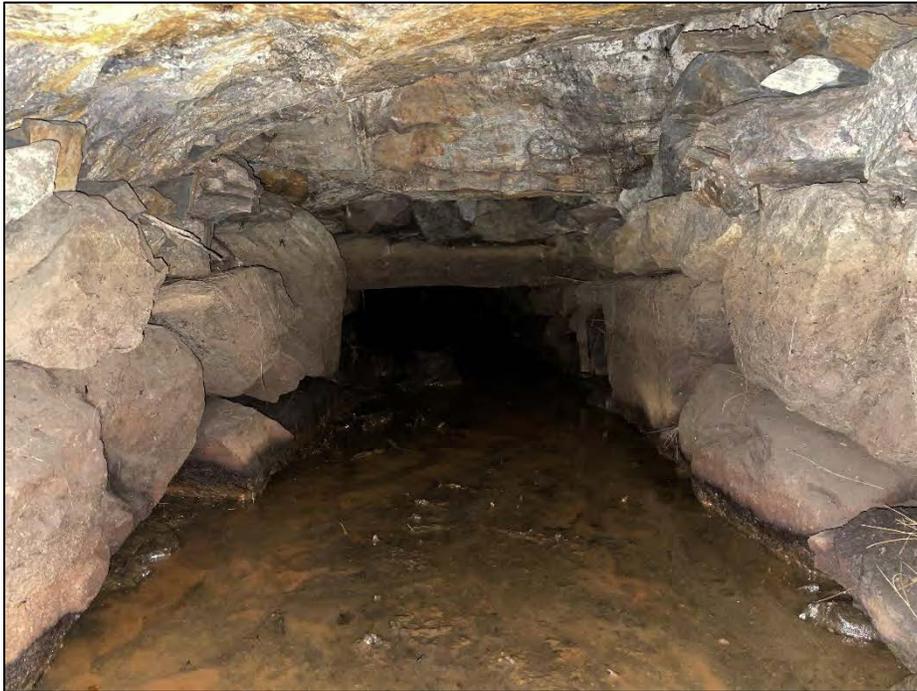
Photo No. 21.: View within the culvert from the downstream end looking upstream.

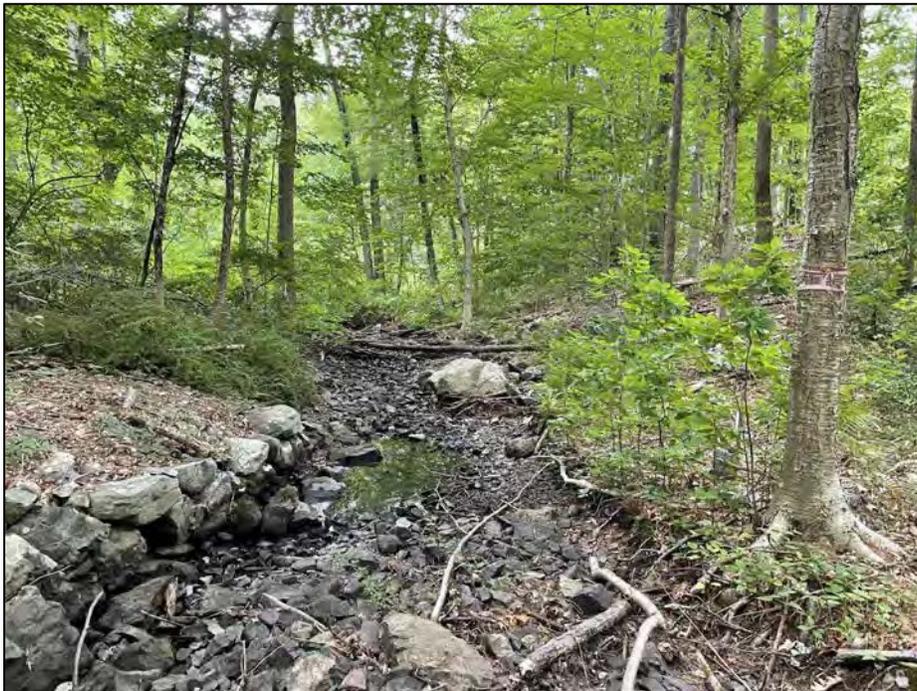
Photo No. 22.: View of the downstream channel at the confluence of the spillway and low level outlet channels looking downstream.
