**UNDERWATER OPERATIONS TEAM
ROUTINE UNDERWATER INSPECTION REPORT**

BR. DEPT. NO. W-11-015

CITY/TOWN WAYLAND	8-STRUCTURE NO. W11015-BHH-DOT-RRO	LEVEL OF INSPECTION IV	93B-DATE INSPECTED NOV 16, 2015
07-FACILITY CARRIED RR BMRR (ABAND)	ACCESS TO BRIDGE EMBANKMENT	UNDERWATER OPERATIONS ENGINEER RANDI E. BONICA <i>Randi E. Bonica</i>	
06-FEATURES INTERSECTED WATER SUDBURY RIVER	DEPTH 2.5 m	VISIBILITY 1 m	TEAM LEADER (DIVE MASTER) RANDI E. BONICA
BOTTOM CONDITION GRAVEL, SILT	CURRENT SLIGHT	TEAM MEMBERS G. BROZ, B. FITZGERALD, J. A. MANKOWSKY

This timber pile supported railroad bridge has been closed and abandoned. The MassDOT Dive Team was requested to inspect the underwater elements prior to it being used as a Rail Head project.

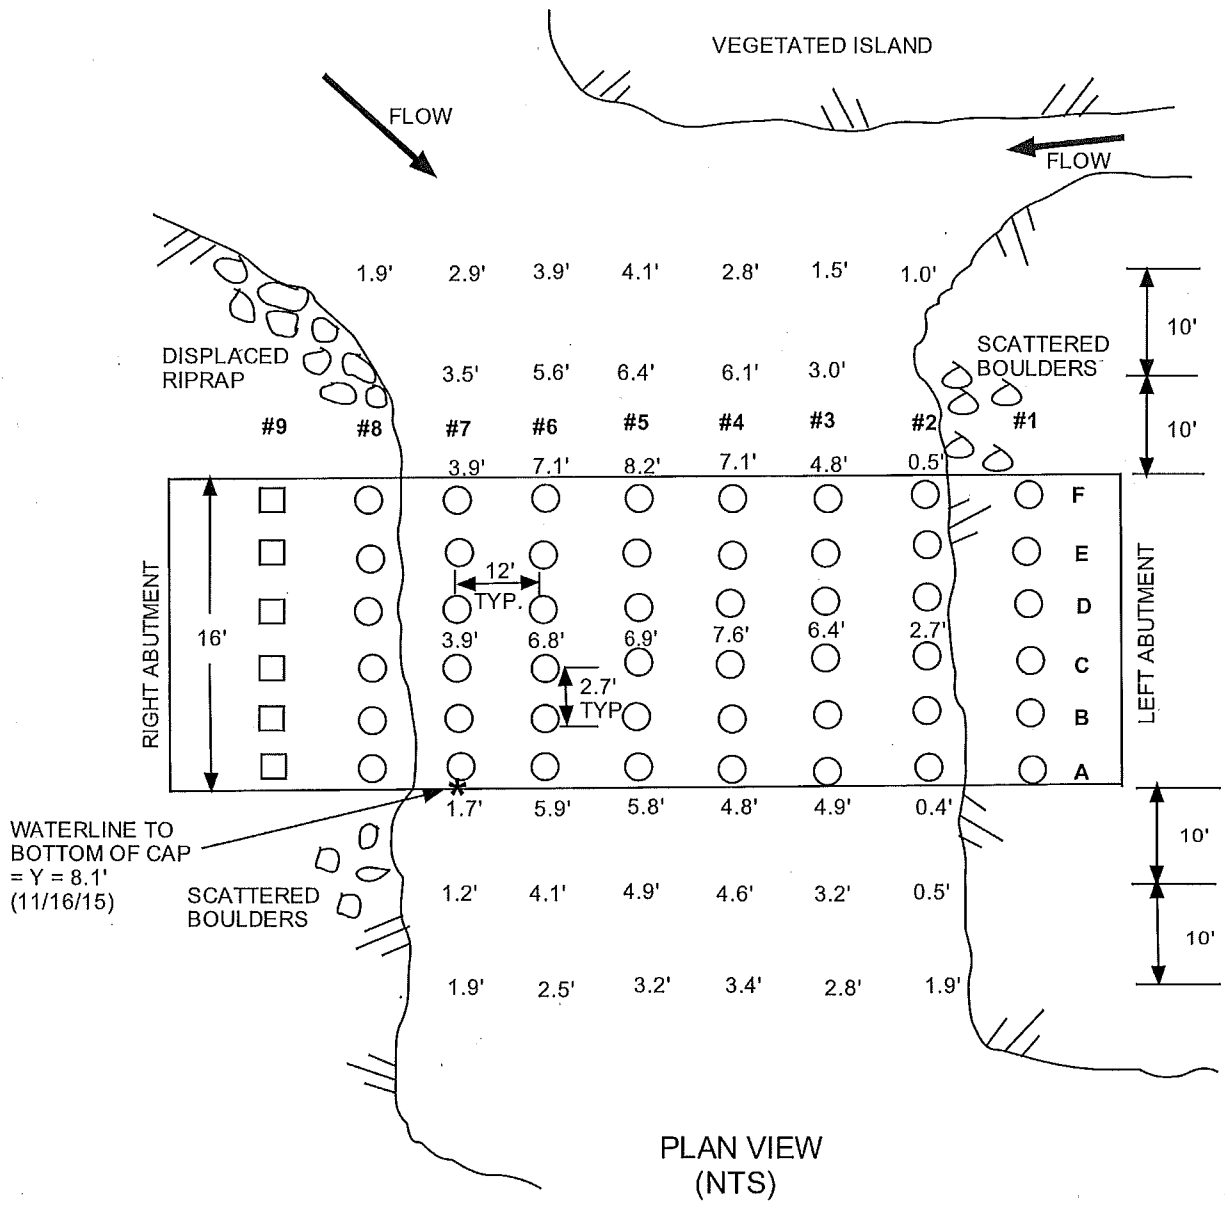
Sketch 1: PLAN VIEW (NTS)

There are nine timber pile bents. Six bents were inspected. Bents are numbered from left to right looking downstream. Piles are lettered from downstream to upstream. Bents #1, #8 and #9 and both abutments are in the dry and were not inspected. Abutments are spill-through with timber piles and and backwalls. Bent #9 has six square columns above round timber piles. The round piles are exposed approximately 1' high. Each bent has six timber piles, approximately 1' diameter.
