PHASE I
ENVIRONMENTAL SITE ASSESSMENT

FORMER DPW GARAGE

195 MAIN STREET
WAYLAND, MASSACHUSETTS

MAY 13, 2022

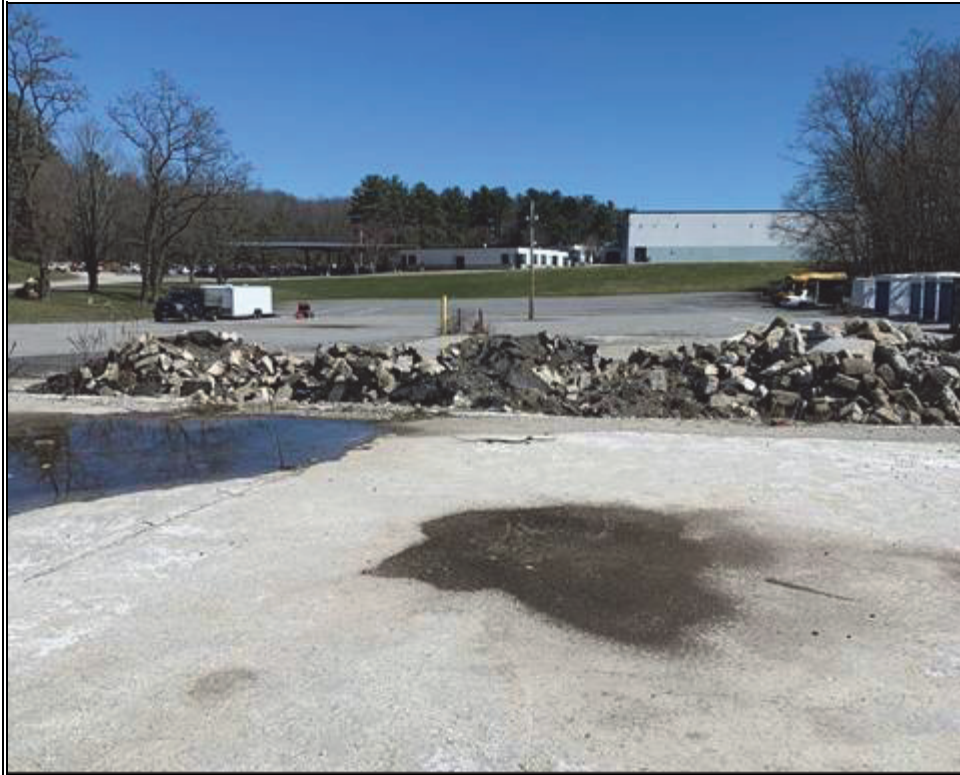
PHOTOGRAPH 1

CMG observed the footprint of the former single-story building at the Site, which comprised 10,342 square feet (see Photograph 1 in Appendix A). According to the Wayland Assessor’s office, the Site building was of concrete and brick construction, with a flat roof and no basement. The town constructed the original portion of the building in 1969. We noted the remnants of a trench drain (see Photograph 2); Mr. Keefe informed CMG that the drains were connected to an oil/water separator. CMG observed a catchbasin and two manhole covers near the center of the Site, northeast of the former building (see Photograph 3 and Figure 3, Historic Site Plan).

CMG observed some staining on the concrete slab of the former Site building (see Photograph 1). We observed minor oil staining on asphalt paving. CMG opines that these are evidence of incidental motor oil drips for which corrective action is neither practical nor warranted (i.e., *de minimus* conditions).

PORTION OF
FORMER BUILDING
FOOTPRINT, WITH
PILES OF
CONCRETE &
ASPHALT RUBBLE IN
CENTER, AND
WAYLAND MIDDLE
SCHOOL IN
BACKGROUND

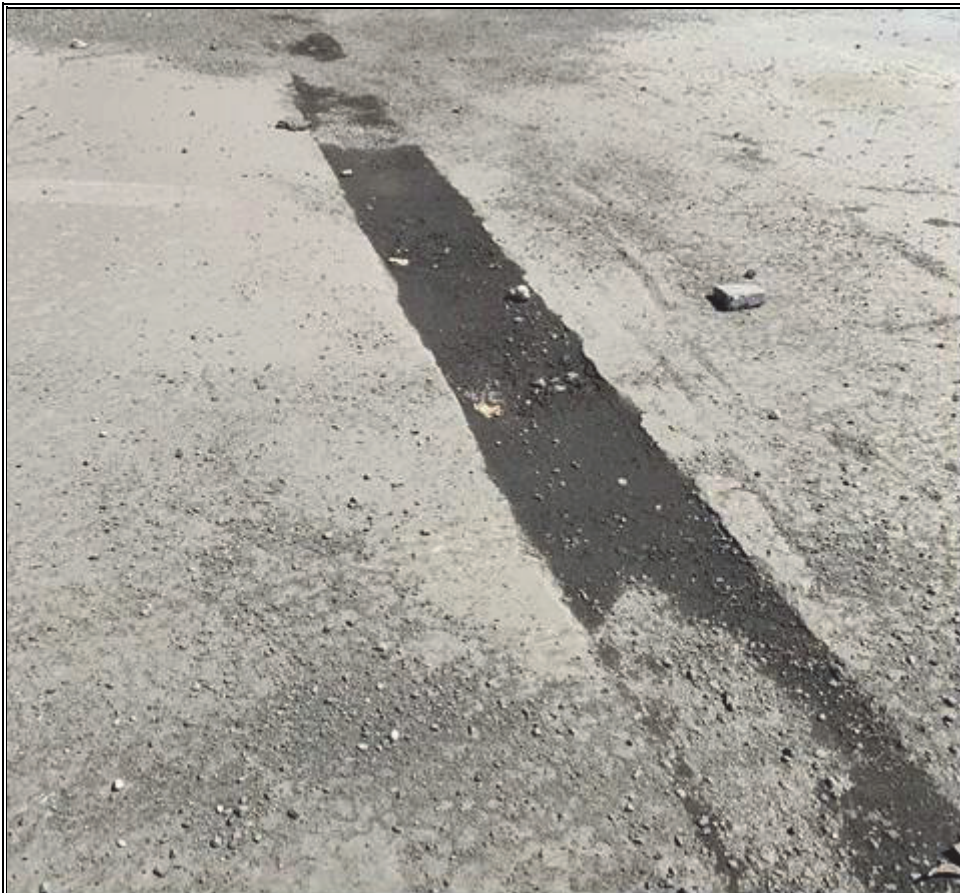
PHOTOGRAPH 2

REMNANT OF
FORMER FLOOR
(TRENCH) DRAIN

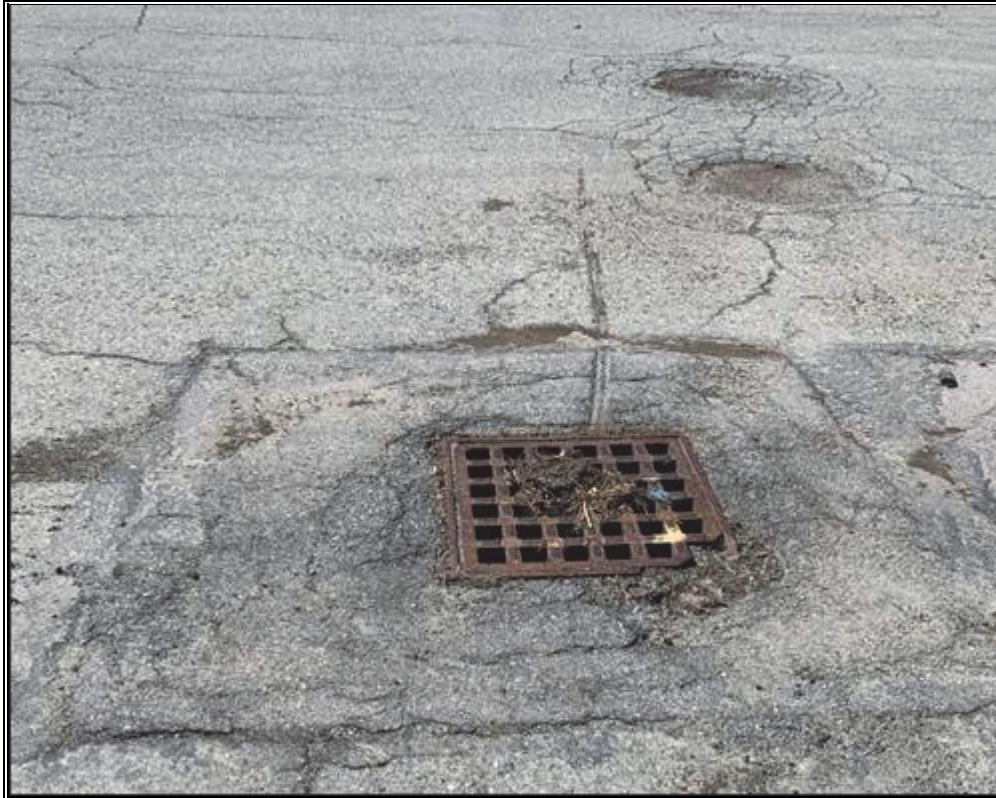
PHOTOGRAPH 3

STORM DRAIN
(FOREGROUND)
AND MANHOLE
COVERS
(BACKGROUND)

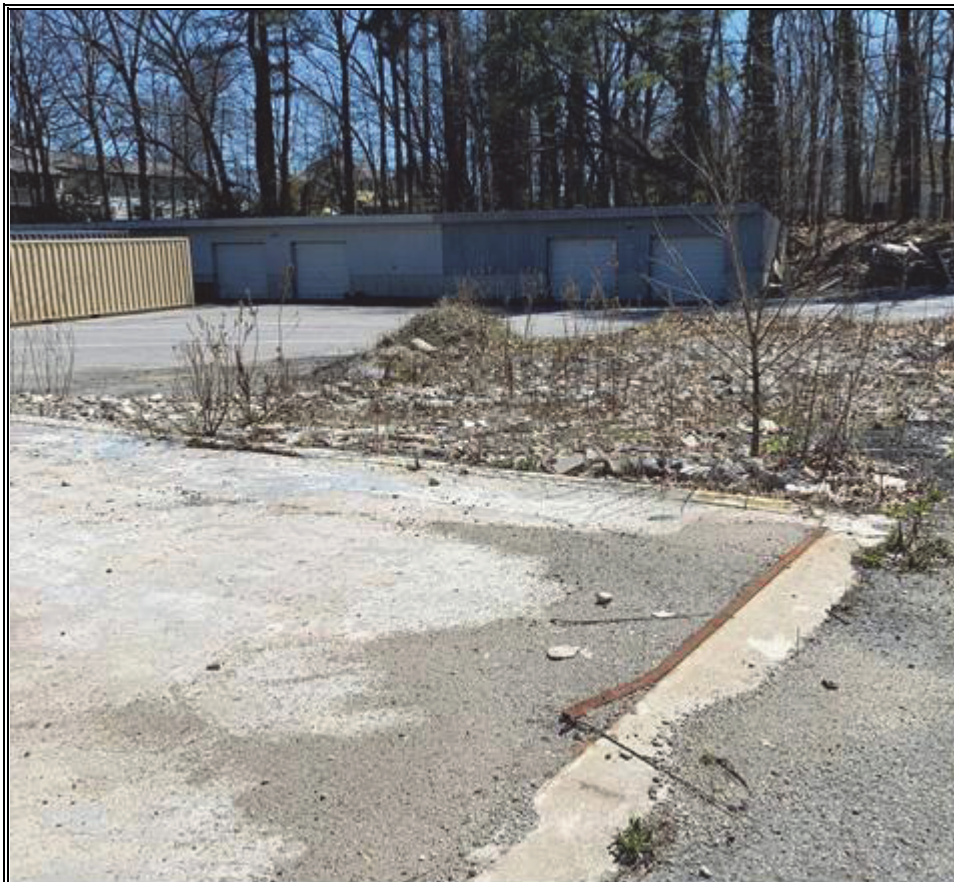
PHOTOGRAPH 4

CMG observed multiple storage containers and a wood-framed storage shed at the Site, which were filled mostly with office and school furniture (see Photographs 4 through 6). There were several cars parked on asphalt pavement near the storage units, which Mr. Keefe said were awaiting auction (see Photograph 7). We also noted piles of concrete and asphalt (see Photograph 1); Mr. Keefe said that DPW brought the concrete from off-Site and placed it there.

WOODEN STORAGE
SHED AND
STORAGE TRAILER
(LEFT)

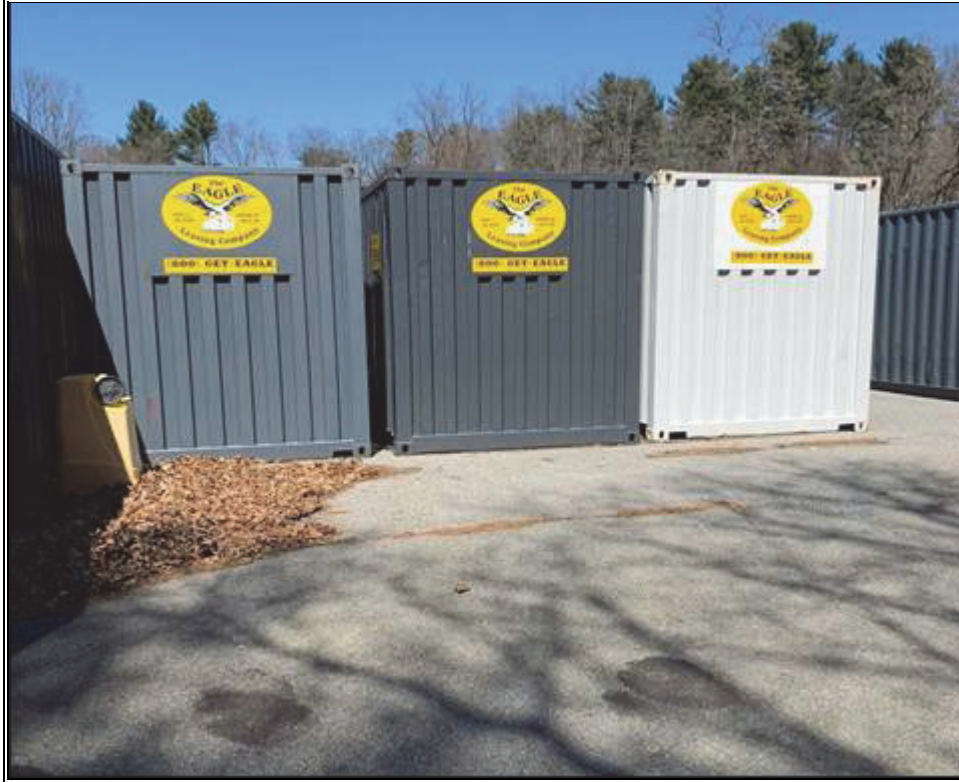
PHOTOGRAPH 5

STORAGE
CONTAINERS

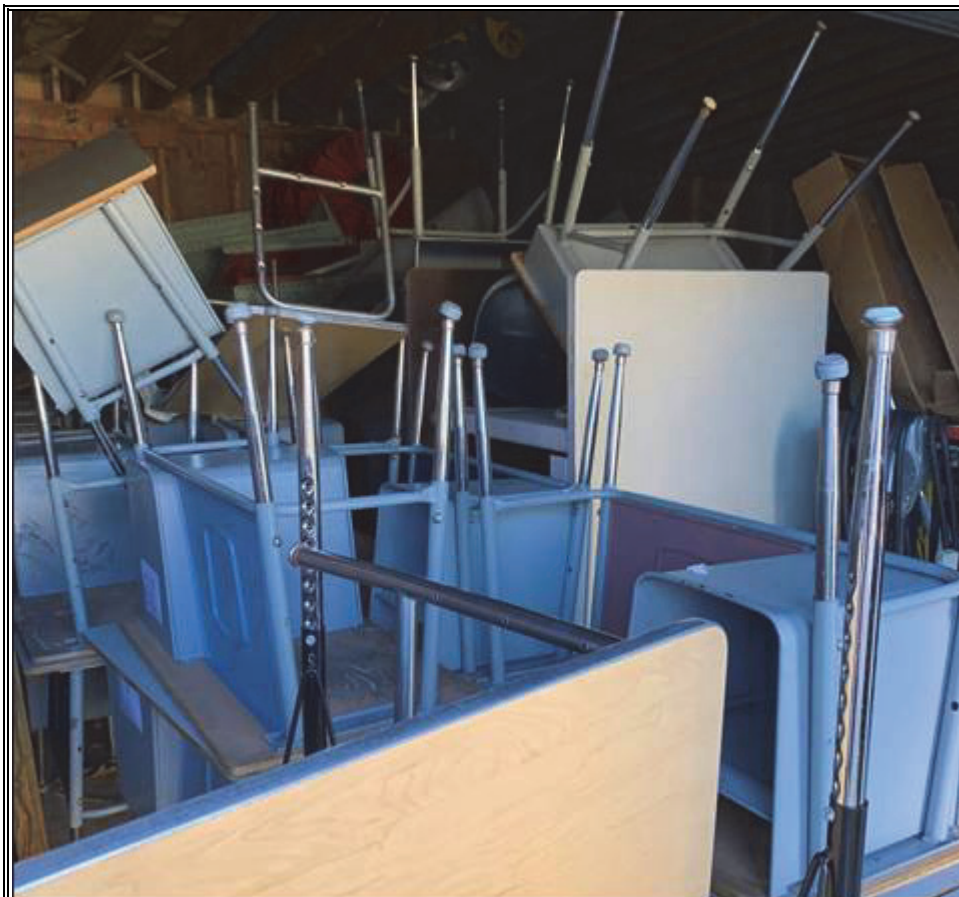
PHOTOGRAPH 6

INSIDE STORAGE
SHED

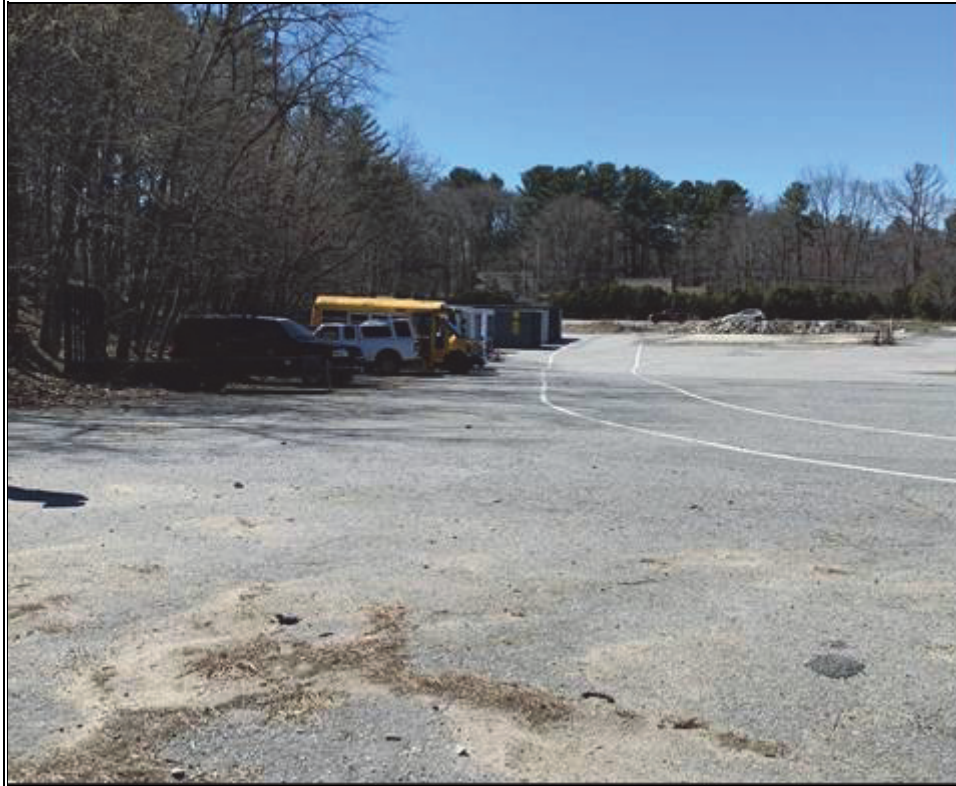
PHOTOGRAPH 7

REC #7: Abandoned cars left at the Site could result in a release of motor oil or gasoline that may not be observed and may enter the subsurface via cracks in the asphalt paving.

VEHICLES STORED
AT SITE (AWAITING
AUCTION)

CMG recommends conducting a subsurface investigation of the Site, including the advancement of soil borings, completion as groundwater monitoring wells, and collection/analysis of soil and groundwater samples to assess for the presence of petroleum constituents, 1,4-dioxane, per- and polyfluoroalkyl substances (PFAS), metals, dioxins, pesticides, and herbicides at the Site.

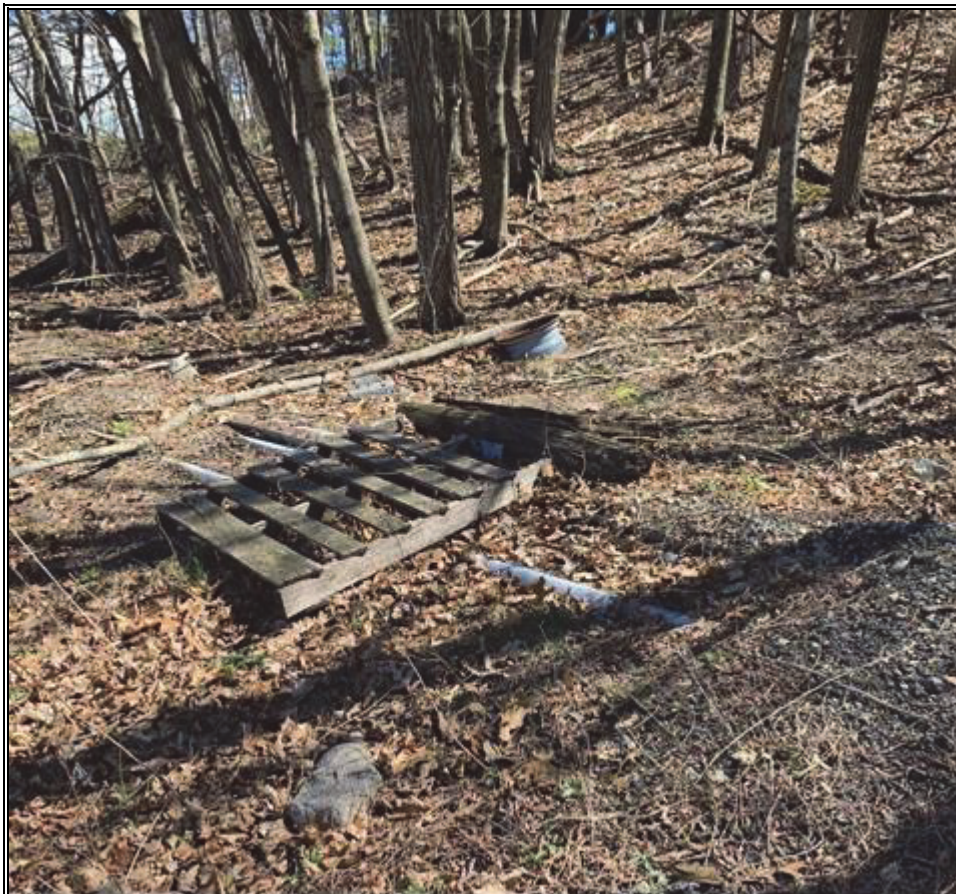
PHOTOGRAPH 8

TRASH (INCLUDING
PARTIALLY BURIED
ITEMS) WITH PILE
OF ASPHALT/
GRAVEL AT RIGHT
FRONT

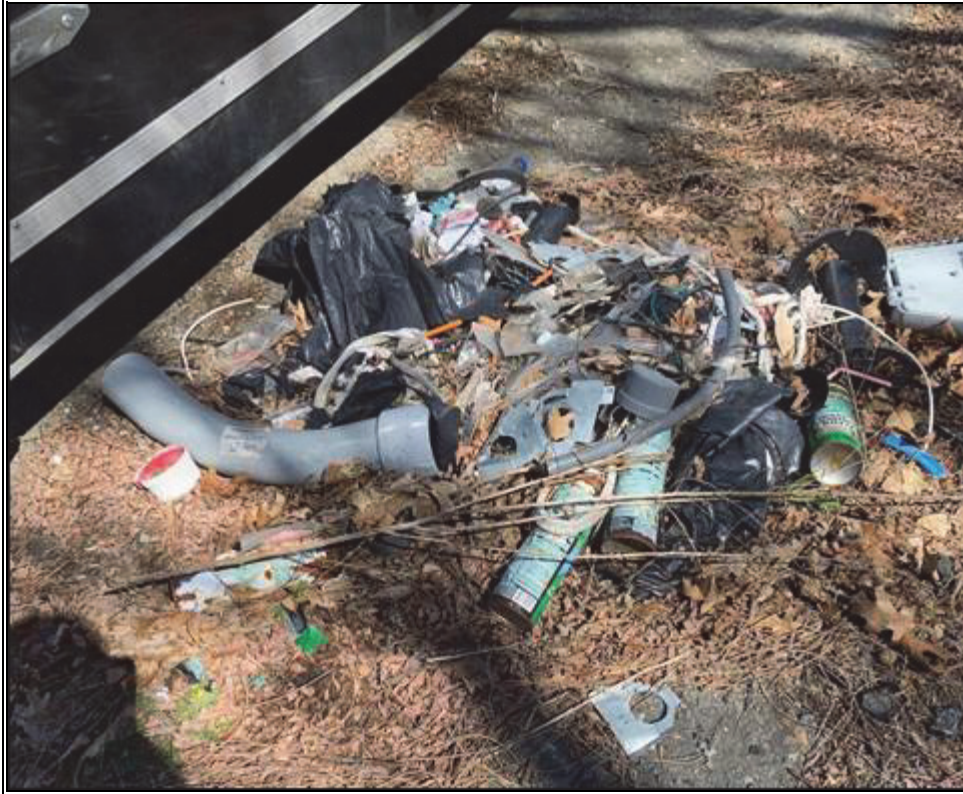
PHOTOGRAPH 9

TRASH LEFT ON
ASPHALT

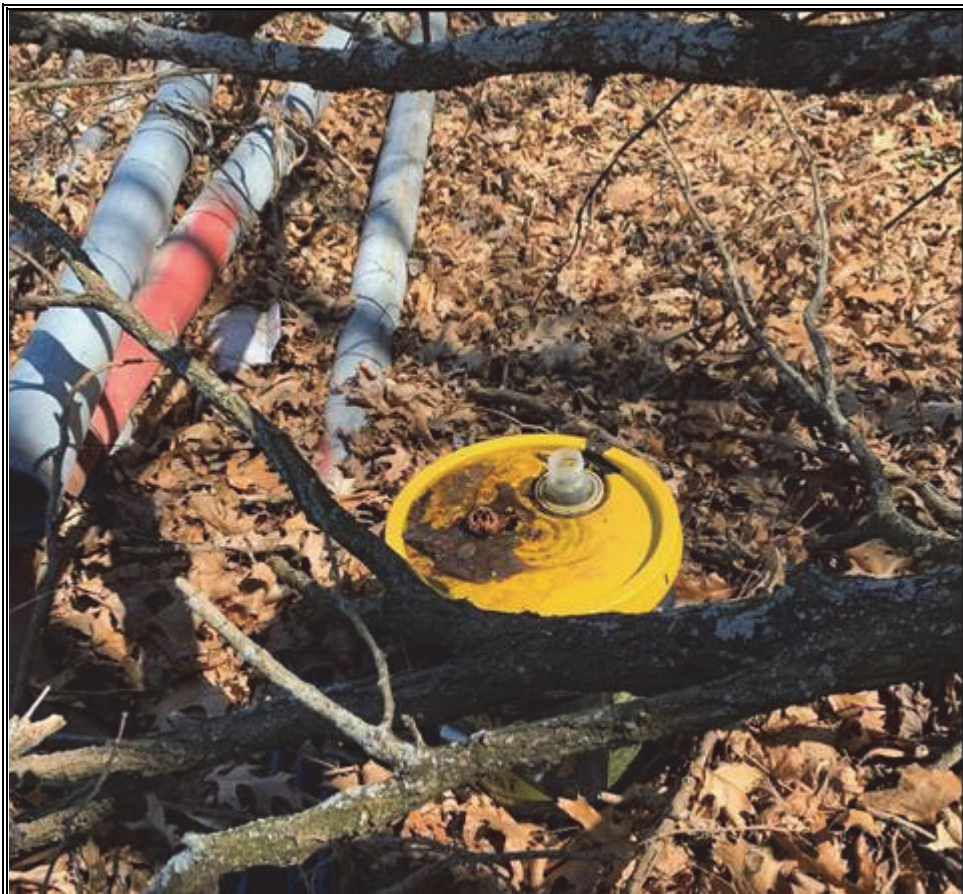
PHOTOGRAPH 10

CMG observed a small undeveloped portion along the southerly boundary of the Site; this area includes trees, leaf debris, pipes, concrete rubble, and trash. The undeveloped portion slopes upward away from the Site.

PIPING AND OTHER
DEBRIS IN WOODED
AREA OF SITE

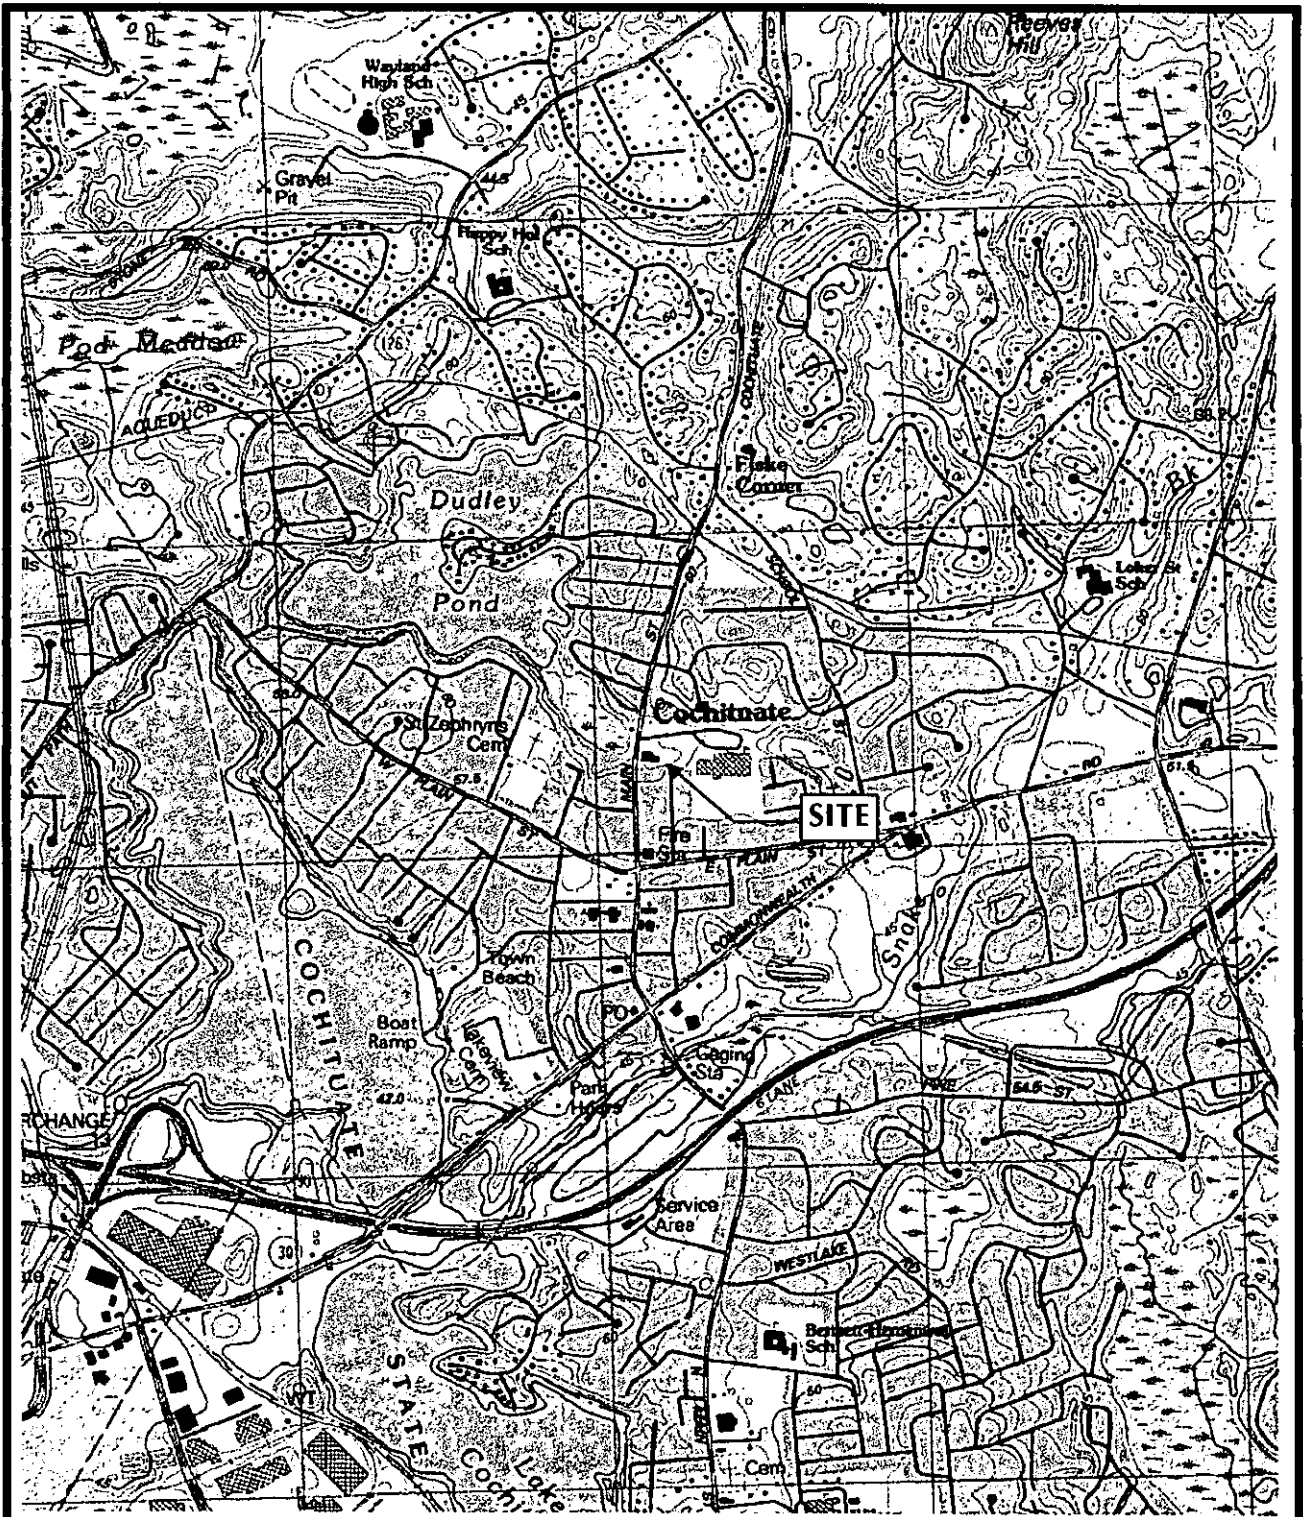
FIGURE 1

LOCUS MAP

The Site is the Town of Wayland Highway Department garage located at 195 Main Street in a well-developed commercial and residential section of Wayland, MA (see **Figure 1**).
