WAYLAND COMMUNITY PRESERVATION COMMITTEE

Project Title: Preservation of Stone's Bridge

Reference: Old Stone Bridge, Wayland, MA

OLD STONE'S BRIDGE REHABILITATION

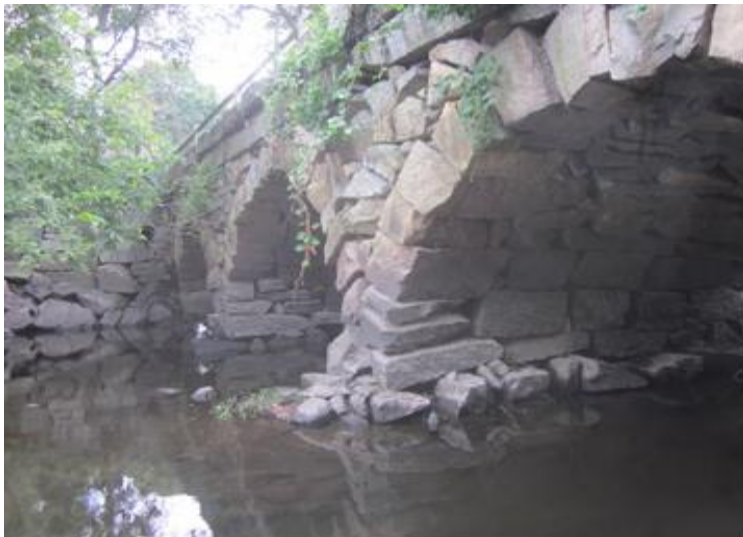
According to historical research, the present bridge is the final replacement of several wood-framed permutations that were built before it. This being said, no conclusive evidence as to the date of its construction has been found, but it is thought to be no older than the Old Town Bridge, which was apparently

built in 1848. I find this surprising because the dry laid stone construction is very primitive for a time when water resistant mortar materials were commonly available.

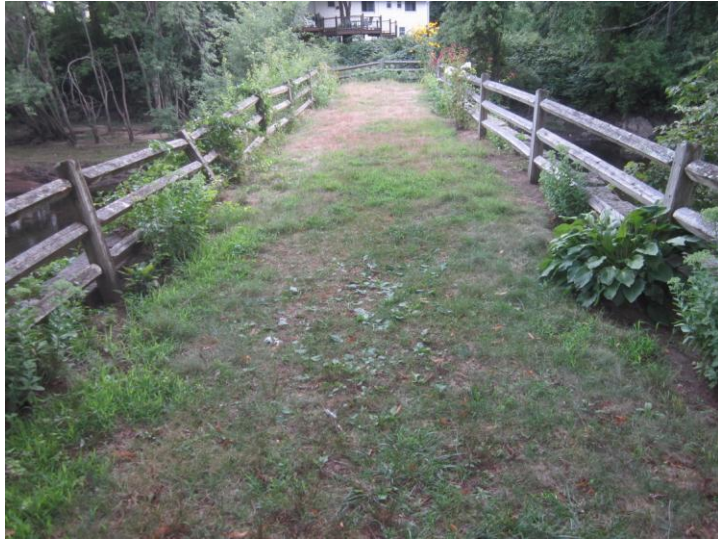
5. Earth was then placed over the arch structure up to the tops of the parapet walls in order to create the level surface for a roadway. According to our test pits, little or no attempt other than chinking (wedging of small, usually angled stones into joints) seems to have been made to seal the stone construction against pass-through water flow and sifting of soil. This being said, the original builders seem to have been at least marginally successful in containing the soil as there are few detectable sink holes on the surface.

6. The modern-era pier at the west end appears to have been constructed by building a three-sided "box" of semi wet laid stone walls within dunnage or containment forms, with the fourth side of the box being the far abutment of the westernmost arch. This box was then filled with bar reinforced concrete. The stone masons were clever to hold back the mortar from the outer faces of the stone walls to that they so one would not easily detected it when viewing the partially mortared pier and the unmortared bridge together as a whole.
7. Dimensional, sawn wooden fence railings presently bound the grassed-in top surface of the bridge which now serves as a small park. These are probably a several-generations-later replacement to the original railing system.

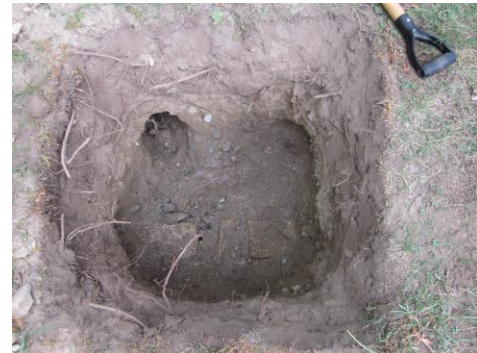
- Where the widenings occur, there is a loss of chinking and an eventual loss of soil. We experienced such soil loss first hand when we excavated one of our test pits near but not directly over one of these widenings and encountered a cavity within the soil at the side of the test pit that quickly turned into a sink hole.

The most immediate effect of these widened joints is the fact they act as funnels through which the retained fill can sift, creating hidden sink holes that grow from below until they eventually reach the retained fill surface. A way of transversely tying the bridge and retaining the soil mass must be devised, but it must allow the bridge to continue acting as a dry-laid masonry structure that allows the soil mass to freely drain.
