**Condition Assessments and Conservation Recommendations for  
North Cemetery, Wayland MA April 2017**

### Summary of conditions

On March 30, 2017, Martin Johnson and Irving Slavid principals of MCC, located the 98 markers designated for restoration. These were located on a gridded map, staked with identification numbers and digitally recorded. They are identified on the enclosed map in red.

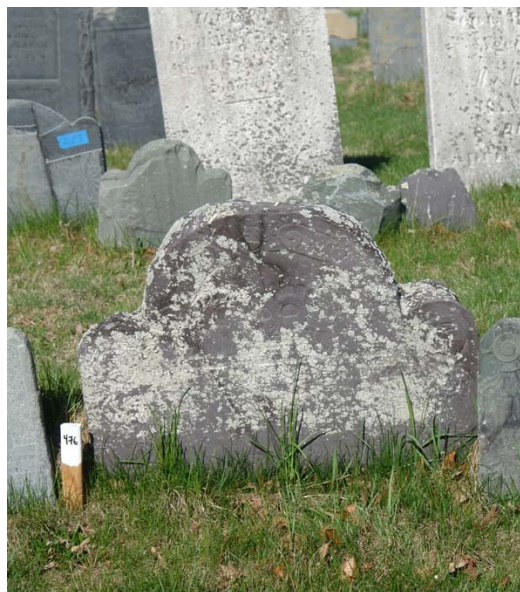
*Typical slate marker, benefitting from cleaning*

Other markers such as slate, schist and sandstone can be successfully cleaned without disturbing the overall aesthetics.

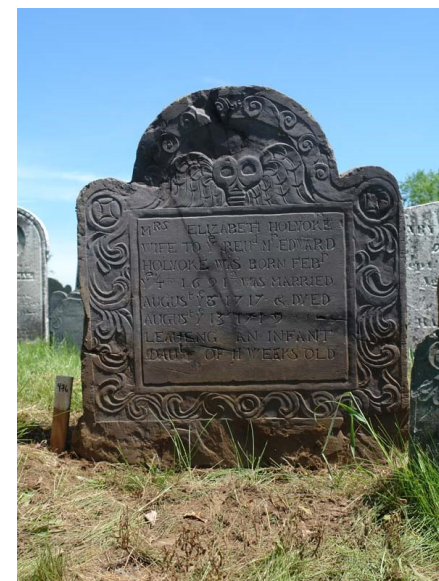
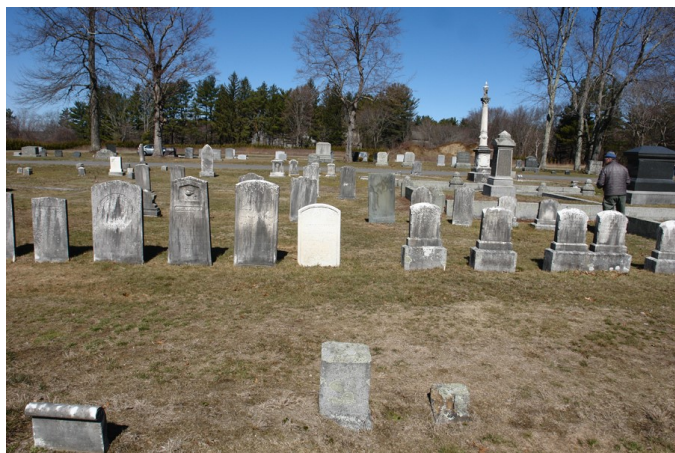
*The cleaning of one marble inappropriately stands out; and cleaning all the stones would be historically incorrect.*

Cleaning of marble markers should be limited to those requiring structural adhesions. General cleaning of marbles would make the markers appear very white and the cemetery would appear historically inaccurate.

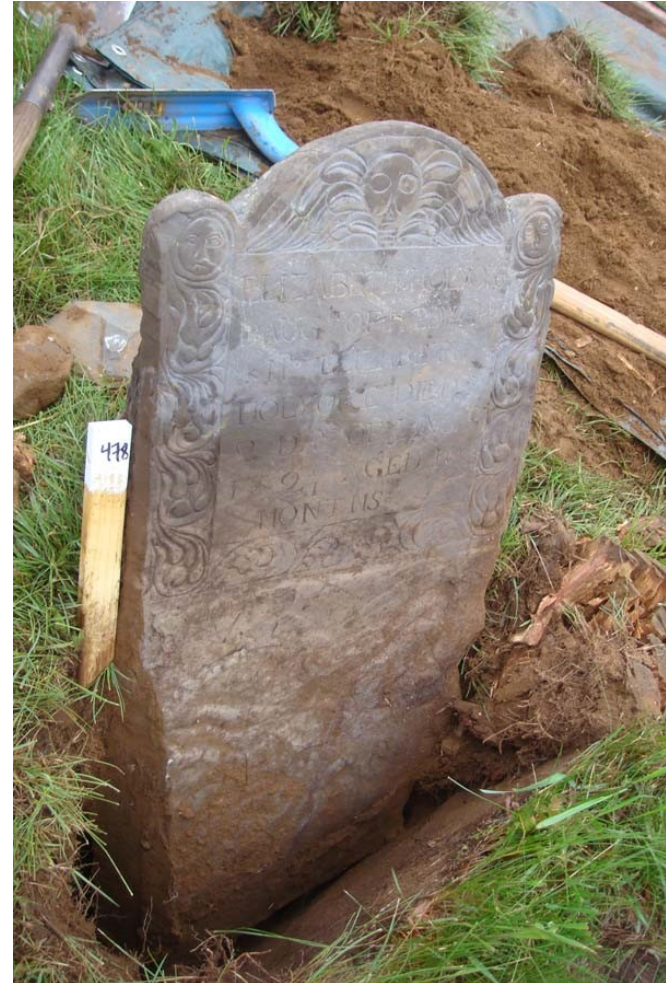
*18th century markers often have as much below the ground as above. Only upon excavating this marker for resetting does the very massive below grade portion becomes apparent..*

Earlier gravestones are typically long panels of stone that were set directly into the ground. After determination of the correct location and orientation of the stone, soil is removed to an appropriate depth. Gravel (or broken stone) is introduced to establish a stable base.

The stone is made plumb and level, and set in plane with the adjacent markers. Backfilling to be done with sand and gravel, wetted and compacted. Replace disturbed areas with the existing topsoil and turf.

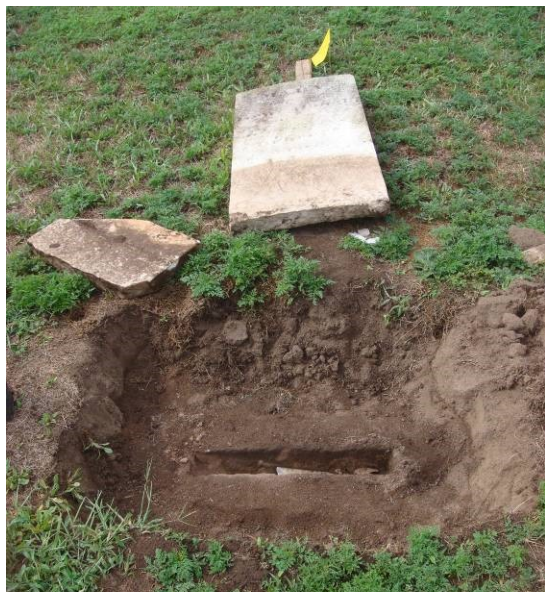
*When excavating for resetting often original, or old bases are discovered*

Older bases should be carefully excavated, examined for soundness and reset level at a higher elevation and aligned with adjacent markers.

Gravestones that required insertion into existing bases are to be set with a relatively weak cement/lime-based grout (3:2:9:1) with fine aggregates (000), made fluid with a high-range water reducer which ensures a complete fill.

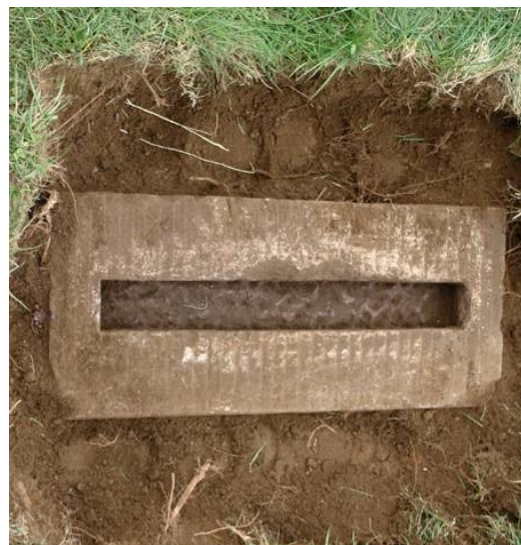
*Old base reset higher and aligned with adjacent markers*

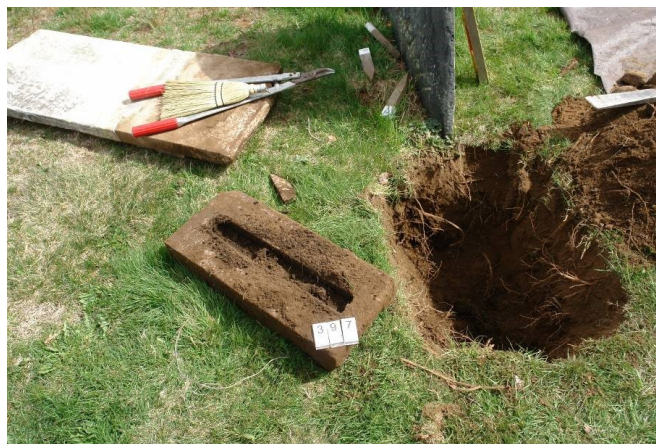
*Old base removed and inspected for soundness*

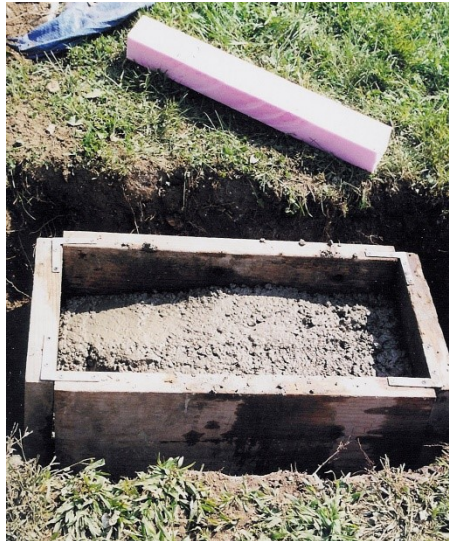
*Formwork for new base*

New below grade bases are made on site by casting in the ground with concrete. The casting is generally 9 to 12 inches deep, and 12 inches greater in thickness and 6 inches wider than the stone itself. The finished top surface of the base should be entirely below grade.

A form insert for a 1-inch deep setting slot, 1/2 inch wider and 1 inch thicker than the stone, is positioned in the concrete, in line with adjacent markers.

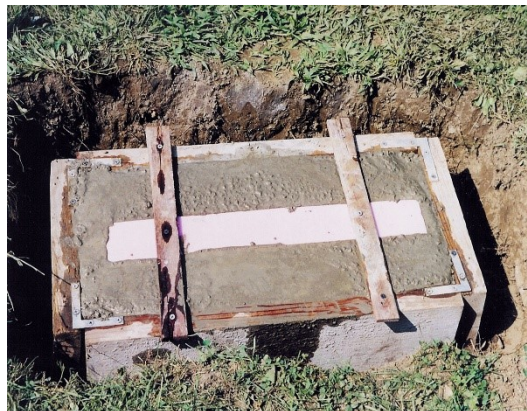
*Poured base with form insert for setting slot*

After the base has cured, the form is removed, and the area backfilled. The gravestone is reset into the slot using a cement/lime mortar (3:2:9) with 00 or 000 sand, made fluid with a high-range water reducer which ensures a complete fill.

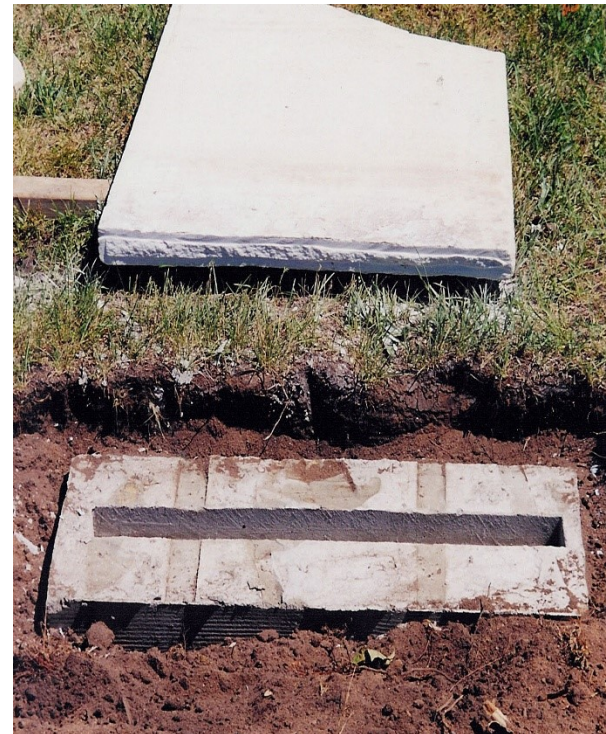
*New base ready for resetting*

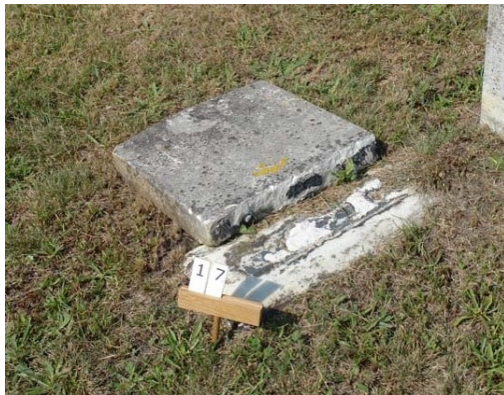
*Example of marker broken just above existing base*

When the gravestone has (typically) broken just above an existing slotted base, stone fragments may have to be removed from the slot and the bottom of the gravestone re-squared. Even with power tools, this is a time-consuming and arduous task.

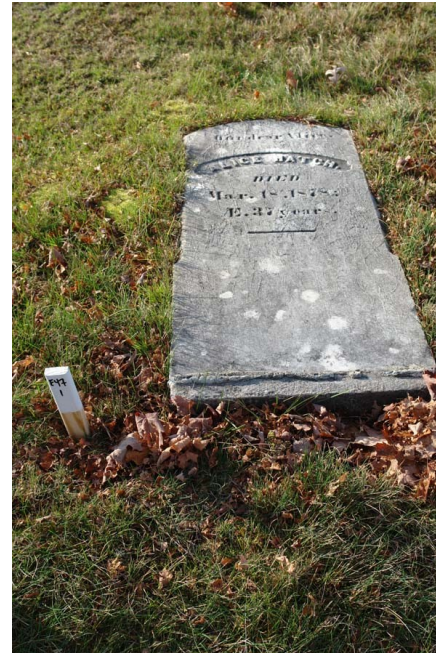
*The original base for this marker may be discovered by probing, or a new below grade base may be required.*

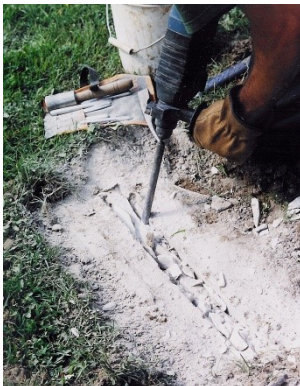
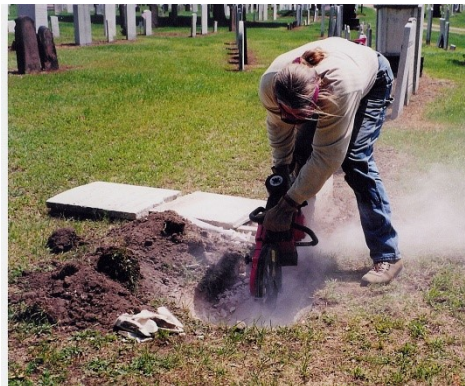
*Removing slot fragments with power tools*

Stones are set with a mix of cement/lime/sand (3:2:9) with 00 or 000 sand made fluid with a high-range water reducer which ensures a complete fill.

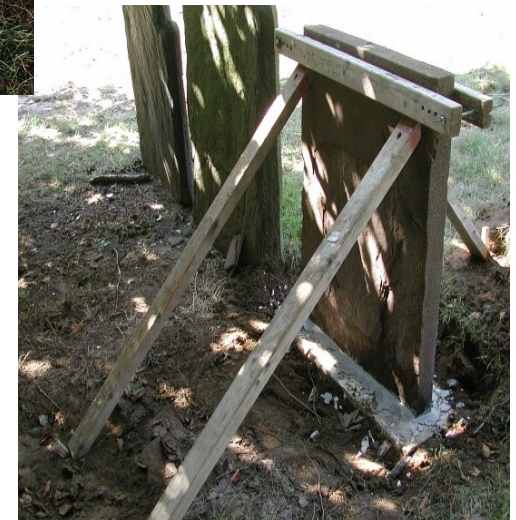
*Example of bracing after re-setting with mortar.*

Set plumb and level, and braced for a minimum of three days to limit movement during curing of the grout.

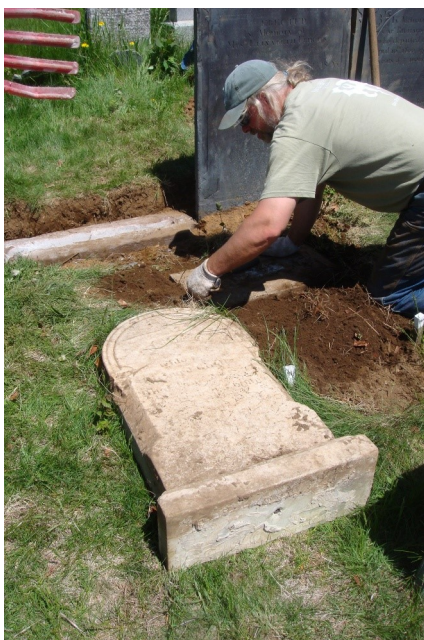
*Discovering and excavating existing foundation or in ground base.*

Often markers are soundly attached to a base yet fallen or unstable on their foundations or in-ground bases. When required, foundations are to be leveled and aligned with adjacent markers.

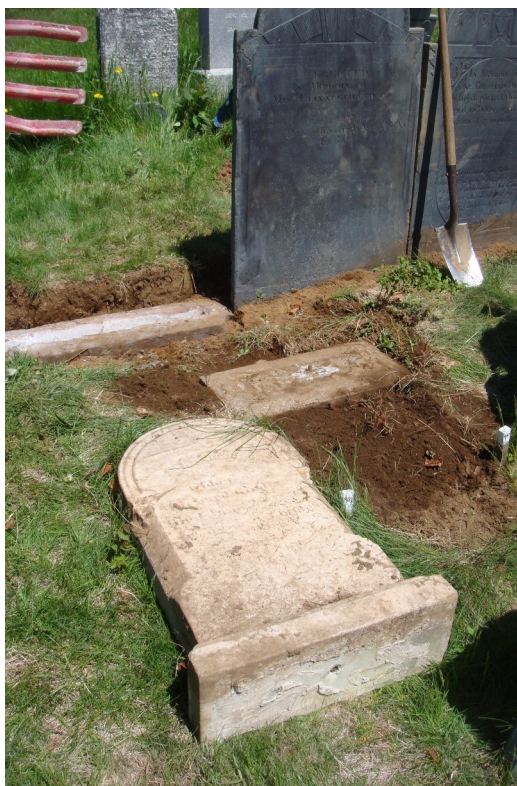
*Raising and leveling in-ground base*

For resetting, setting surfaces were first cleaned and any remaining failed mortar removed with hand tools. Prime setting surfaces with Acryl 60 diluted with water 1:3, and reset markers with a cement/lime-based grout (3:2:9:1) with fine aggregates (000).

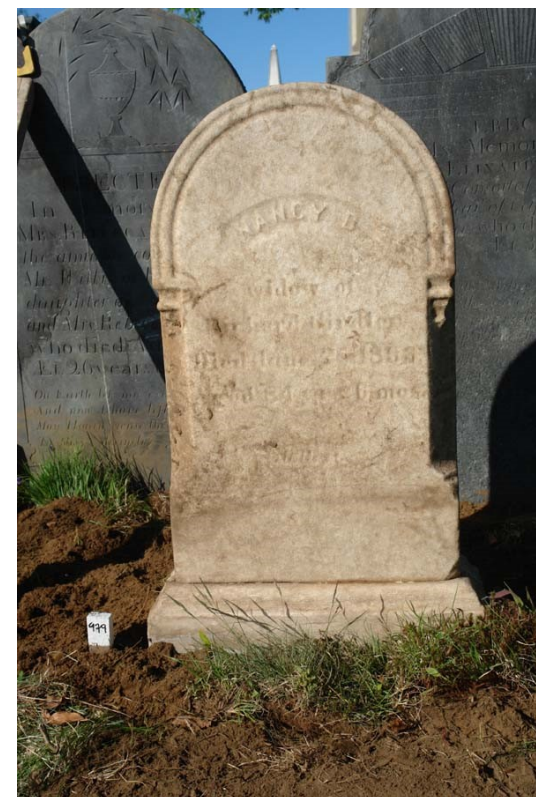
*Marker reset*

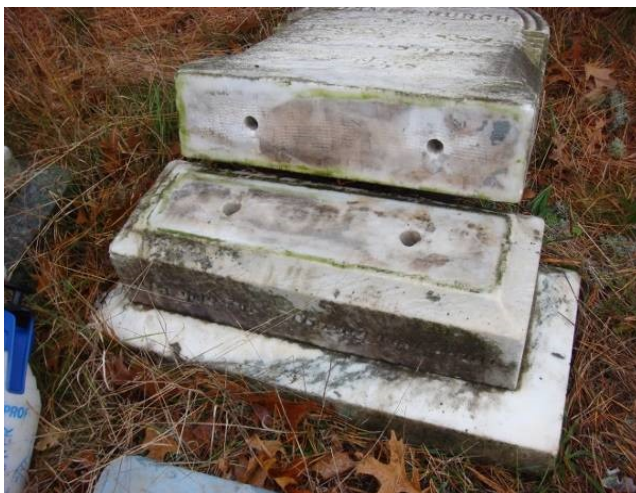
*Loose pins are often easily removed by hand and replaced with threaded stainless steel. Setting mortar is removed from setting surfaces with hand tools and areas treated with D/2 Biological Solution*

Inspect existing pins and if sound and made of copper or bronze can be re-used. Replace all iron pins. If missing or unsound carefully remove by drilling around them with a core drill and replace with stainless steel threaded rods. Setting holes were drilled to clean out debris.

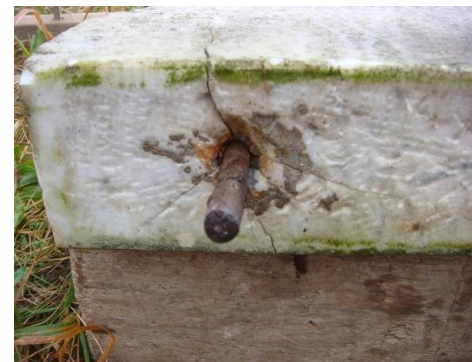
*Above: Examples of cracking cause by rusted pins.*

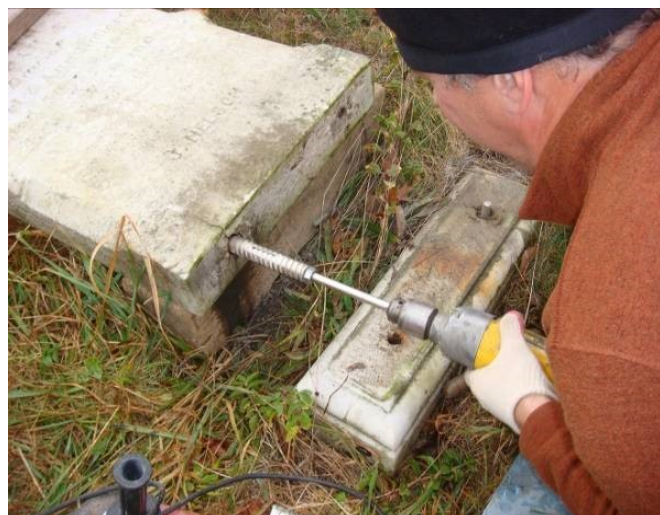
*Example of removing iron pins with a core drill. These will be replaced with threaded stainless steel rods*

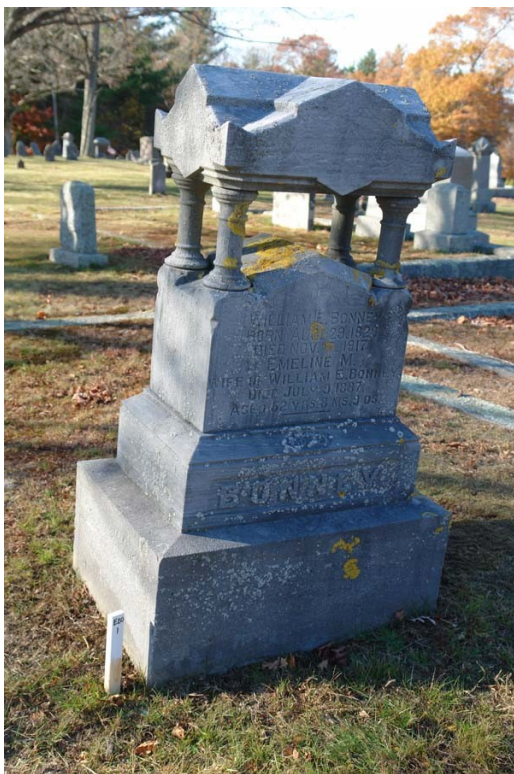
*The large die (above) will require mechanical assistance to reset level. Resetting this monument after it falls is considerably more costly than stabilizing it now.*

After leveling and stabilizing the in-ground base or foundation, marker elements are re-set on a full bed of mortar. A successful mix is a cement/lime/sand (3:2:9) with 00 or 000 sand.

Setting surfaces can be primed with Acryl 60 diluted with water 1:3 for good bonding. Lead shims can be used to establish a reasonable joint dimension, or for minor adjustments to level.

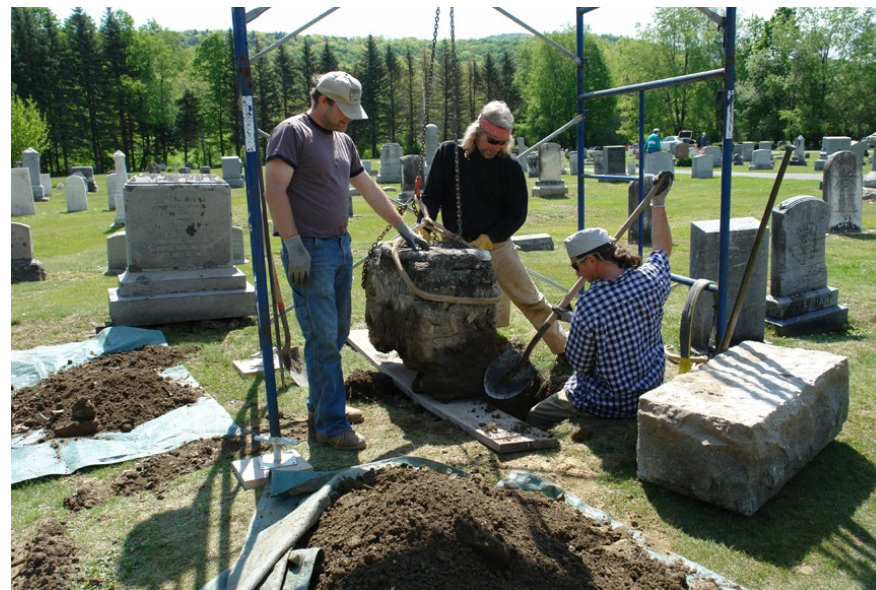
*Example of re-setting a large monument onto base with scaffolding and chain hoist*

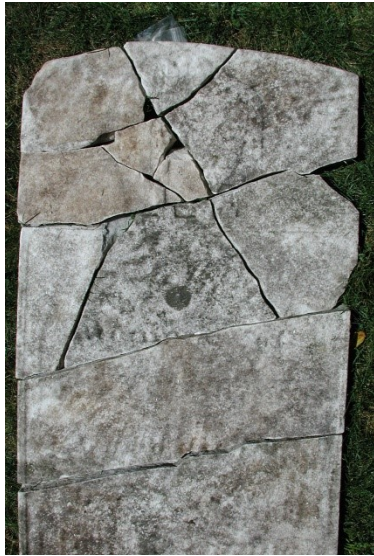
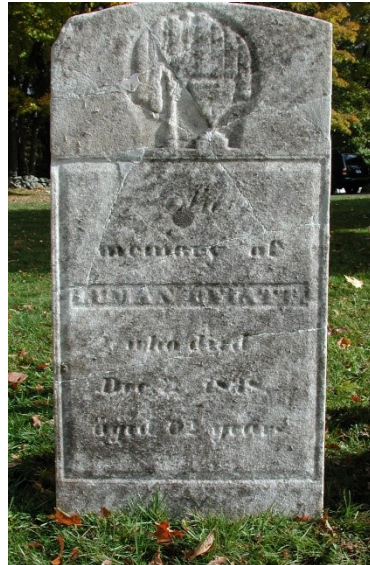
*Marble gravestone, before and after restoration*

All bonding surfaces to be carefully cleaned and the fragments dry fitted. Aboweld 55-22 (Abatron, Inc.), a thixotropic, moisture-insensitive two-part epoxy, is thinly and evenly applied along both surfaces of the glue line, keeping slightly back from the edge of the break.

The properly-aligned fragments are joined with clamps, and braced during curing, which is typically a period of several days. Any extra epoxy flowing from clamped joints should be left to partially cure for 24 hrs before attempting removal, and carefully chipped off. The slight gap created is concealed with a crack filler.

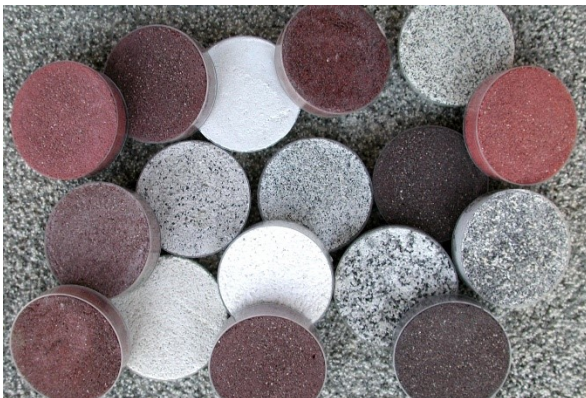
*Examples of cement-lime repair mortars*

Losses designated for treatment can be filled with a pigmented cement/lime mortar, using colored aggregates.

The mortar color and texture should be matched to that of the unsoiled stone. If the stone has not been cleaned, artificial "soiling" of the cured mortar surfaces can be done by a variety of means, including use of potassium silicate paint systems, such as Keim, or a diluted acrylic wash with alkali-stable pigments.

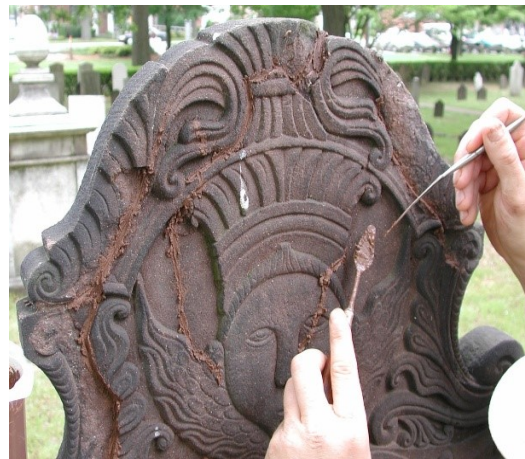
*Filling cracks in a sandstone with a pigmented crack filler*

Losses in sandstone are filled with a custom-colored cementitious restoration mortar, such as Jahn™ M-70 (Cathedral Stone Products, Inc.). For marble, losses are filled with Jahn™ M-70 Custom Limestone Maximum White or with RepliCal™ Marble, a marble-based repair composite designed to match the appearance of weathered surfaces. Most fine cracks can be filled with pigmented Voidspan PHLC, a pozzolanic hydraulic lime crack filler and grout.

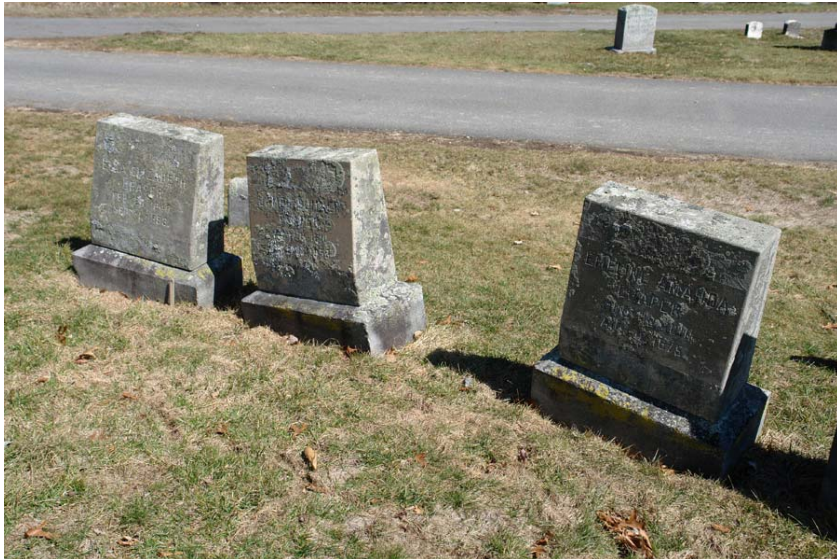
Poss extra Tilted Sherman(D.6)

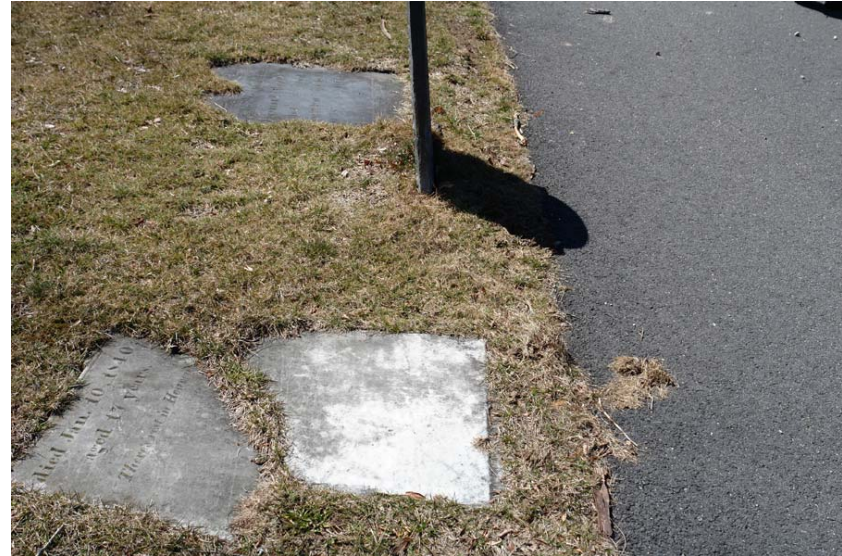
Poss extra Tilted adj to 91 (D.9) numerous
