EcoTec, Inc.

Re: 24 School Street, Wayland, MA

Subject: Peer Review Findings & Recommendations

SITE EVALUATION PHOTOS TAKEN AT 24 SCHOOL STREET, WAYLAND, MA

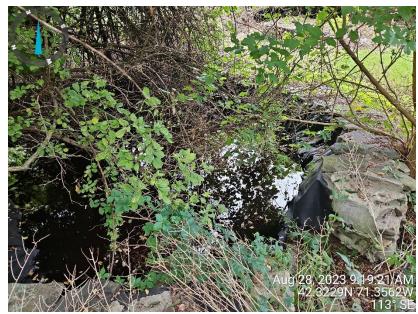
1. Lined "Fish Pond" Water Feature

- 4. I noted a small, ponded water feature on the site that is labeled "Fish Pond" on the plans. The water feature appears to have a heavy plastic liner and, accordingly, would not be regulated under the Wetlands Protection Act due to the artificial, impervious basin exemption at 310 CMR 10.04. I defer to the Commission regarding the status of the water feature under the local Bylaw.

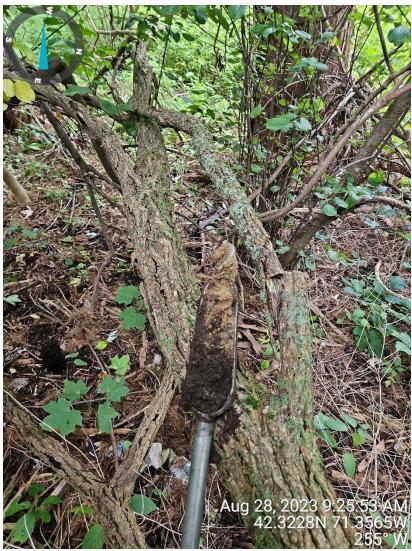
3. Representative non-hydric soil from southerly part of wetland boundary

- 3. On August 28th, I visited the site to confirm the wetland boundaries. I was accompanied by Francis Alves of CLAWE. It is my understanding that the recently installed, pink flags labeled WF-1 to WF-12 represent the wetland boundary as approved under the 2015 Order of Resource Area Delineation ("ORAD"). I reviewed those flags and noted one additional flag labeled WF-A1, located between flags WF-2 and WF-3. I am in agreement with all flags except WF-2 where I found hydric soils upgradient, between WF-2 and WF-A1. I recommend connecting flag WF-1 to WF-A1 to WF-3 and eliminating flag WF-2. Flags WF-1 to WF-7 are located on a gradual slope with some wetland vegetation extending upgradient of these flags. I observed the soil profiles and found non-hydric soils upgradient of all flags with the exception of WF-2 (see above). Flags WF-8 to WF-11 are located at the toe of a well-defined slope with dominant wetland vegetation upgradient. Representative photos, taken along the wetland boundary, are attached.
