Reference: Old Town Bridge, Wayland, MA

On 10 August 2012 we performed an investigation of the Old Town Bridge in Wayland. This included visual observations from the top, sides, and undersides of the bridge, three test pits, and several samplings and probes.

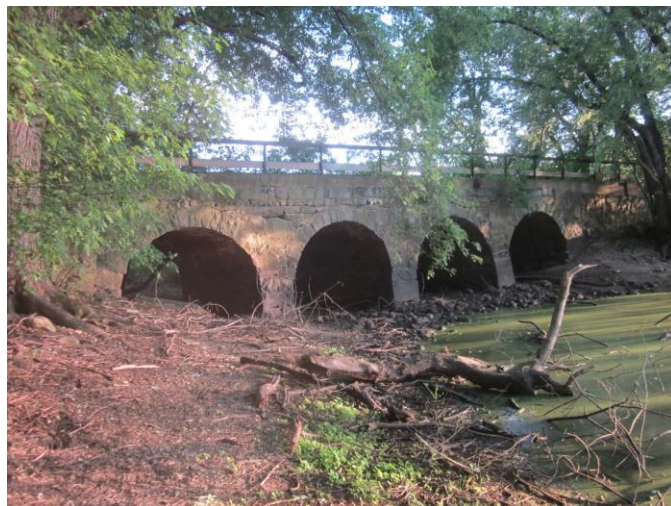
The Old Town Bridge is approximately 56-feet long by 18-feet wide, and has four barrel vault arch spans of approximately 11-feet across. 15- and 18-foot long splayed wing walls at each end make the total construction approximately 89-feet long.
