PREPARED FOR:
THE TOWN OF WAYLAND CONSERVATION COMMISSION

DESIGN BASIS REPORT
SNAKE BROOK DAM
MA01119
WAYLAND, MASSACHUSETTS

PARE PROJECT NO. 19167.00

APRIL 2020

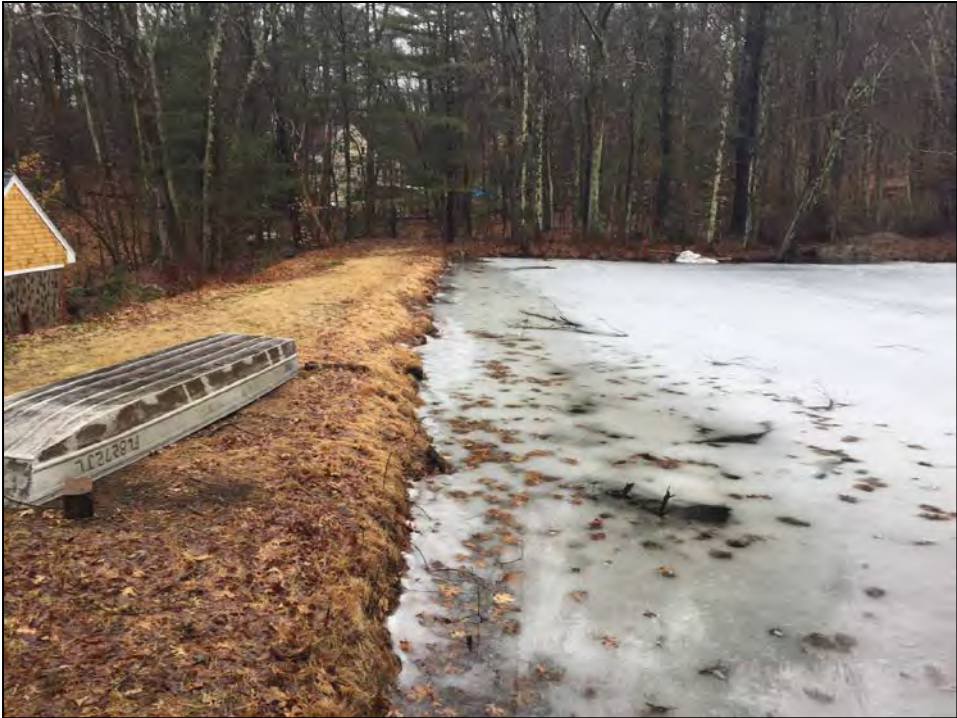
Photo No. 3: Upstream slope from the left abutment looking right. Note limited freeboard at the dam.

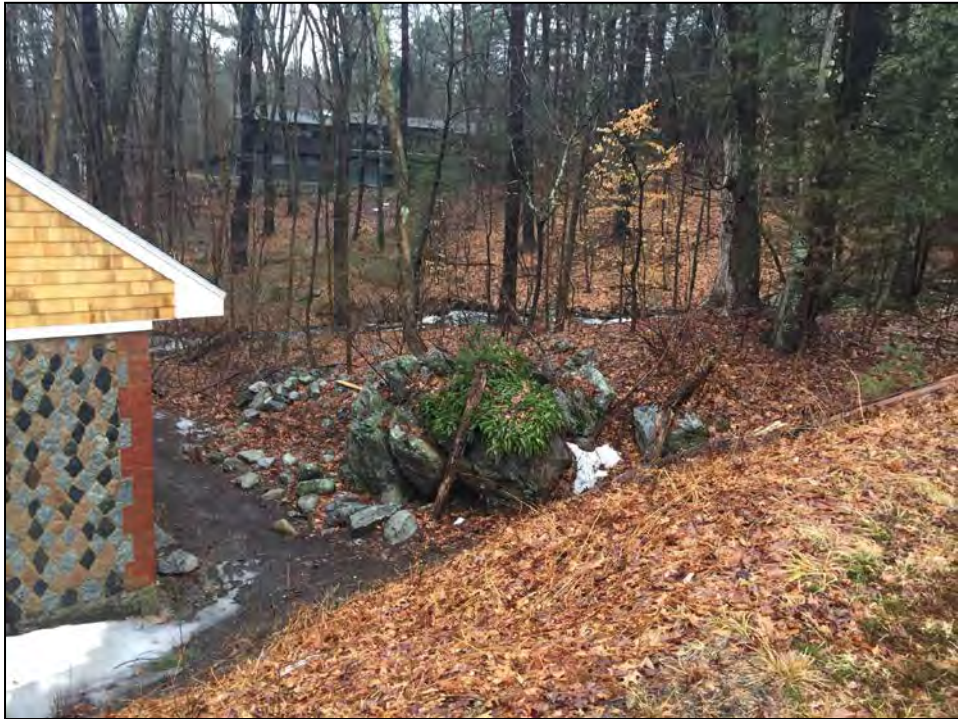
Photo No. 8: Apparent bedrock outcrop in the downstream slope right of the gatehouse.

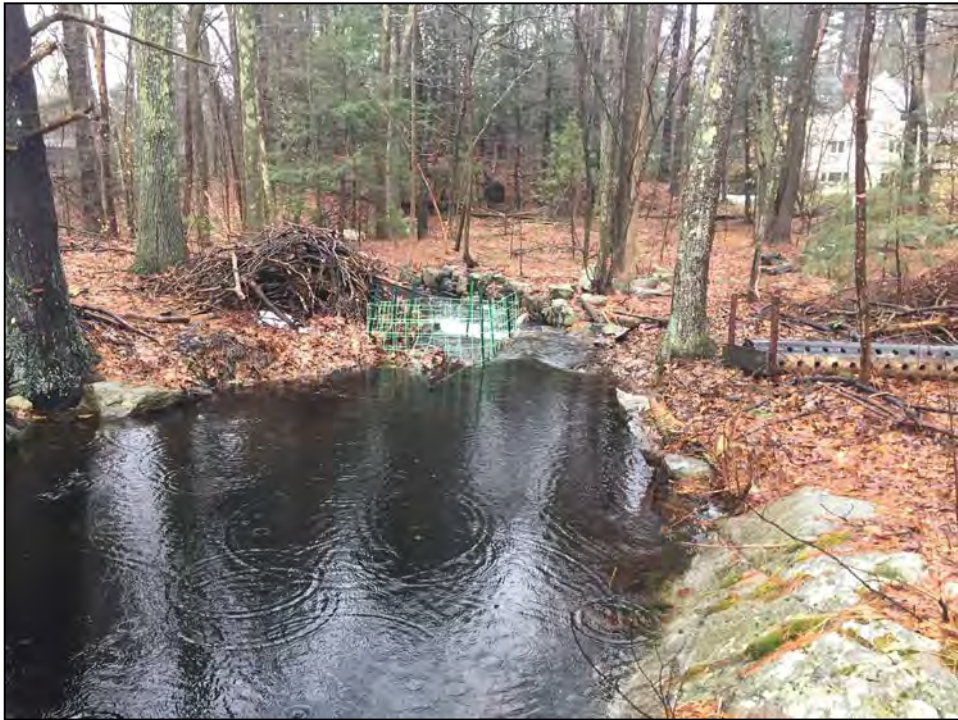
Photo No. 11: Spillway control section from the approach looking downstream. Note apparent bedrock outcrop in picture foreground.

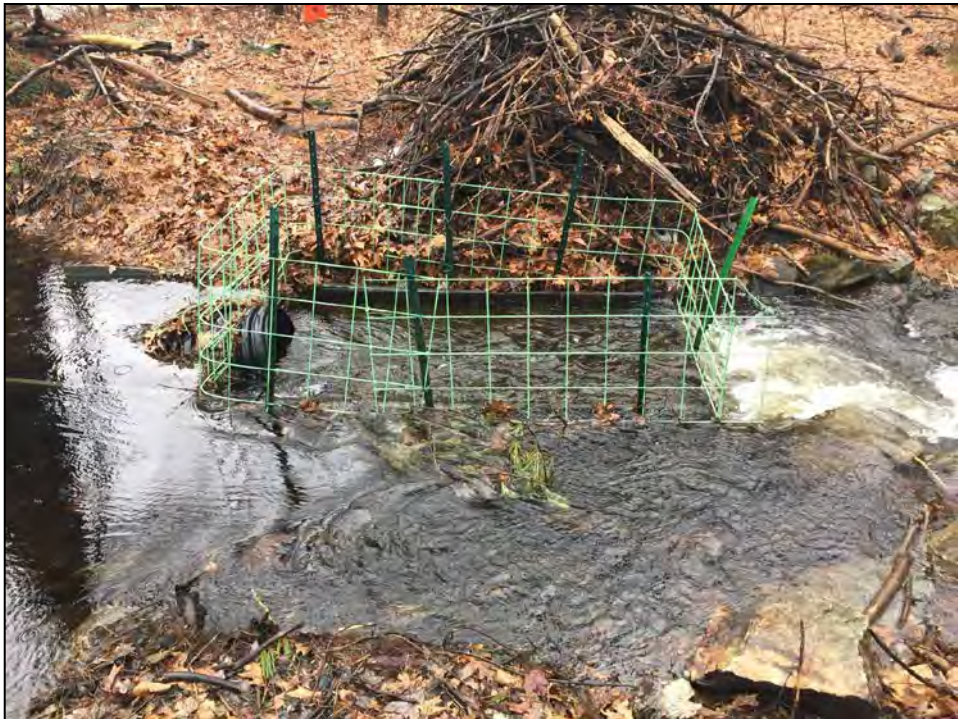
Photo No. 12: Spillway control section with apparent past beaver deceiving devices.

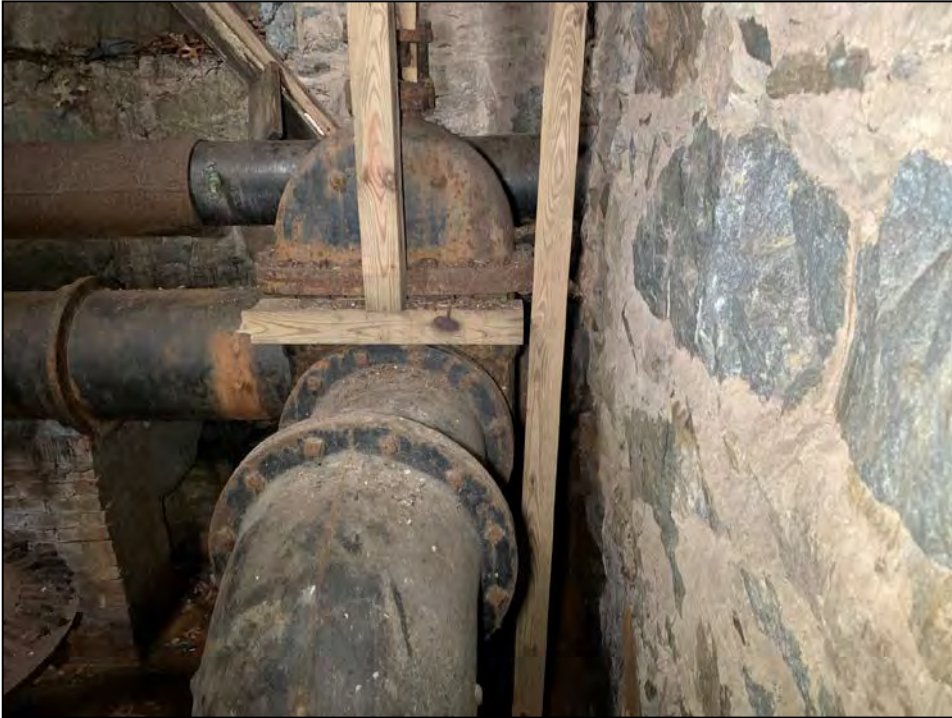
Photo No. 19: Intake lines extending through the upstream wall of the gatehouse.

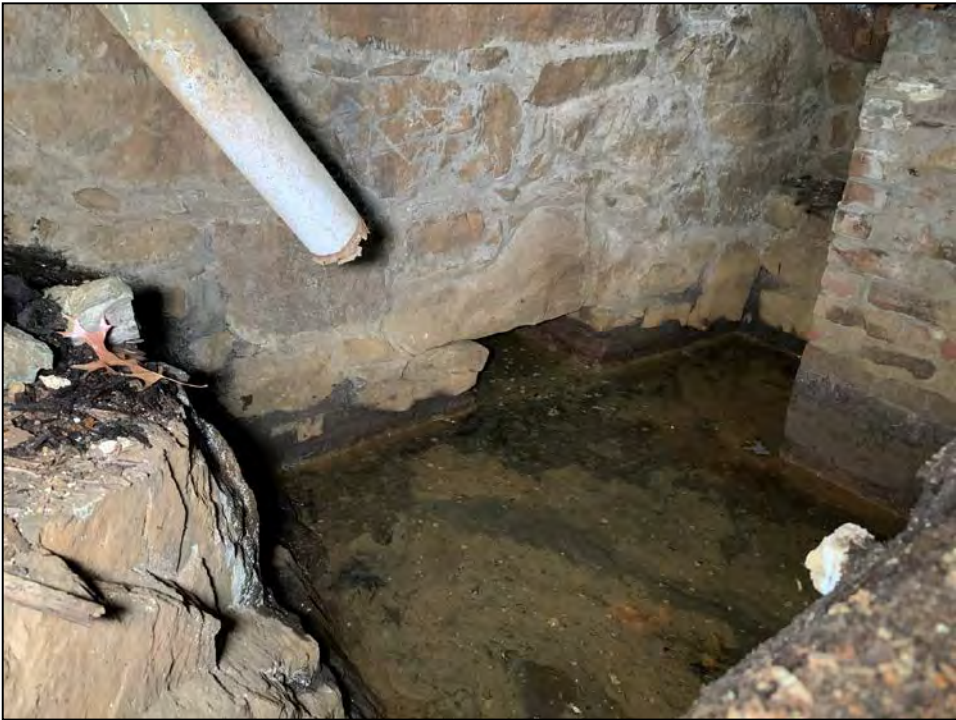
Photo No. 21: Outlet culvert in the base of the downstream wall of the gatehouse.

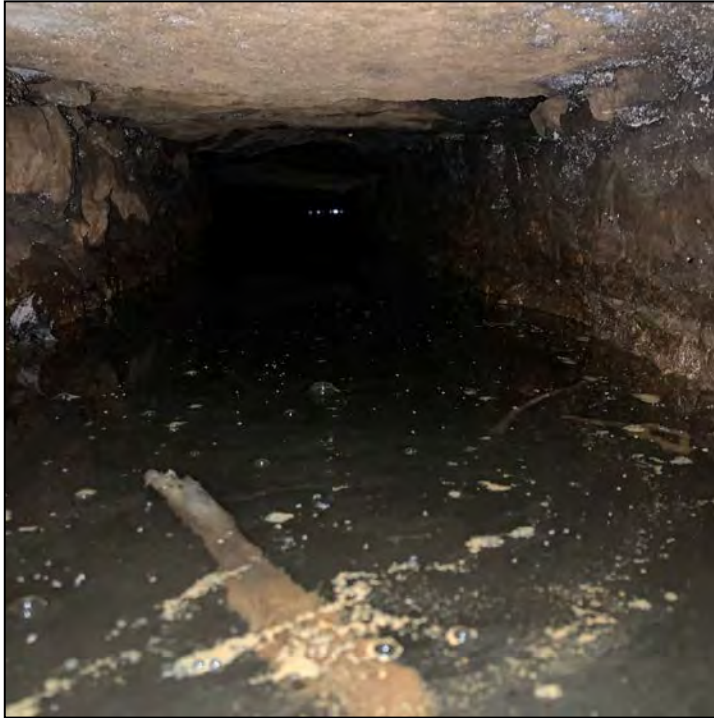
Photo No. 23: Outlet culvert interior from the upstream end at the gatehouse looking downstream. Note daylight at the downstream end of the culvert at the downstream channel.

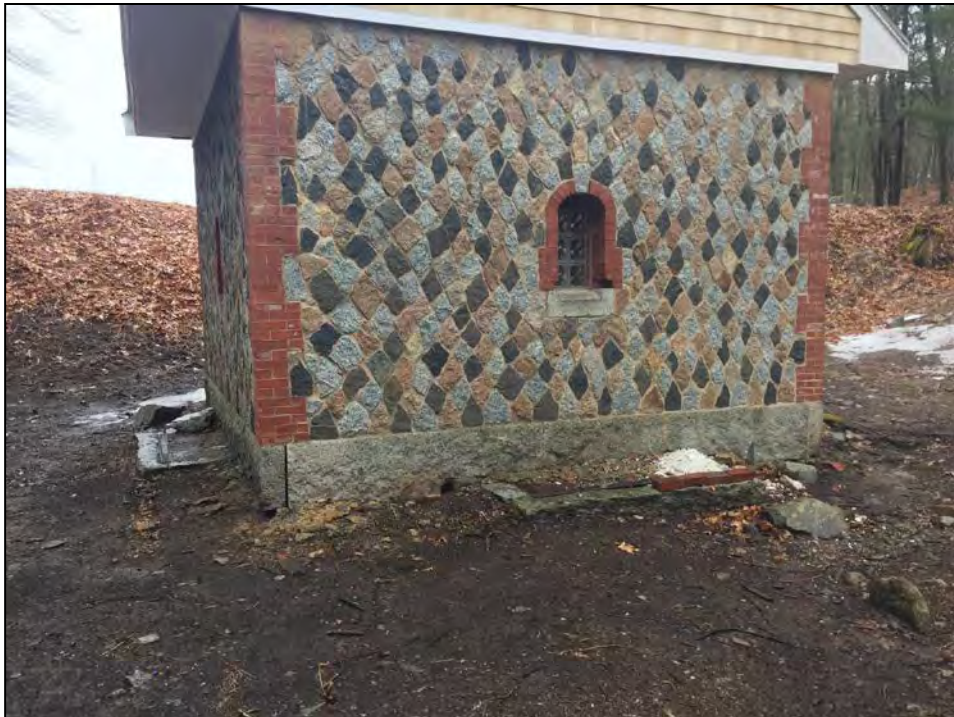
Photo No. 24: Downstream wall of the gatehouse superstructure.

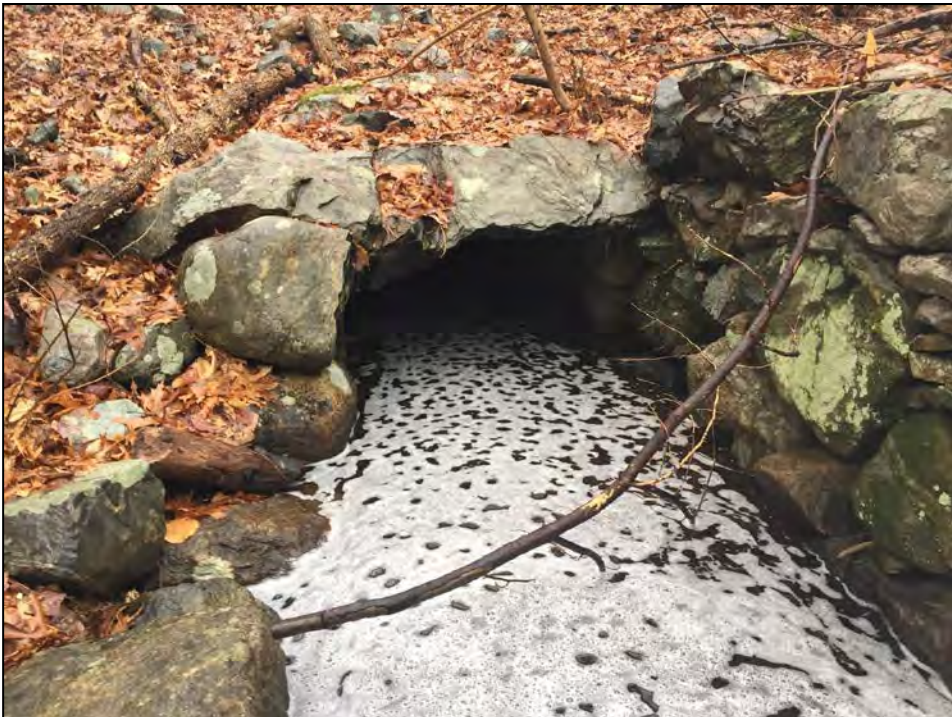
Photo No. 26: Outlet end of the outlet culvert

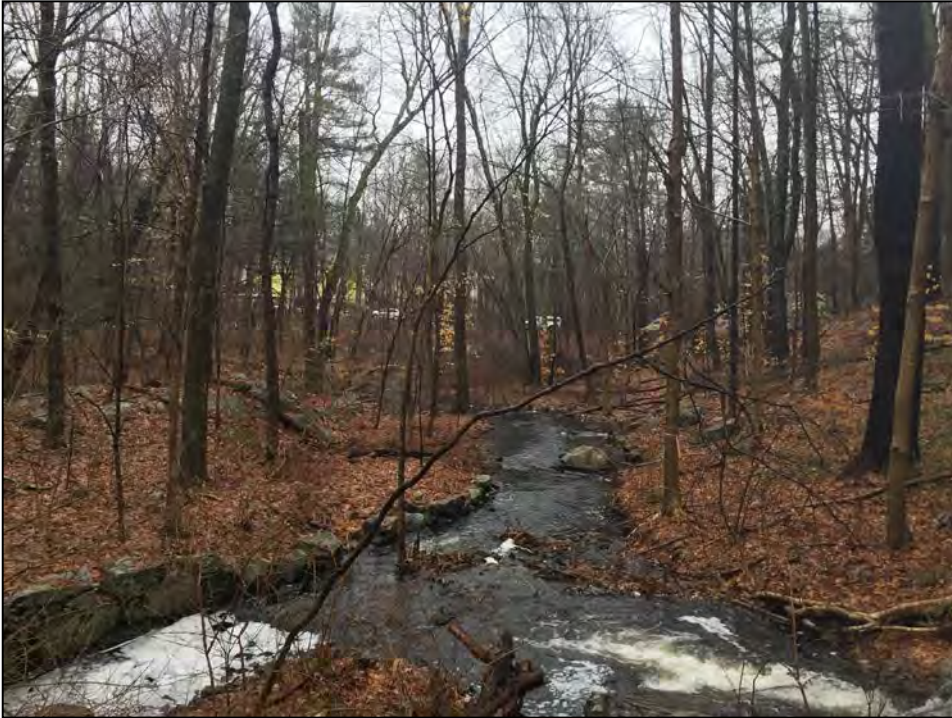
Photo No. 27: Downstream channel. Note Woodbridge Road culvert crossing located several hundred feet downstream.

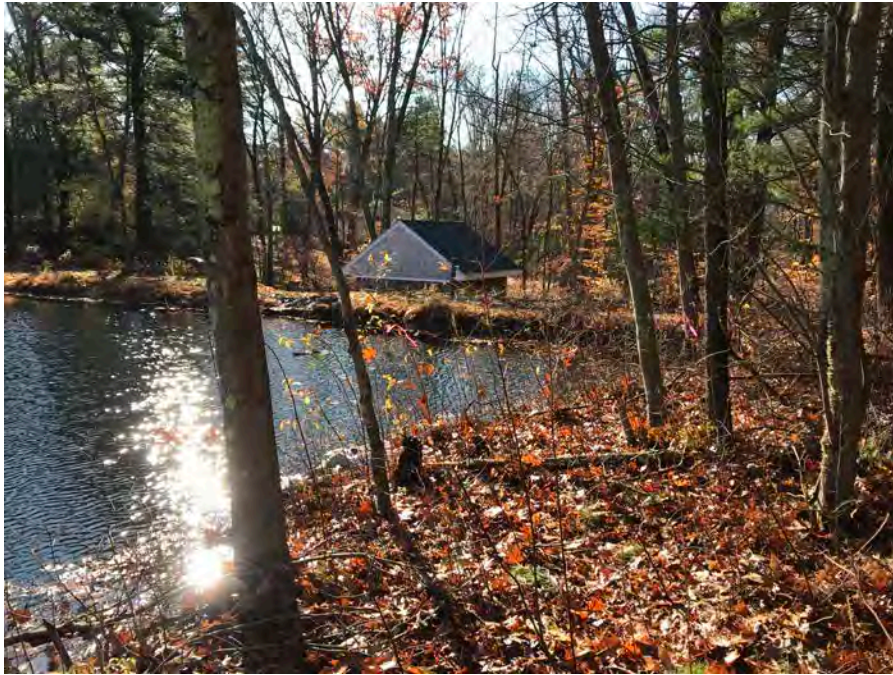
Photo 3: Wooded section of bank at upstream right side of dam, facing southeast toward gatehouse.

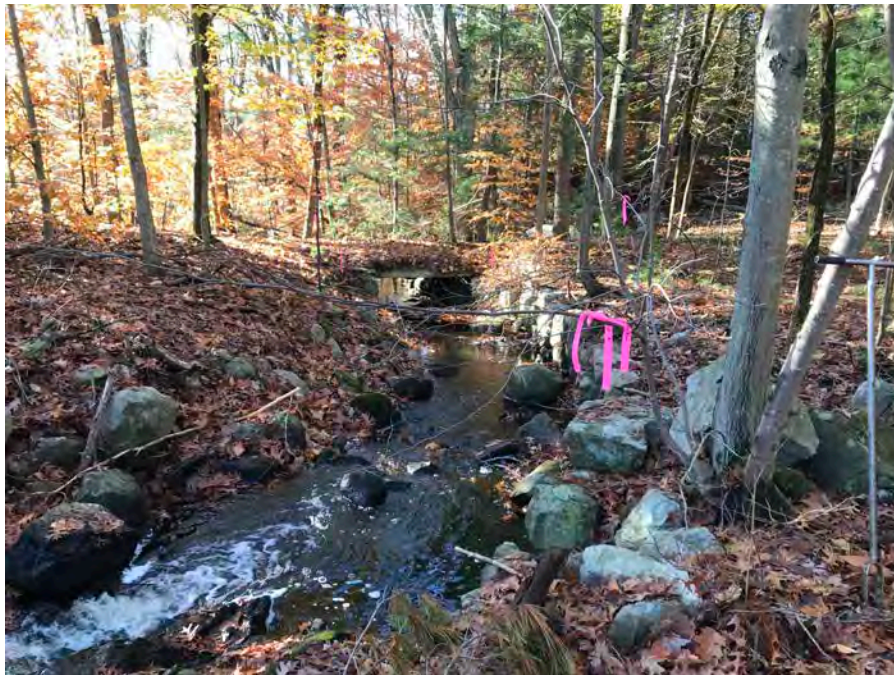
Photo 6: Outlet channel, facing downstream from spillway toward footbridge.

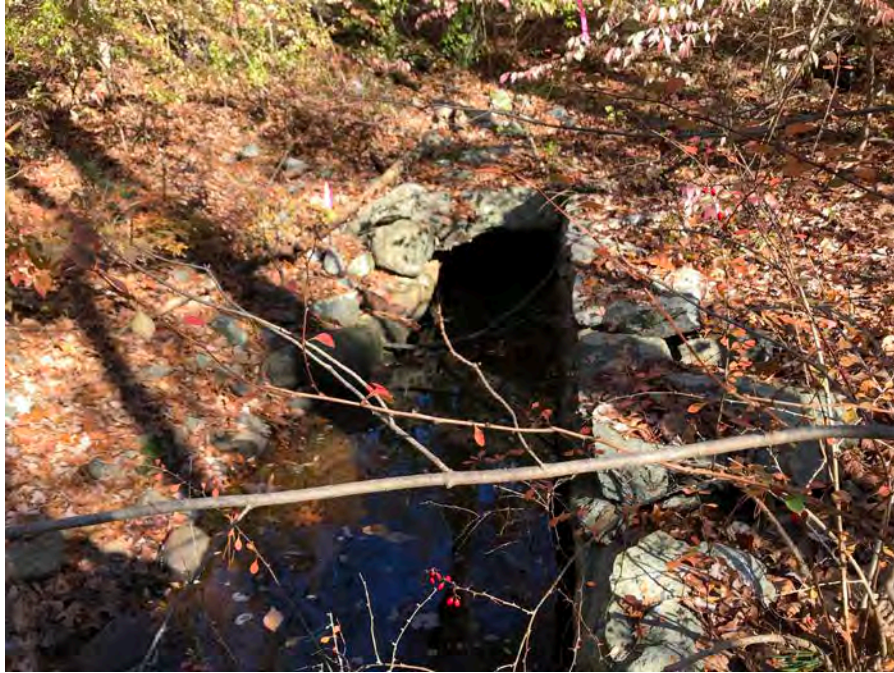
Photo 7: Walled outlet channel downstream of dam, located between flags R-12 and R-15.

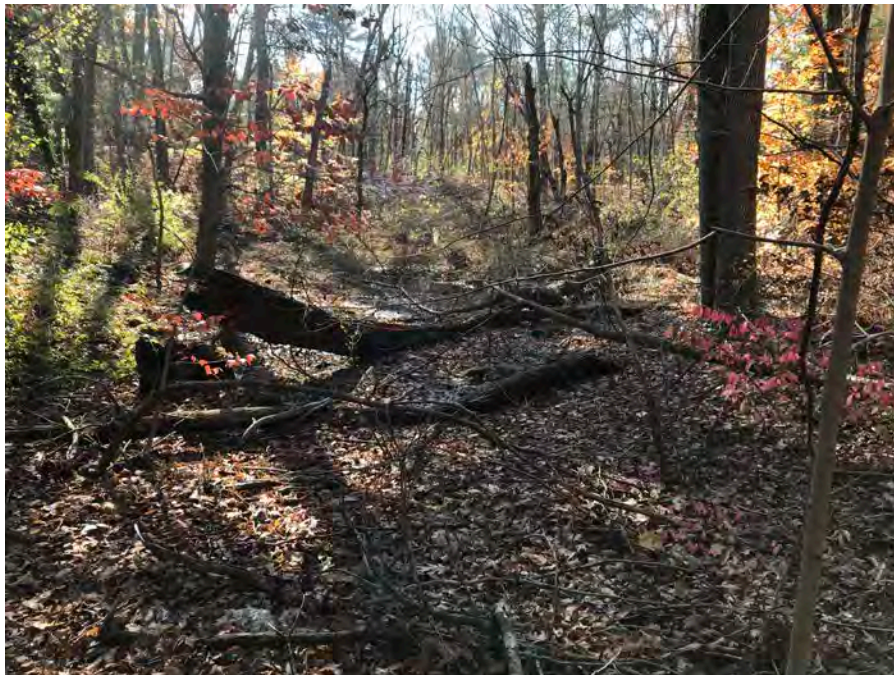
Photo 8: B-series BVW within the wooded area downstream of the dam.
