To Wayland Zoning Board of Appeals

From: John Sax - President of the Willow Brook Condominium Association

Subject: Three Unresolved Issues in the Loker field project

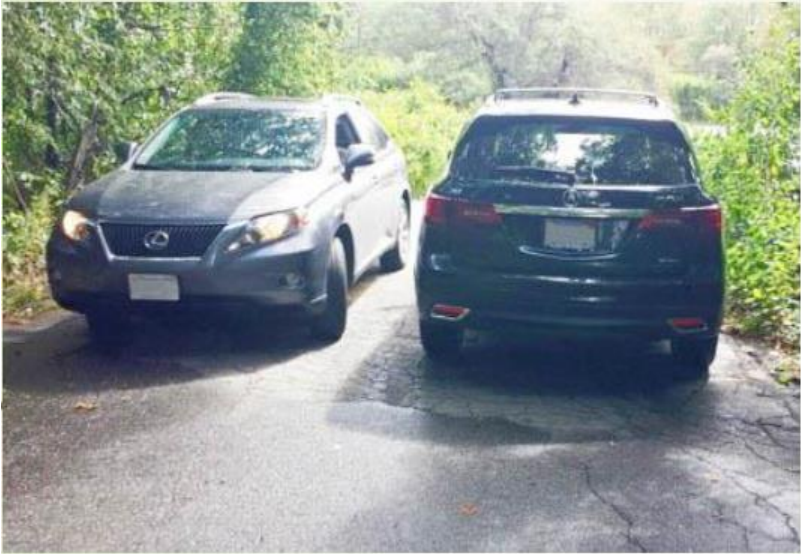
Figure 1

17 Ft wide access road

- Driveway is barely wide enough for two cars
- Sharp turn with steep slope
- No sidewalk Pedestrians compete with cars
- Emergency vehicles use the same access road
- Cars can't move to the side for emergency vehicles

- The access road is very narrow particularly at the first sharp turn going uphill where road width drops to 17 feet. This is also the part of the road with and a steep incline.

- This means that cars will barely be able to pass each other even in the best conditions as shown in figure 1 below. Cars will be forced to move very slowly up and down the hill as the pickup and drop of children.

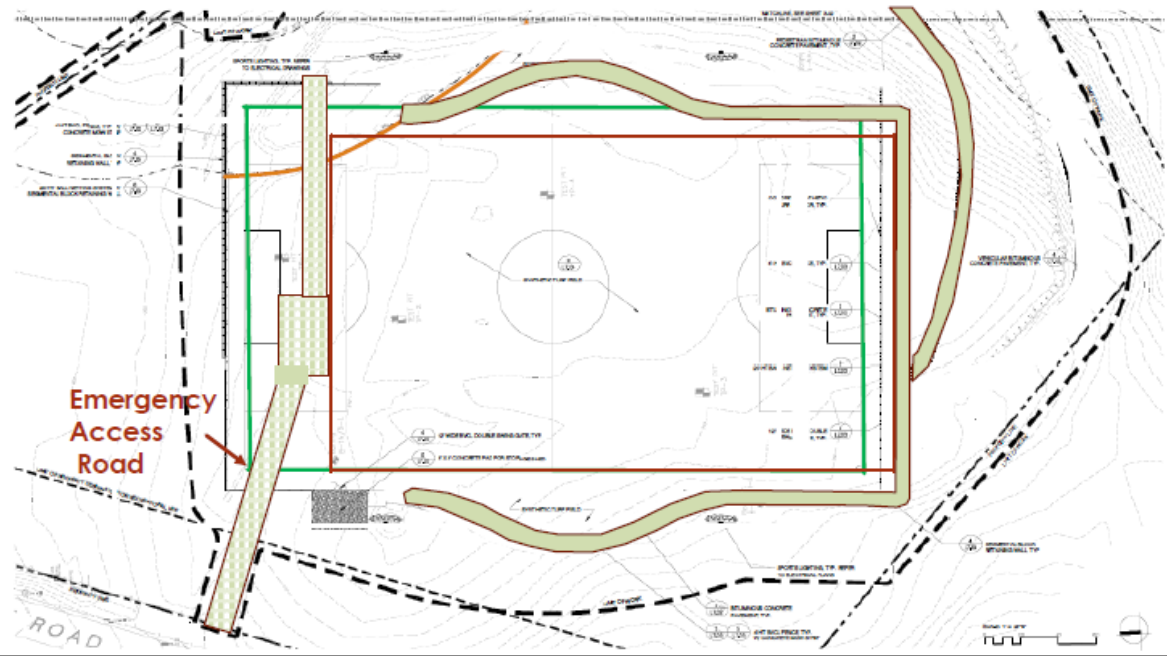
Figure 3

Proposed Turf field 110yds by 63yds
 Smaller Field 100yds by 60yds

If the field size is reduced so that it no longer blocks the Rice road access as shown in figure 3 below the access could then be dedicated to emergency vehicles which would give them easy access to both the field and the parking lot.
