**DESIGN BASIS REPORT
SNAKE BROOK DAM**

MA01119

WAYLAND, MASSACHUSETTS

APRIL 2020

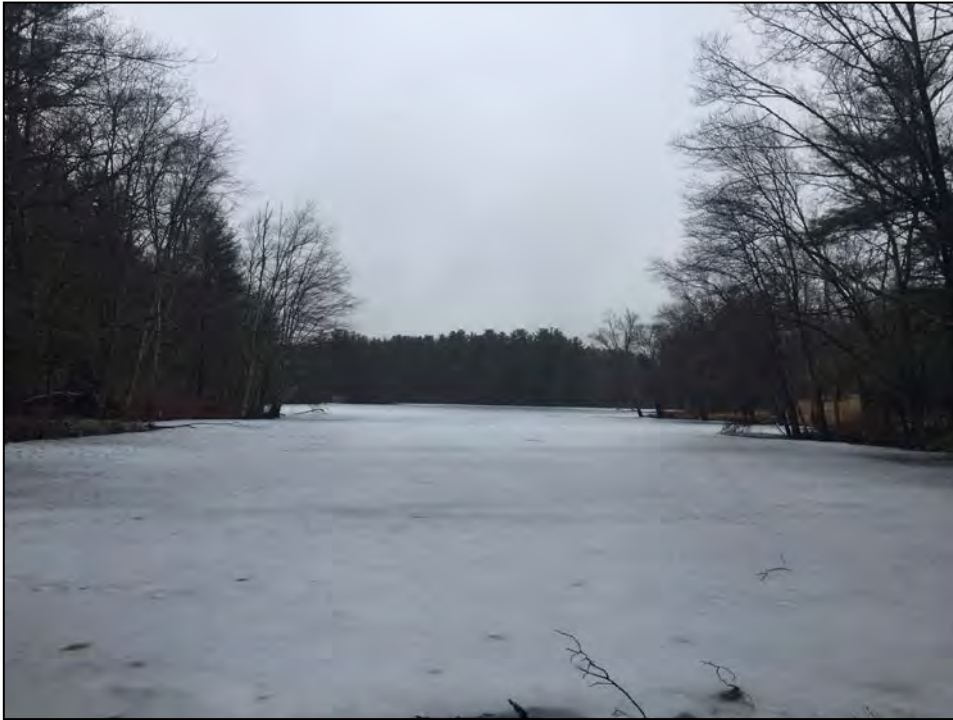
Photo No. 1: Overview of the impoundment created by Snake Brook Dam from the dam crest looking upstream.

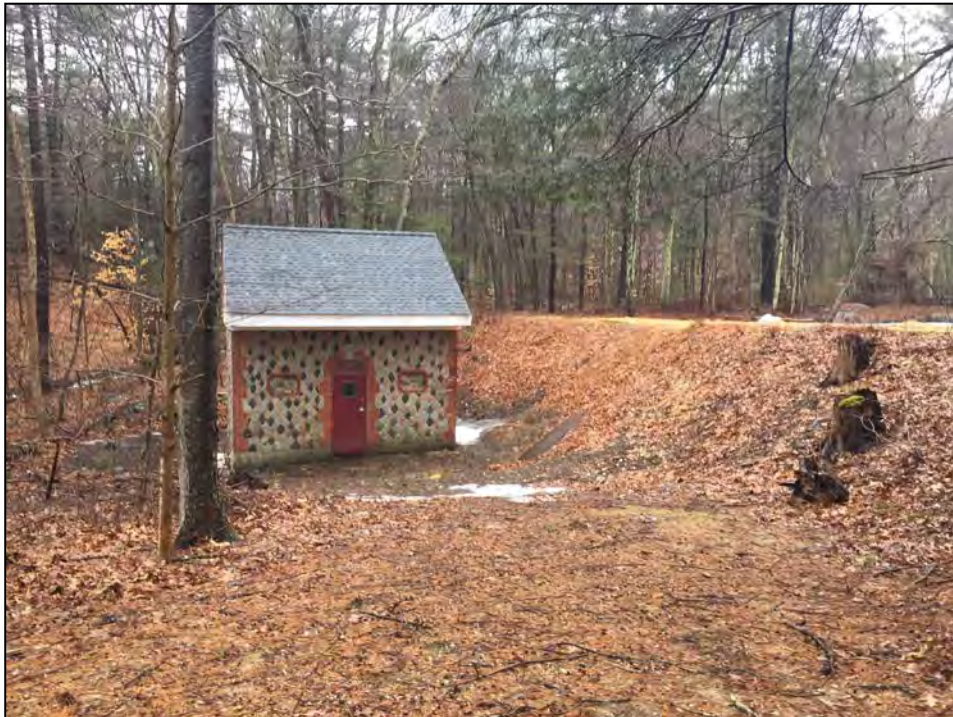
Photo No. 2: Overview of the downstream side of the dam.

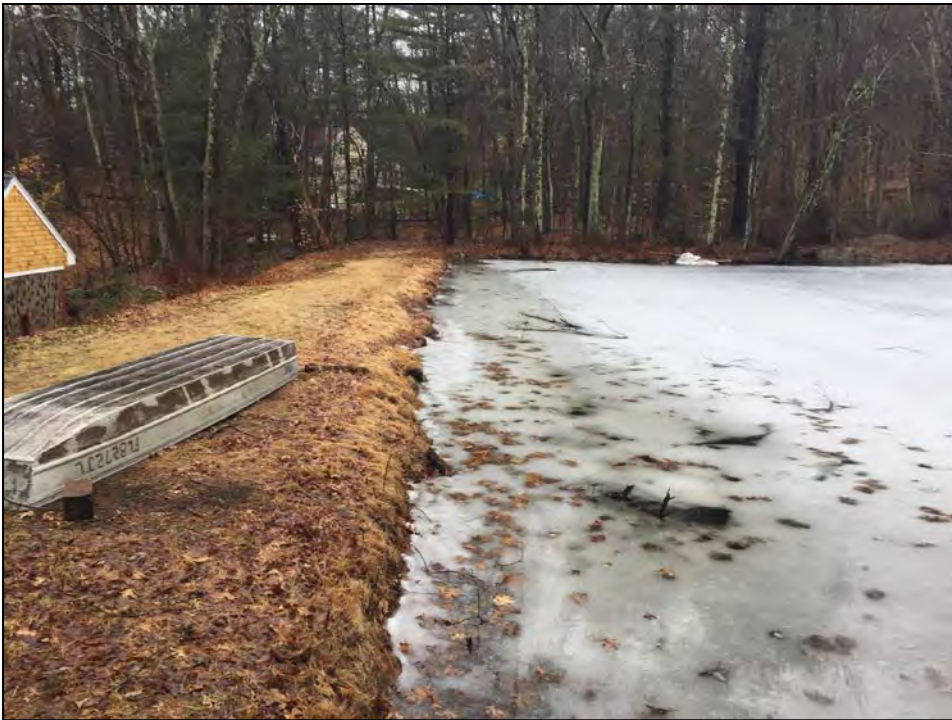
Photo No. 3: Upstream slope from the left abutment looking right. Note limited freeboard at the dam.

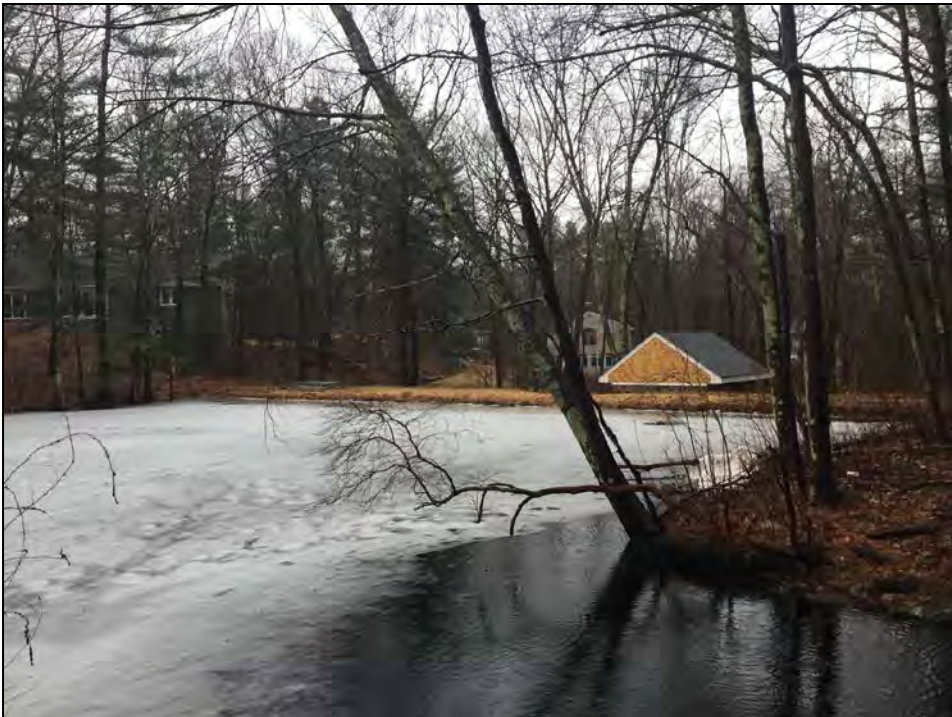
Photo No. 4: Overview of the upstream face of the dam from the spillway approach looking downstream and left..

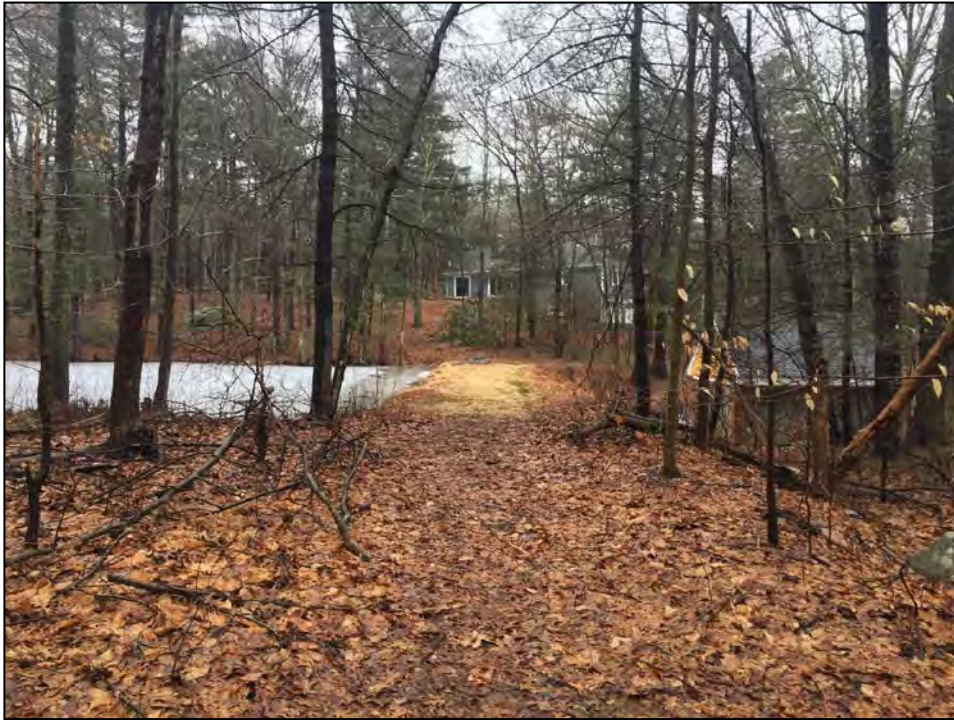
Photo No. 5: Crest of the dam from the stone culvert looking left.

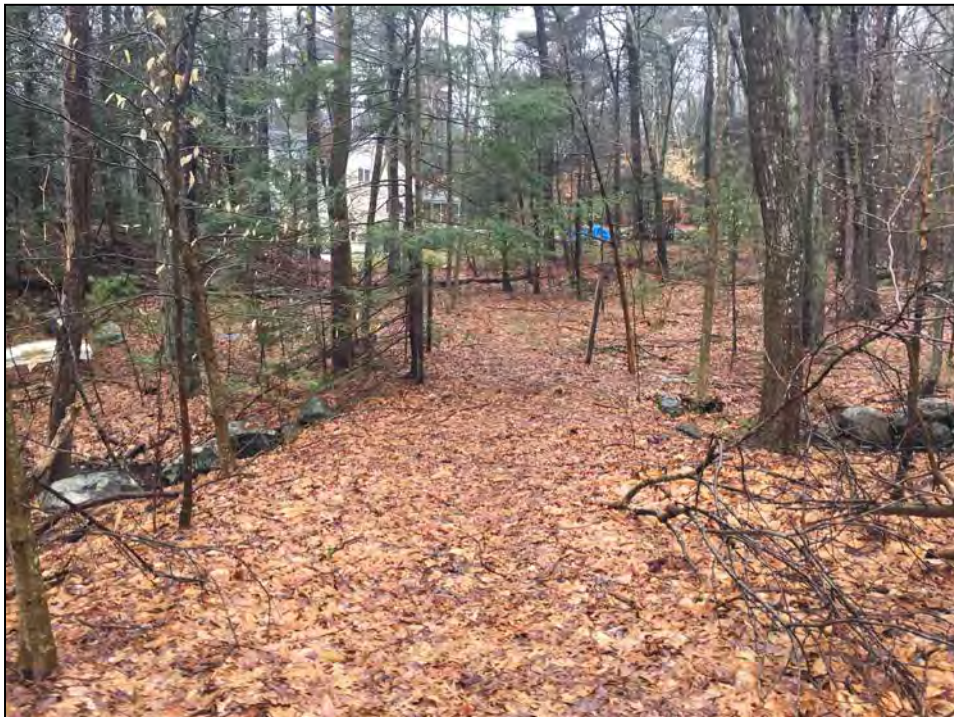
Photo No. 6: Crest of the dam looking right.

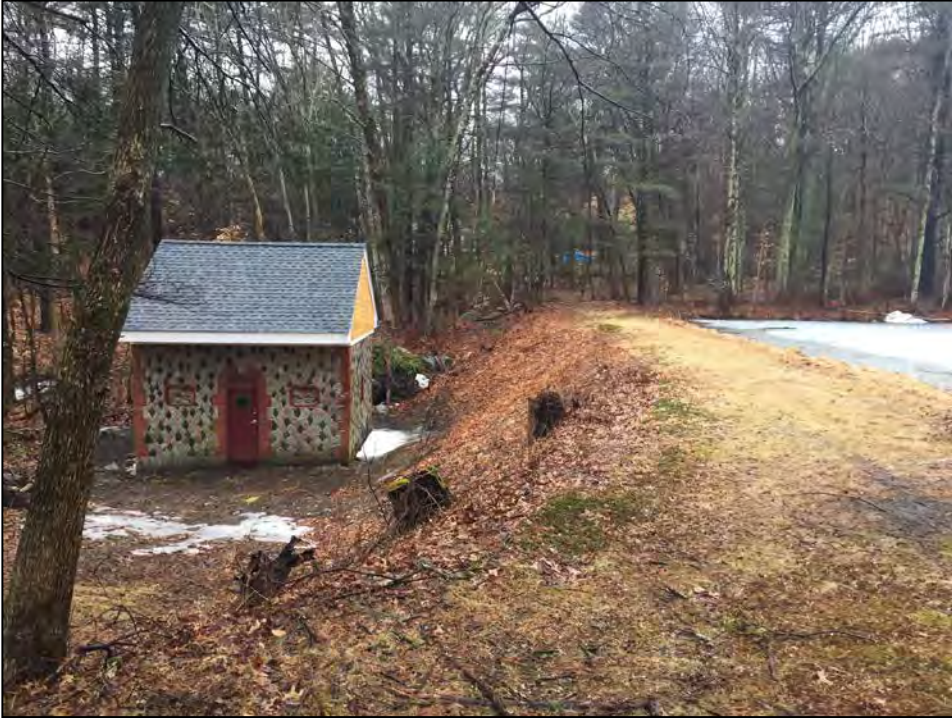
Photo No. 7: Downstream slope from the left abutment looking right.

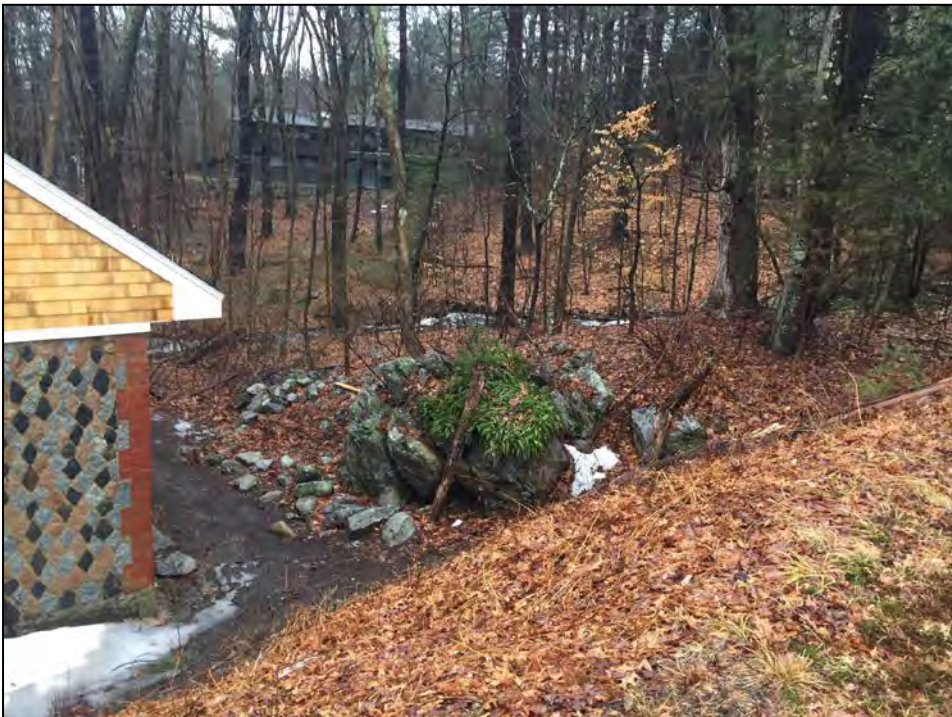
Photo No. 8: Apparent bedrock outcrop in the downstream slope right of the gatehouse.

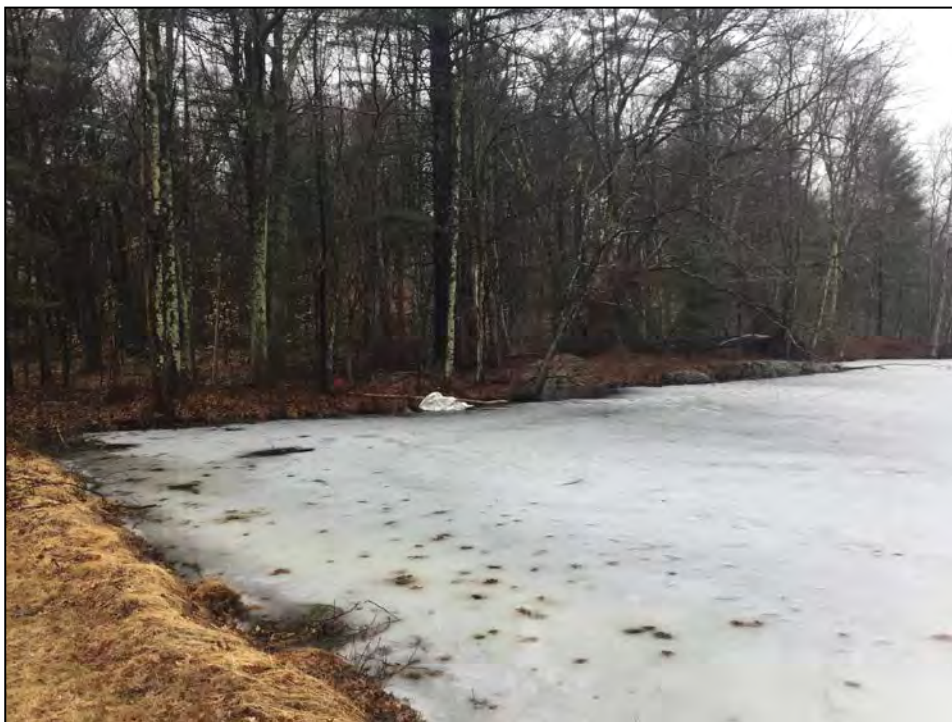
Photo No. 9: Spillway approach from the dam crest looking upstream and right..

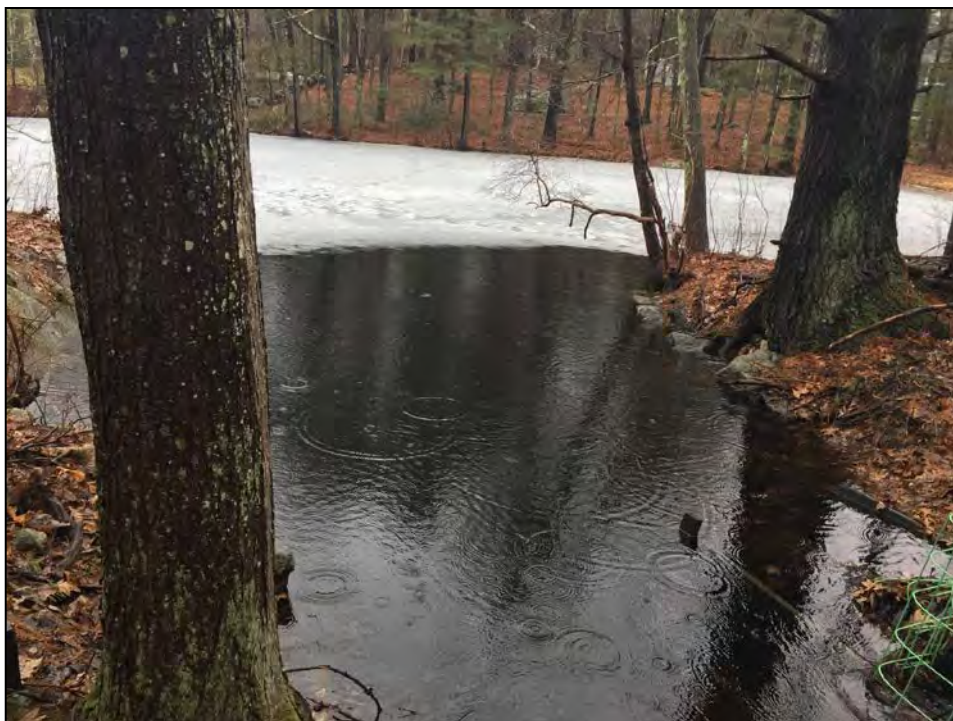
Photo No. 10: Spillway approach from the control section looking upstream.

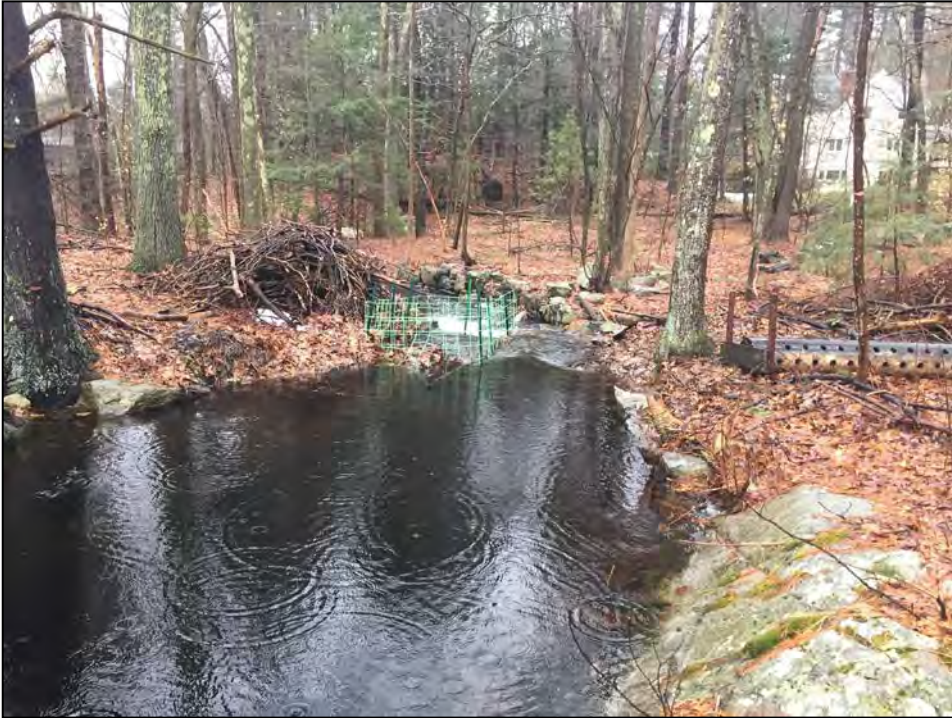
Photo No. 11: Spillway control section from the approach looking downstream. Note apparent bedrock outcrop in picture foreground.

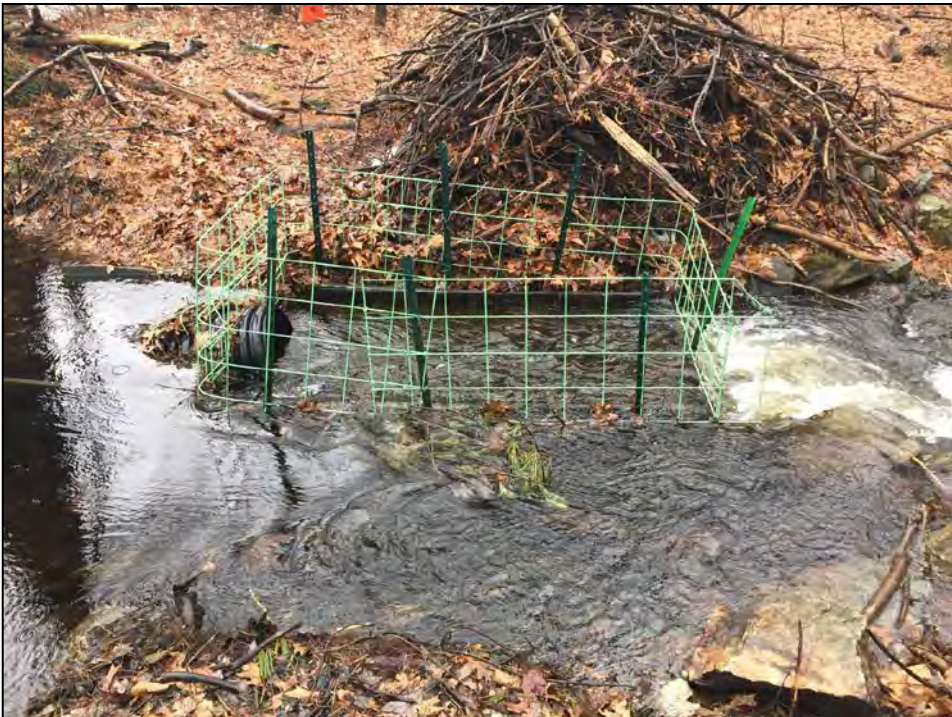
Photo No. 12: Spillway control section with apparent past beaver deceiving devices.

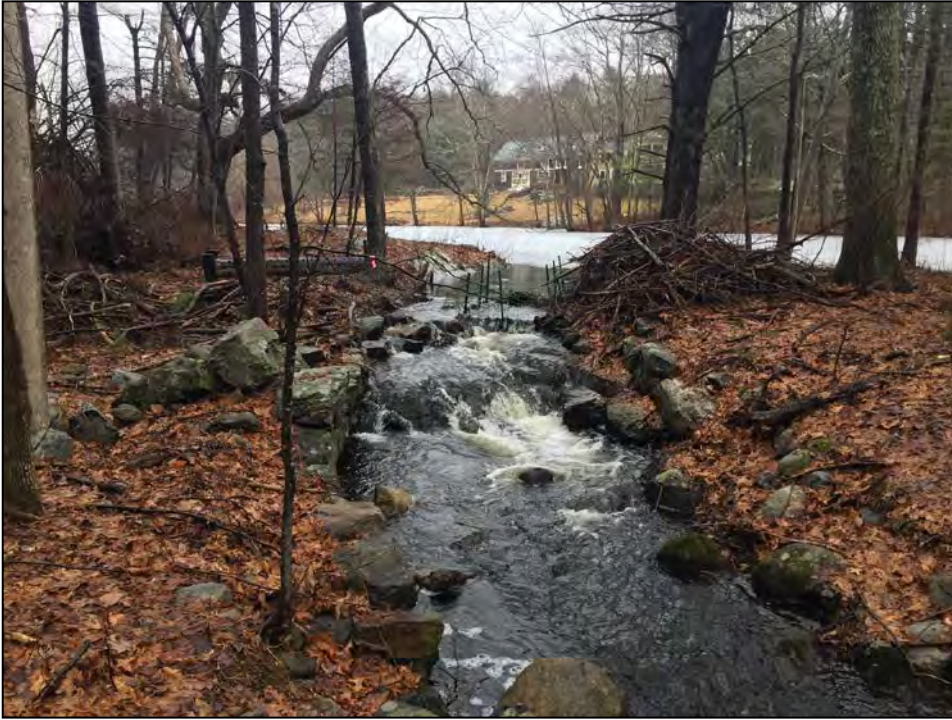
Photo No. 13: Discharge channel of the spillway.

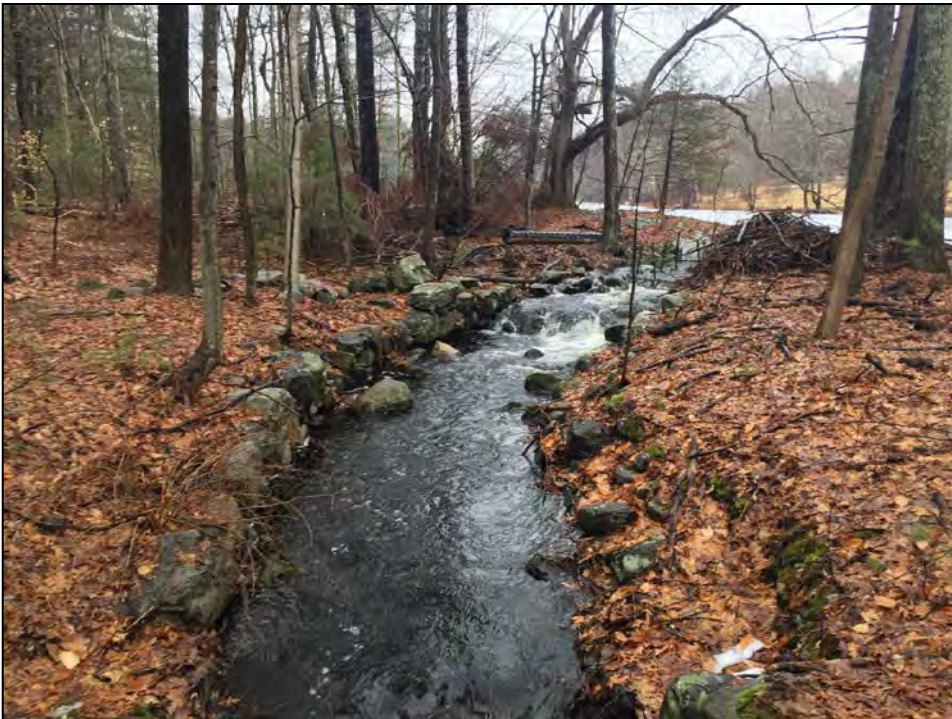
Photo No. 14: Discharge channel of the spillway.

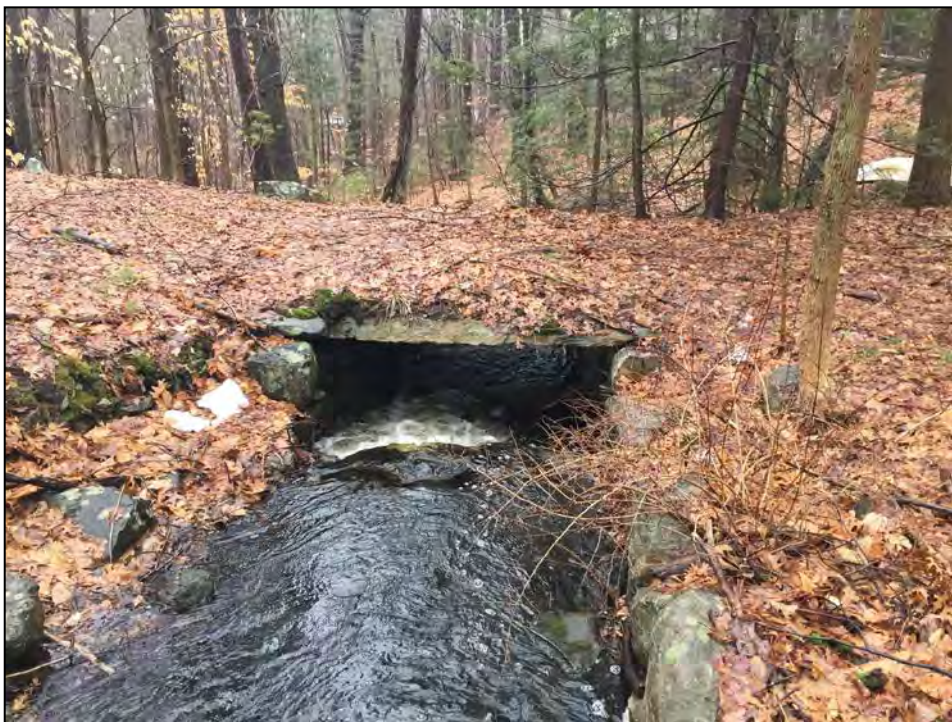
- It was noted that one of the roof stones of the culvert (approximately 10 feet upstream of the downstream end appeared lower than the rest and may be partially collapsed.

Photo No. 15: Stone culvert that carries the spillway channel beneath the crest.

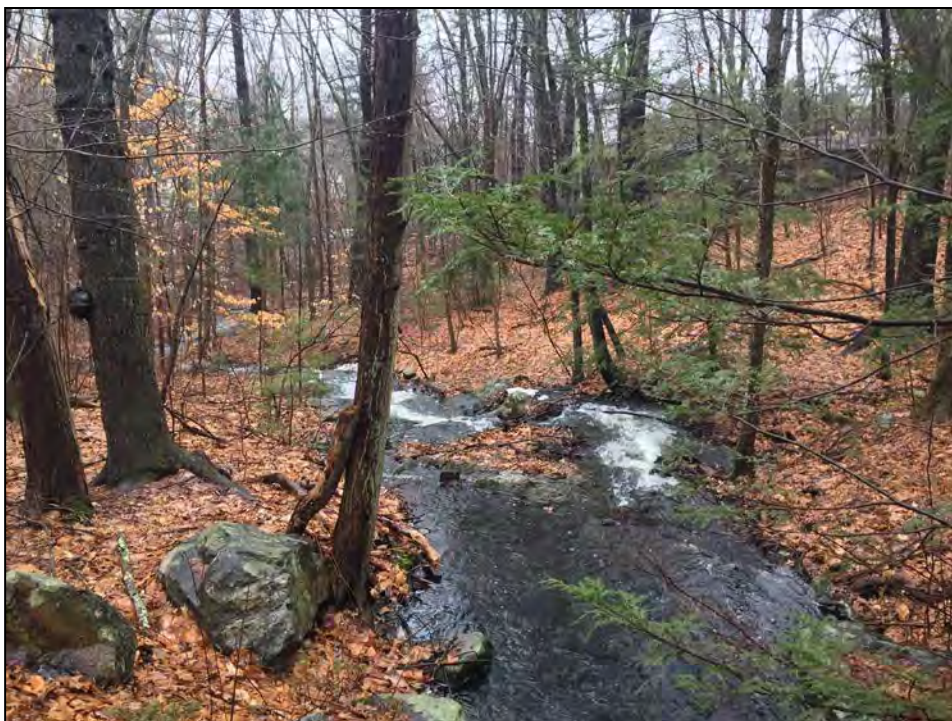
Photo No. 16: Discharge channel of the spillway from the stone culvert looking downstream.

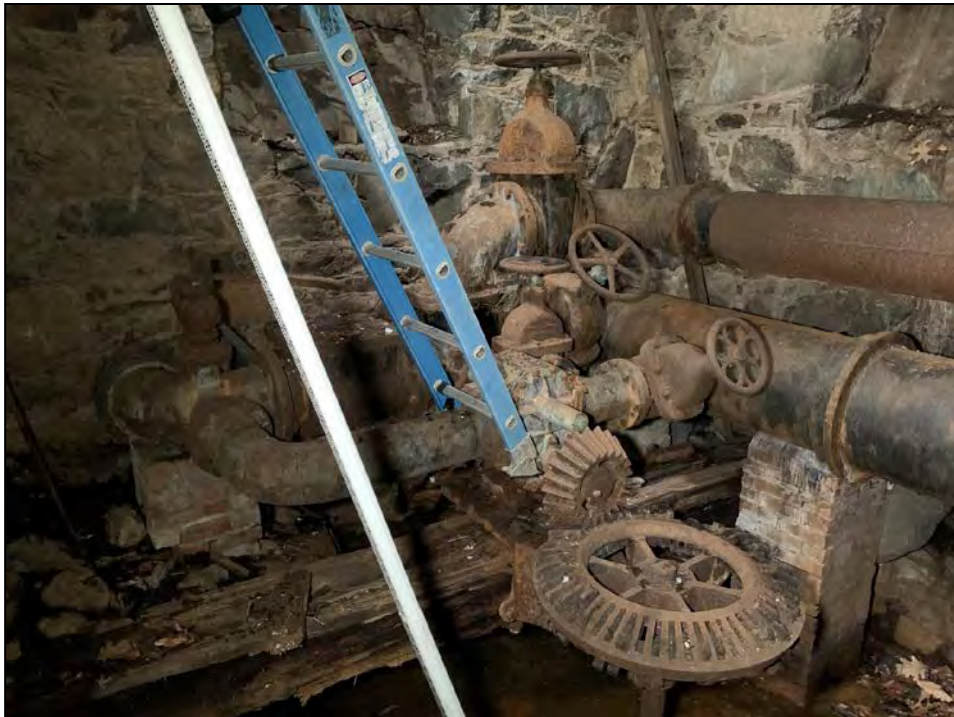
Photo No. 20: Overview of the water supply piping from the upstream left corner of the gatehouse looking downstream and slightly right.

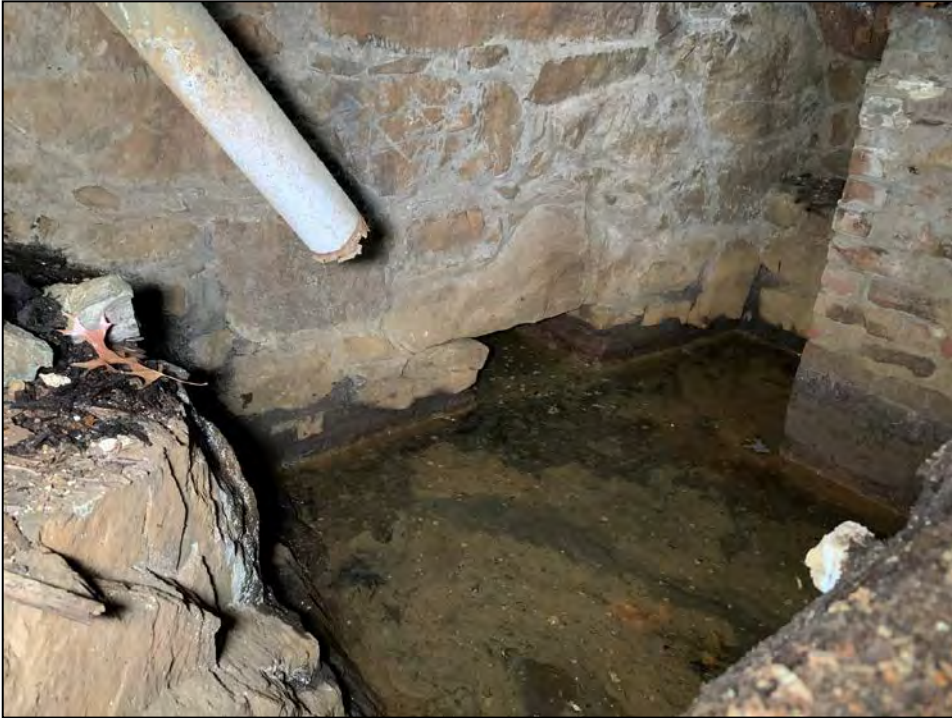
Photo No. 21: Outlet culvert in the base of the downstream wall of the gatehouse.

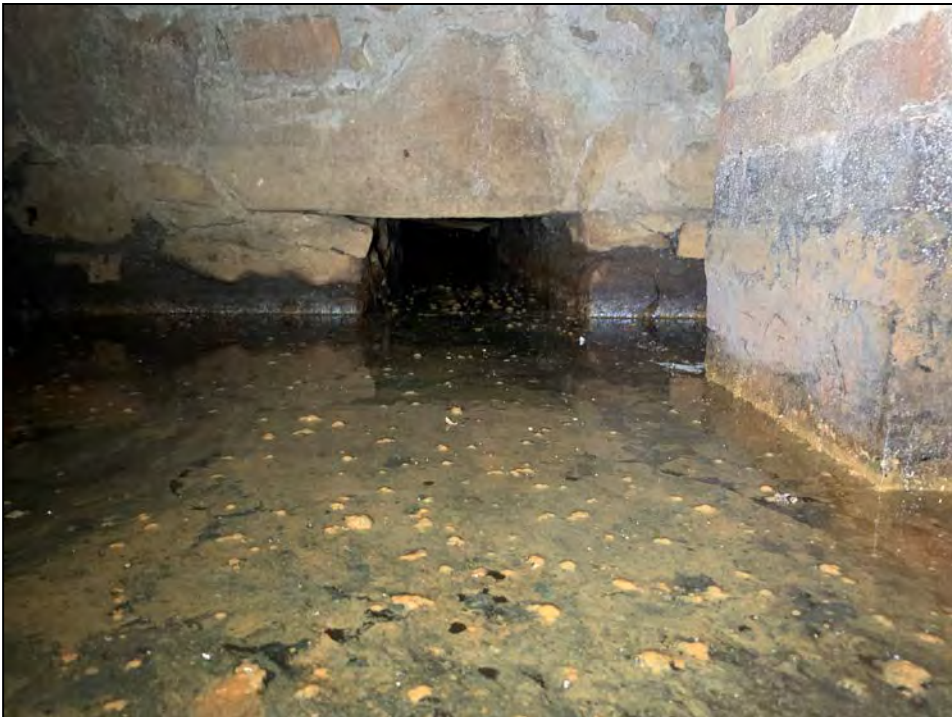
Photo No. 22: Outlet culvert.

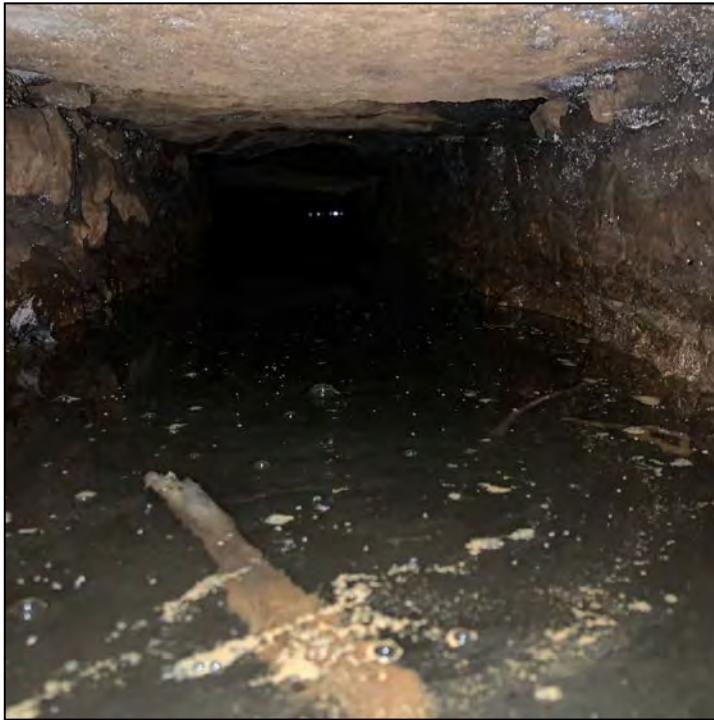
Photo No. 23: Outlet culvert interior from the upstream end at the gatehouse looking downstream. Note daylight at the downstream end of the culvert at the downstream channel.

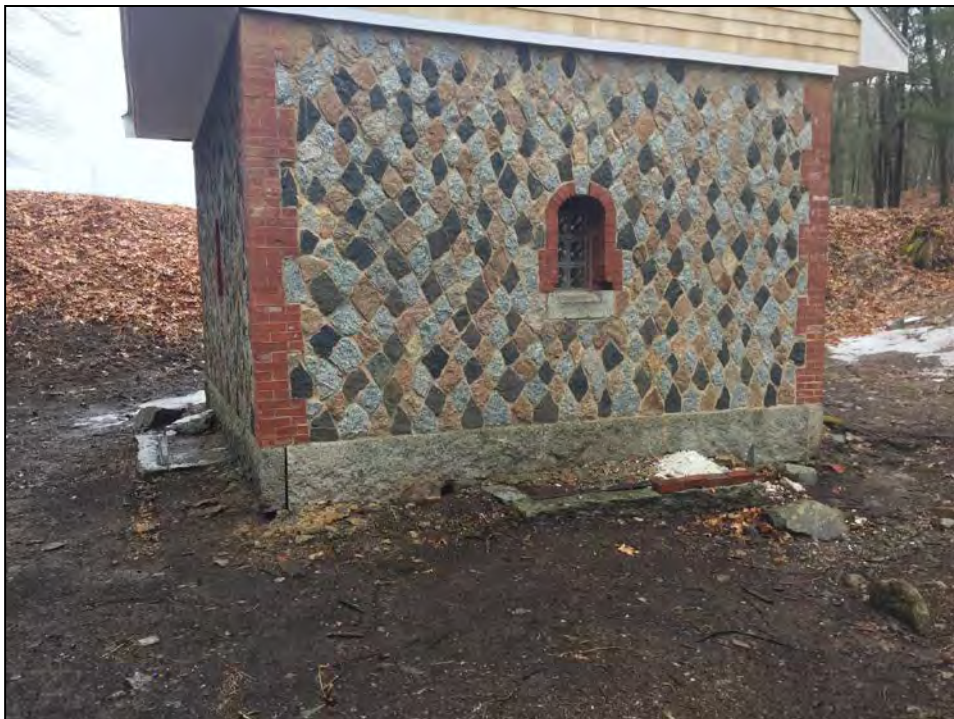
7. Areas of overgrown tree and brush vegetation along the dam embankment.
8. Gatehouse deficiencies including collapsed roof, inoperable door, and no safe access to mechanical equipment.

Photo No. 24: Downstream wall of the gatehouse superstructure.

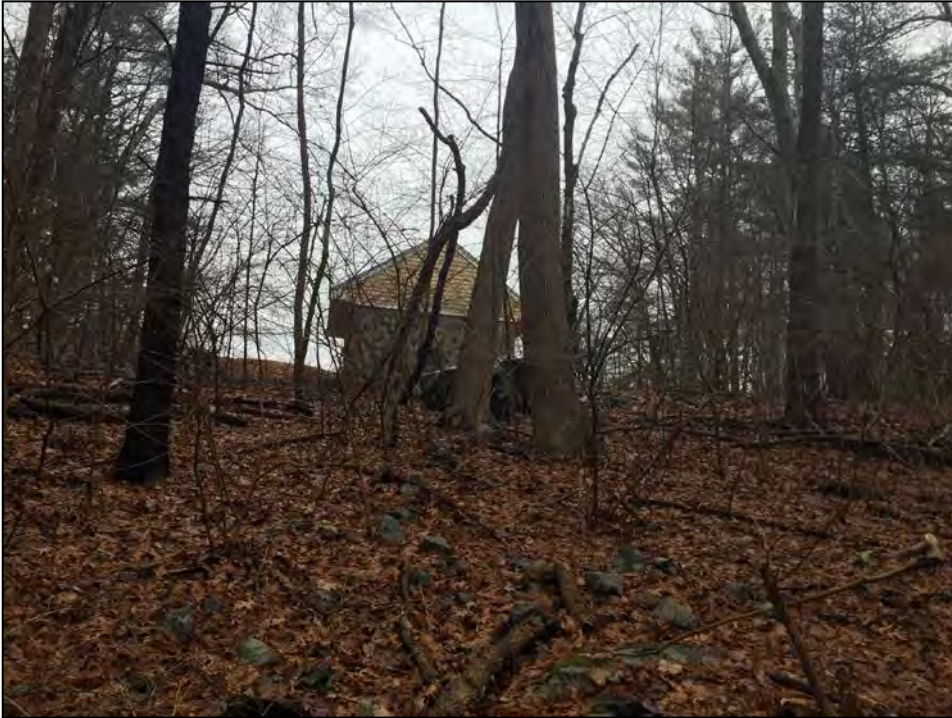
Photo No. 25: Ground surface along alignment of outlet culvert from the outlet end of the culvert looking upstream.

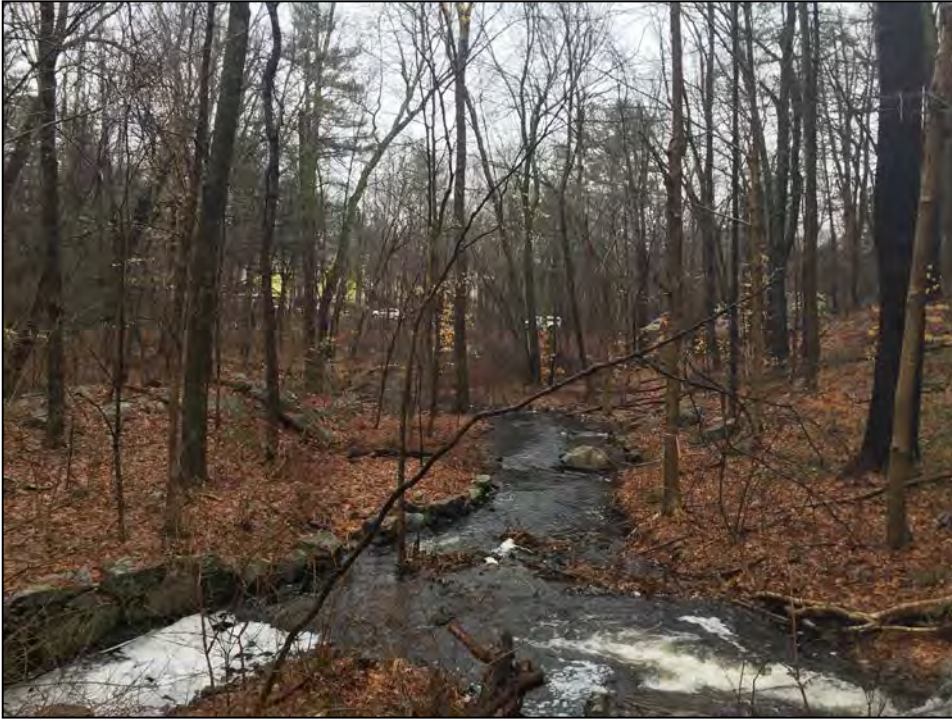
Photo No. 27: Downstream channel. Note Woodbridge Road culvert crossing located several hundred feet downstream.

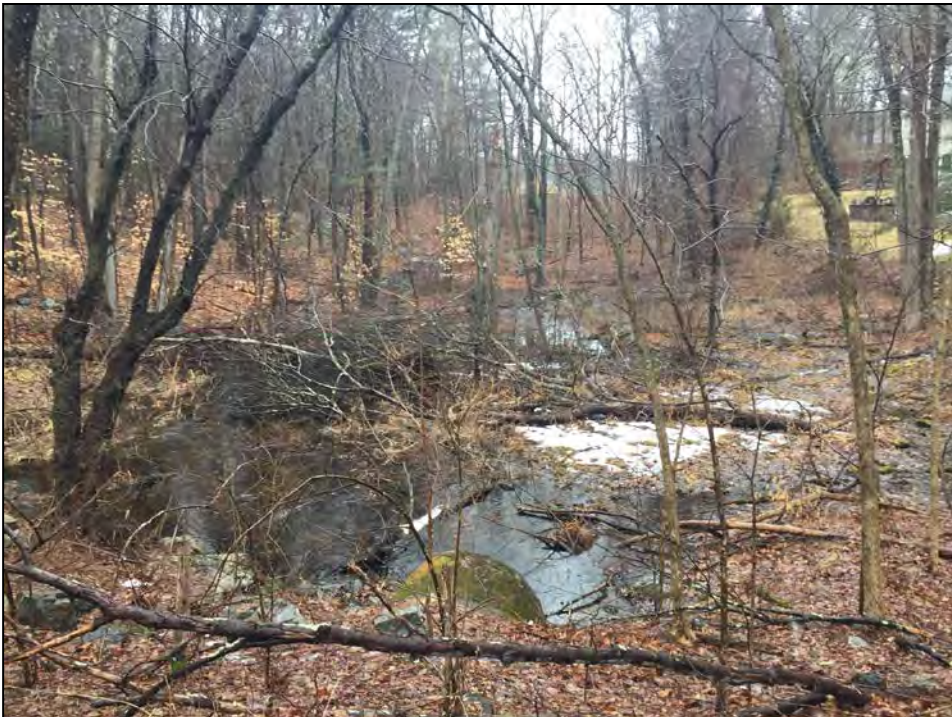
Photo No. 28: Downstream channel from the Woodbridge Road culvert crossing looking upstream.

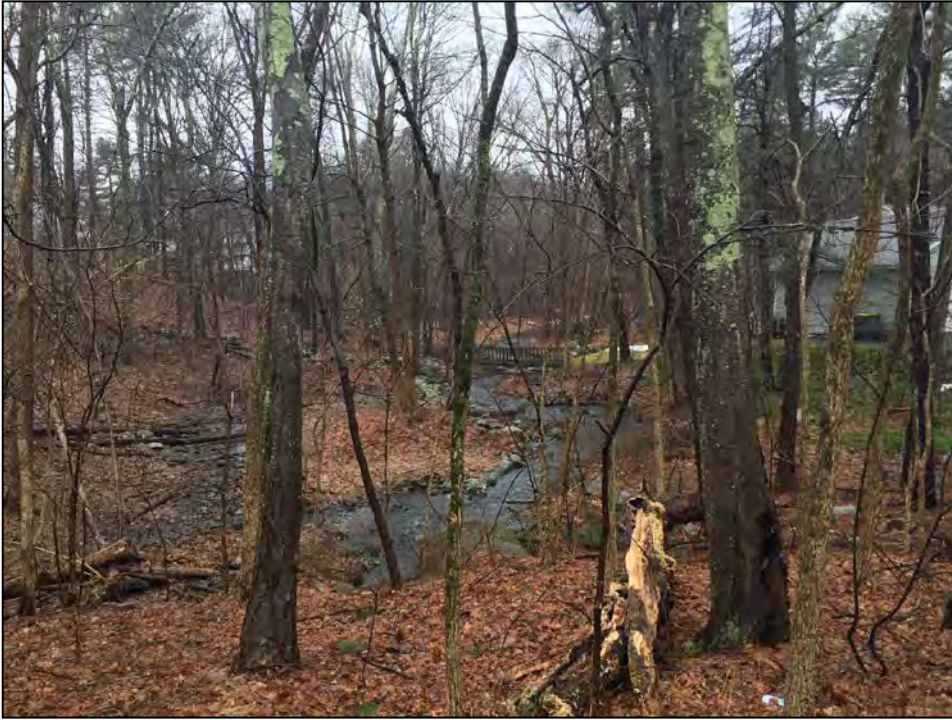
Photo No. 29: Downstream channel downstream of the Woodbridge Road culvert crossing.

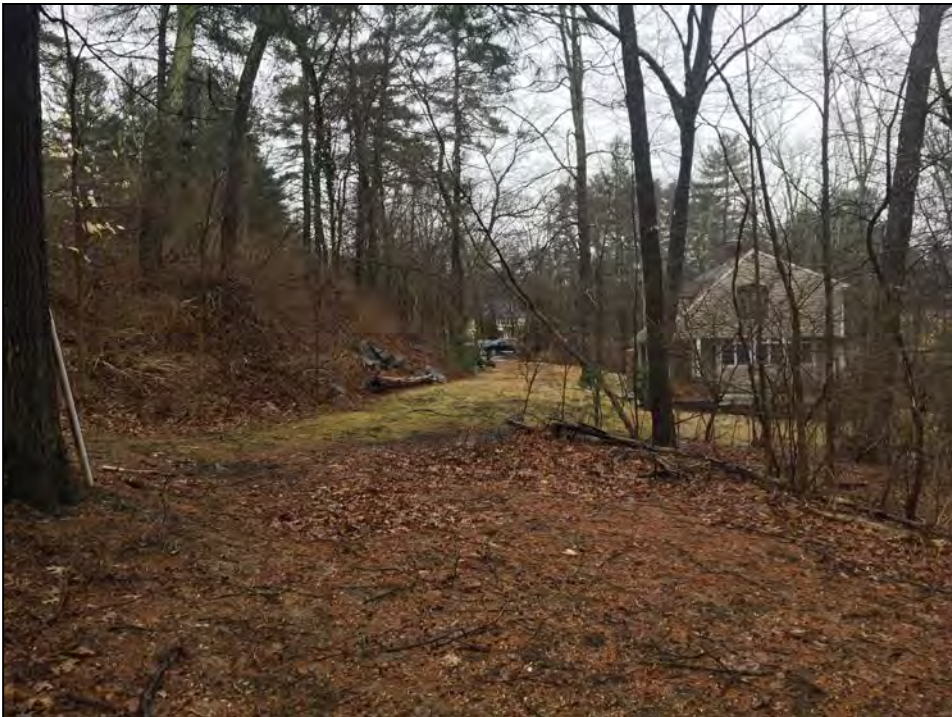
Photo No. 30: Access easement to the left abutment of the dam through 68 Rice Road property.

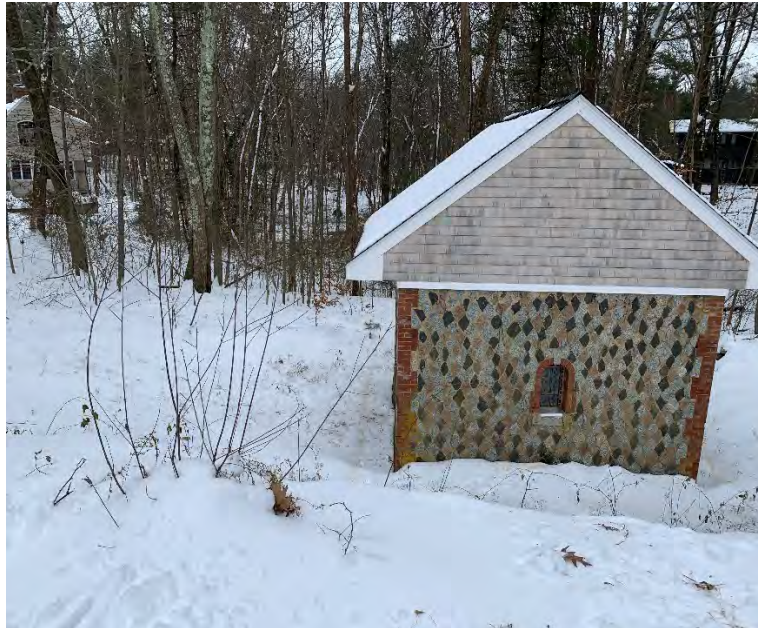
After setting up and testing the diving equipment, a triangular hole was cut into the ice roughly in line with the edge of the gate house. The diver entered the water and found the dam face was covered with a soft layer of mud, leaves and other organic debris. A search was conducted for the outlet pipe. After searching a reasonable distance from the access hole, the derelict water pipe was located but not the low level outlet. Another access hole was cut into the ice after scaling out approximate distances and known locations from the gate house. The diver located the city water pipe where it crosses over a rock wall located at the toe of the dam. The low level outlet was found by searching through the soft mud below the city water pipe, down the side of the rock wall. The outlet pipe was found to be 75% filled with mud in the rock wall. The diver had to push his hands into the mud to locate the pipe. An attempt was made to place the robotic camera into the outlet pipe. Visibility was 0 due to the mud and the robot could not traverse through the soft mud.

Inner Tech assisted the Pare resident engineer to perform inspections of the inside of the gate house. The piping inside was rusted and a level control mechanism appeared inoperable. A large gate valve was noted which was believed to be the low level outlet gate. The gate appeared non functional. The outlet pipe had a 1 inch plugged tap hole in the side, perhaps for water sampling or pressure testing.

REMEDY PROCEDURES: The outlet pipe could not be inspected due to the presence of the soft mud inside the pipe. Possible remedies for eliminating the mud are placing an inflatable plug with a bypass in the outlet pipe and attempt to operate the outlet gate, to flush out the mud. The gate could be repaired to replaced while the plug is in place. Tapping a large hole into the outlet pipe in the gate house and installing a gate valve. Attempt to pump out the mud in the outlet pipe from the outside.

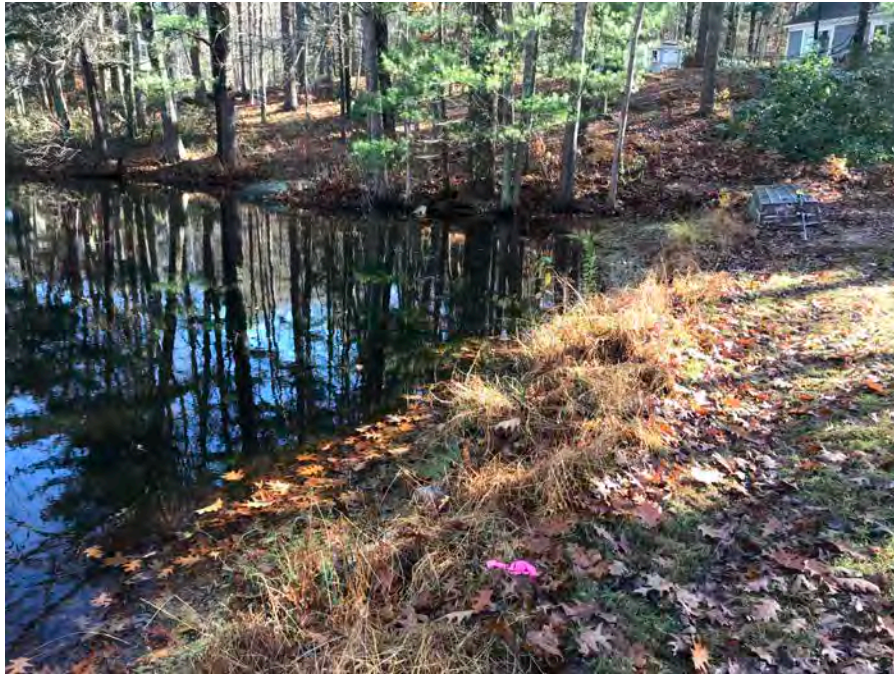
Photo 1: Bank along upstream slope of embankment, consisting of maintained grass slope.

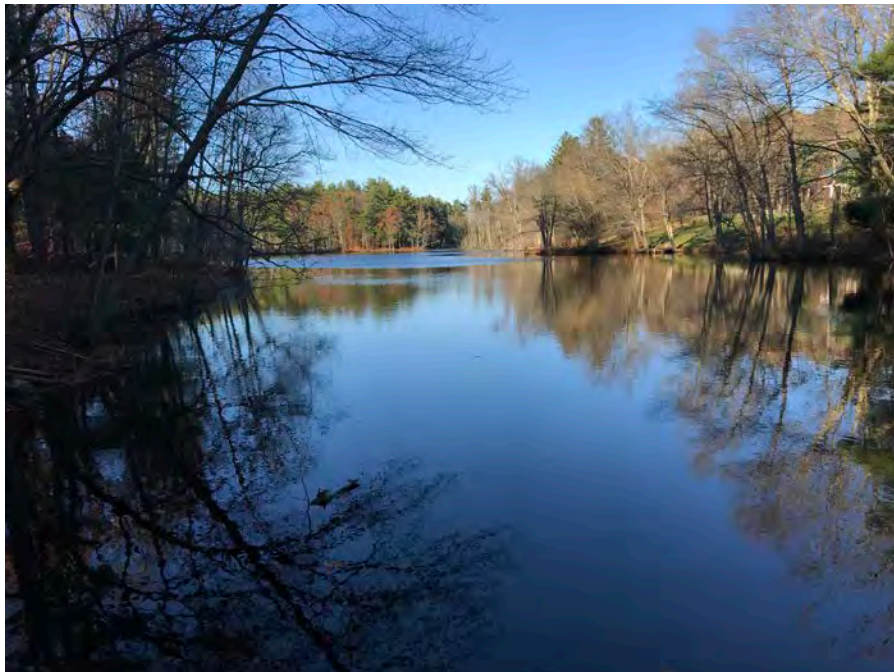
Photo 2: View of impoundment, facing north from dam.

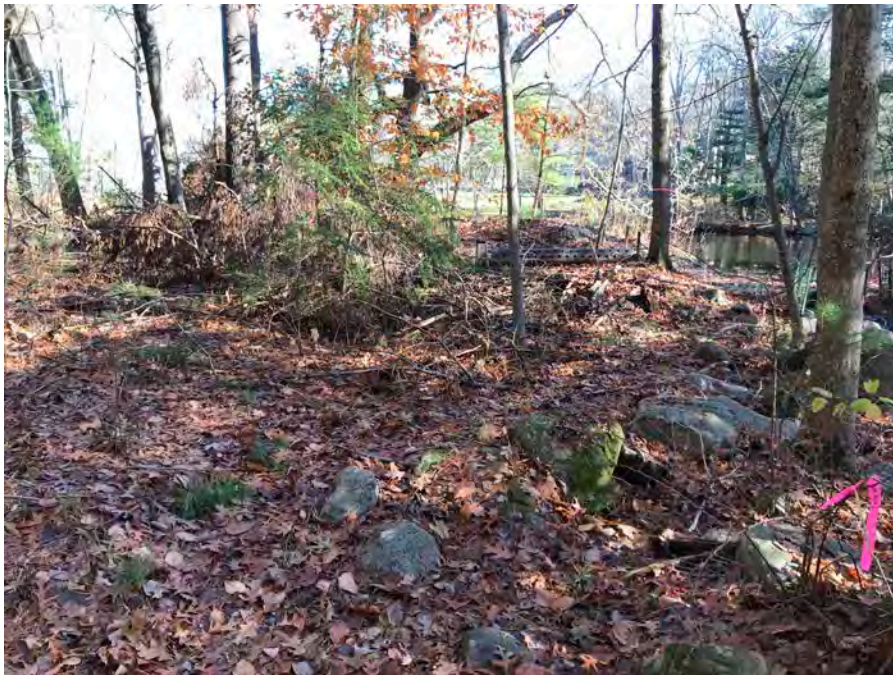
Photo 4: A-series BVW to the west of the impoundment and outlet.

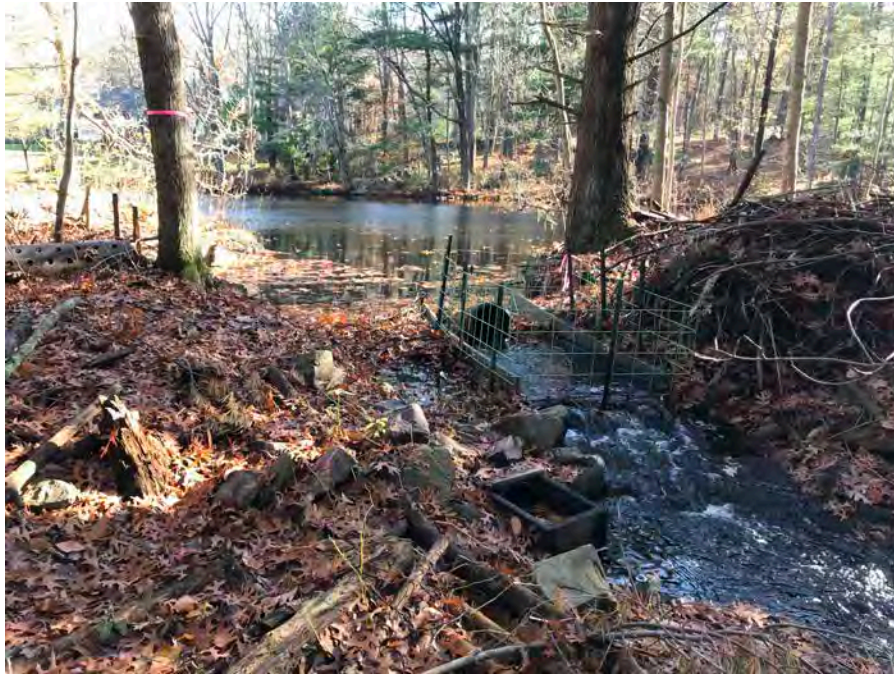
Photo 5: Uncontrolled spillway with beaver control device at right abutment.

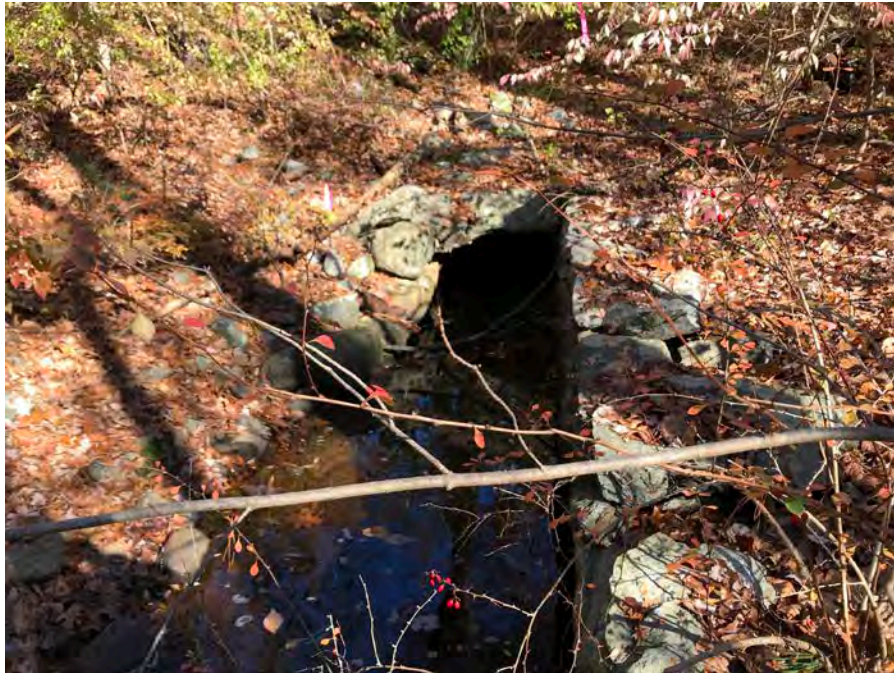
Photo 7: Walled outlet channel downstream of dam, located between flags R-12 and R-15.

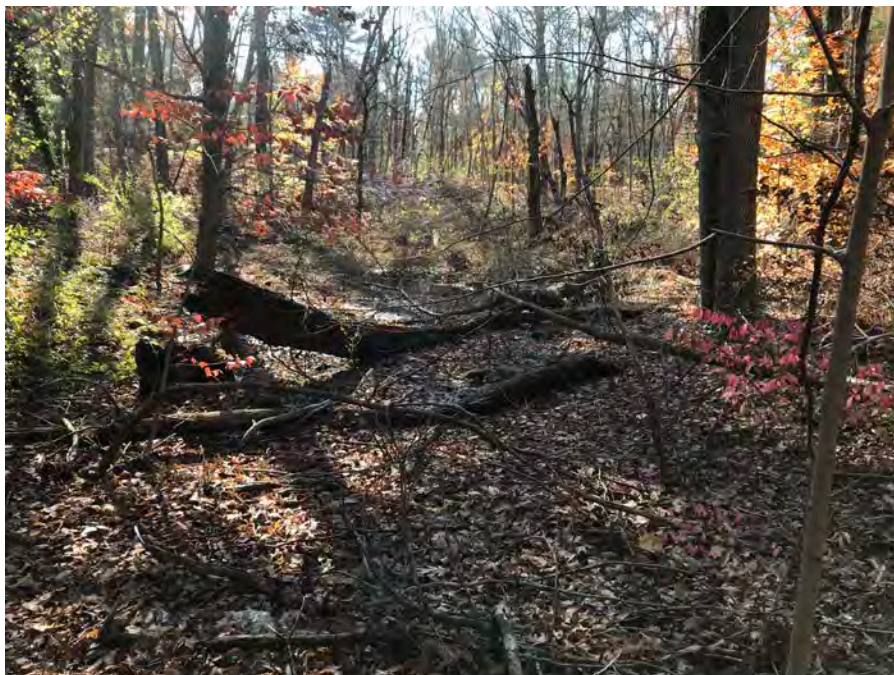
Photo 8: B-series BVW within the wooded area downstream of the dam.
