PREPARED FOR:
THE TOWN OF WAYLAND CONSERVATION COMMISSION

DESIGN BASIS REPORT
SNAKE BROOK DAM
MA01119
WAYLAND, MASSACHUSETTS

PARE PROJECT NO. 19167.00

APRIL 2020

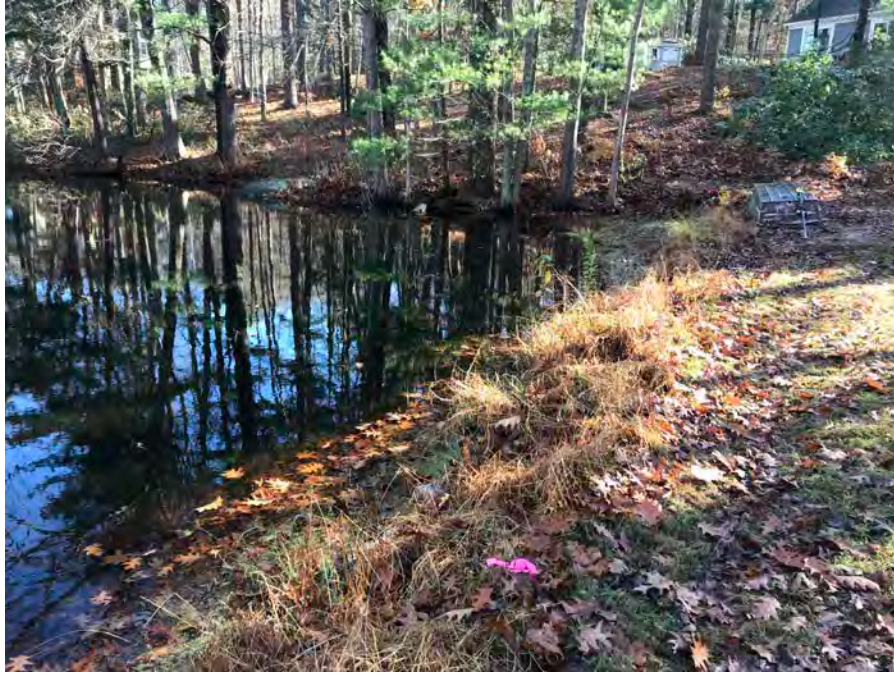
Photo 1: Bank along upstream slope of embankment, consisting of maintained grass slope.

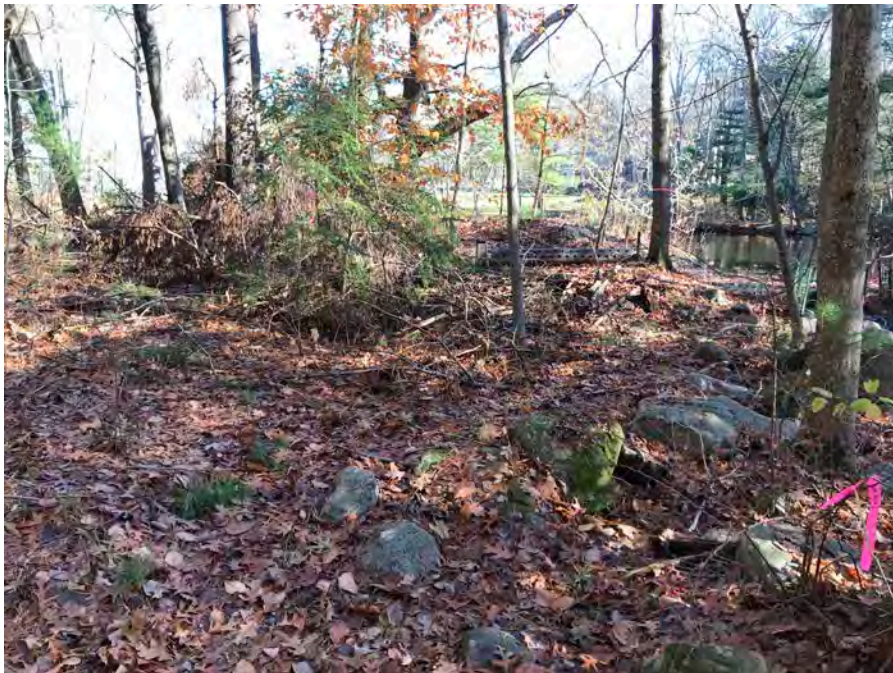
Photo 4: A-series BVW to the west of the impoundment and outlet.
